# CACHE CREEK ANNUAL STATUS REPORT 2011

Cache Creek Technical Advisory Committee:

**February 28, 2012**

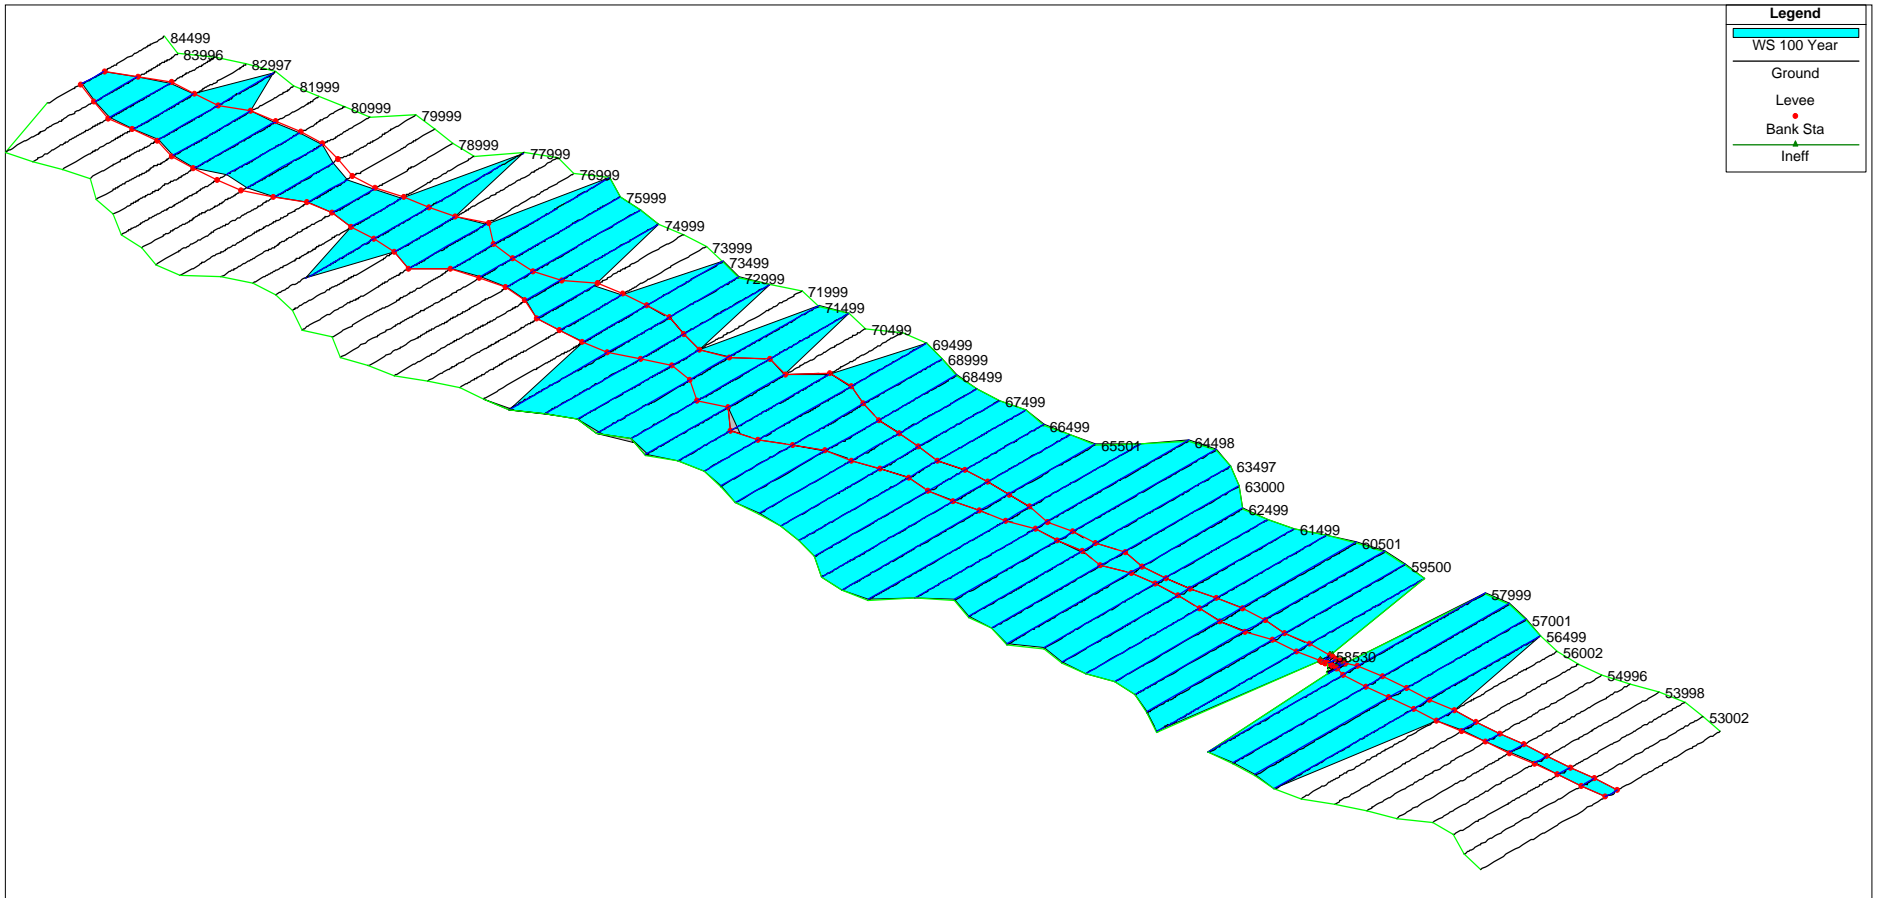
**Figure 4 HEC-RAS figure showing the over-bank flooding in the vicinity of Huff's corner**

In general, the results show that the 100-year flood overtops the banks in the vicinity of Huff's corner, but does not overtop the banks both upstream and downstream from Huff's corner. This has been observed and reported anecdotally (Pers. Com. Pollock, Adamo.)

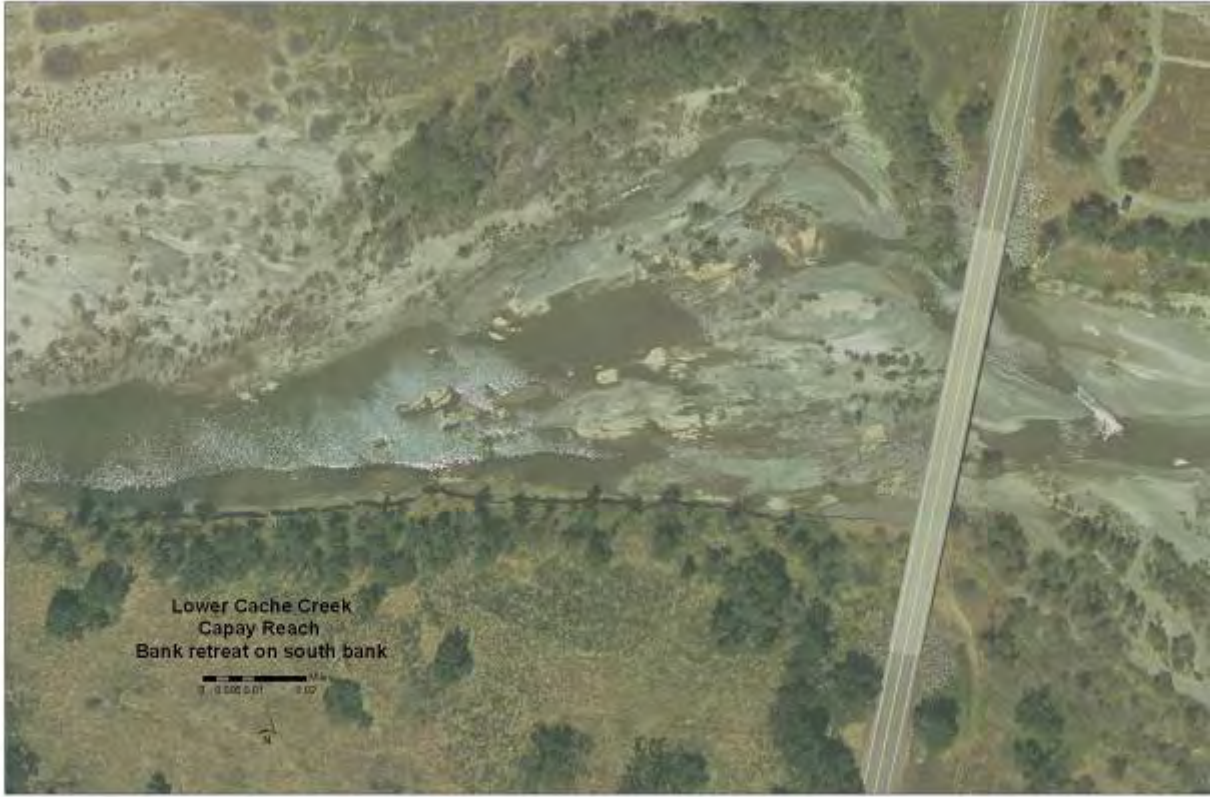
Figure 23 b Capay Reach detail of bank retreat on the south bank near Capay Bridge

Figure 24 shows the bank retreat patterns in red. In 2006-2010 the main area of bank retreat was between RM 26.5 and 26.4 on the south bank, with a smaller area underneath and downstream from the bridge (Figure 24 upper image). In 2010-2011, the patterns were similar, but there was more bank retreat immediately downstream and upstream from the bridge (Figure 24 lower image). The area between RM 26.5 and 26.4 on the south bank continued to shift in 2011. This area should be actively monitored for possible future action. No remedial action is recommended at this time

- **Channel shifting patterns** near RM 26.4 on the south bank near Capay Bridge, which has resulted in erosion near the south side of the bridge, should be actively monitored for possible future action. No remedial action is recommended at this time.

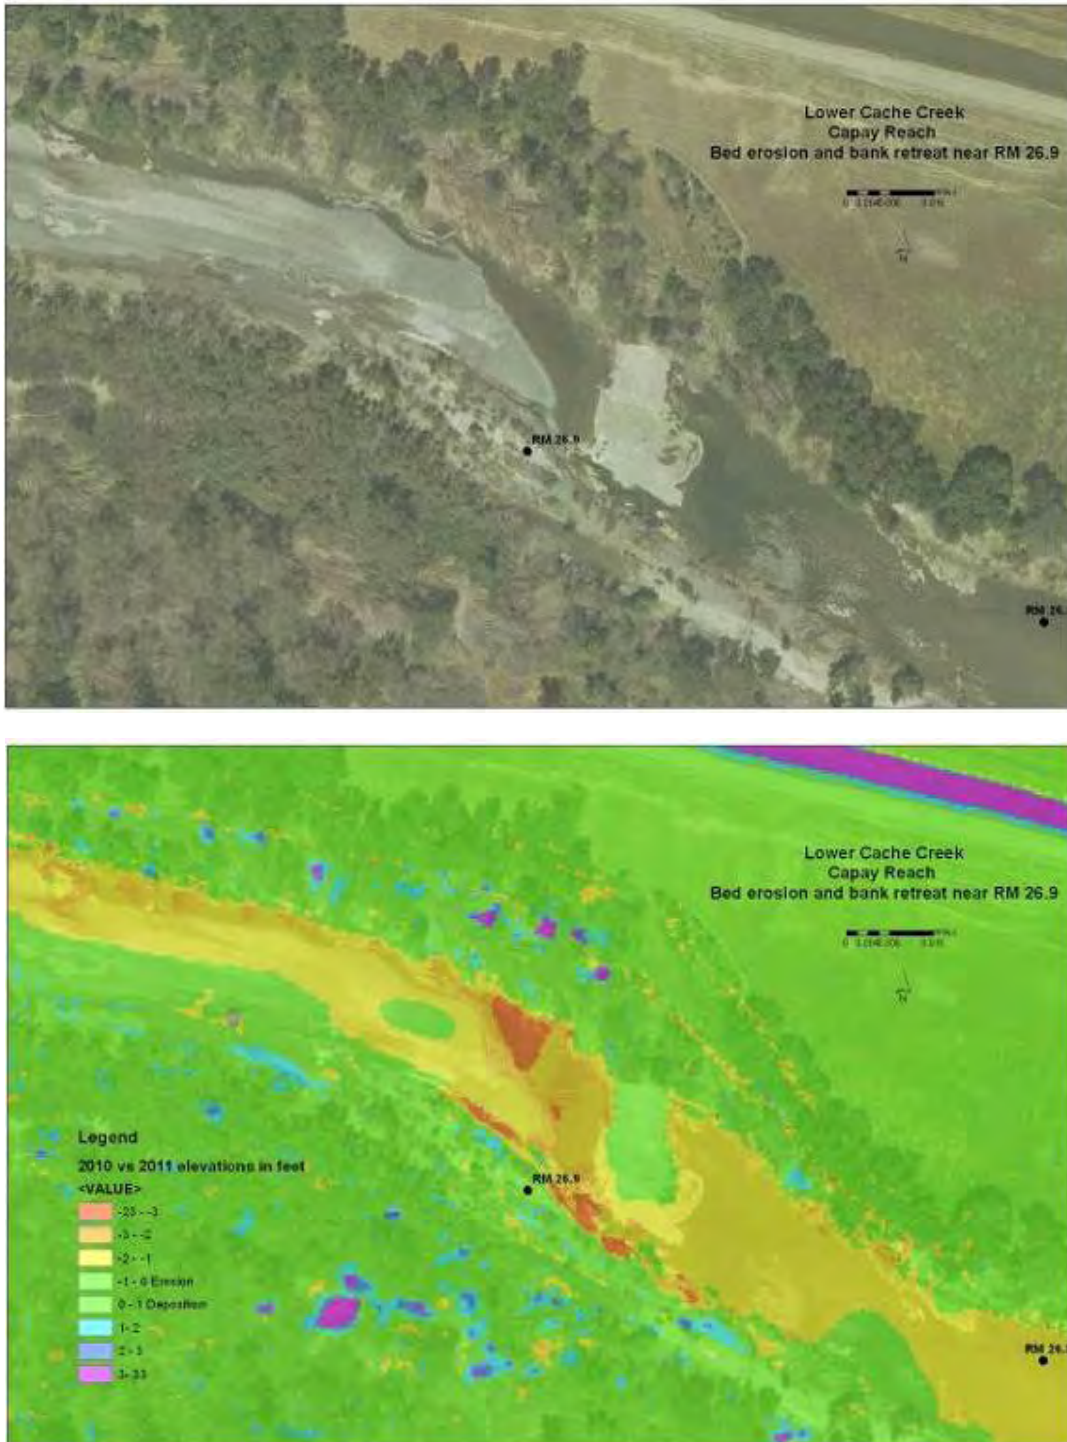
Figure 25 Capay Reach detail of erosion near PGE pipeline crossing RM 26.9

Another area that shows significant elevation change between 2010 and 2011 is in the reach immediately downstream from the diversion dam. In addition, the 2010-2011 data show erosion in the bed immediately upstream from the PGE crossing and bank retreat on the south bank across from the concrete pillows that have been installed in the creek (Figure 25). Continued coordination with PGE is recommended to insure that new stabilization is consistent with the CCIP.

- DTM analyses show that **bank erosion** at RM 26.9 on the south bank is occurring adjacent to the PGE instream structure. The TAC recommends continued engagement with PGE to insure that new stabilization is consistent with the CCIP, and that the existing right-of-way weed management problems are resolved.

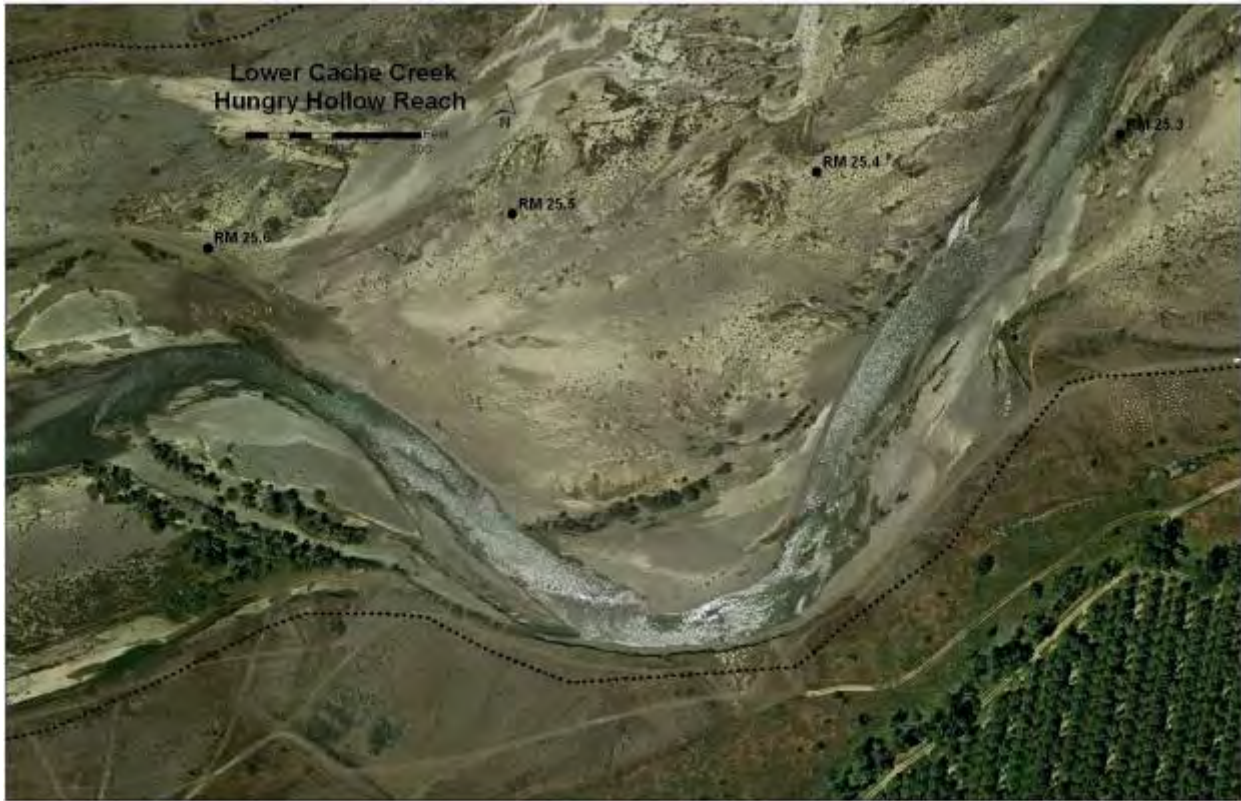
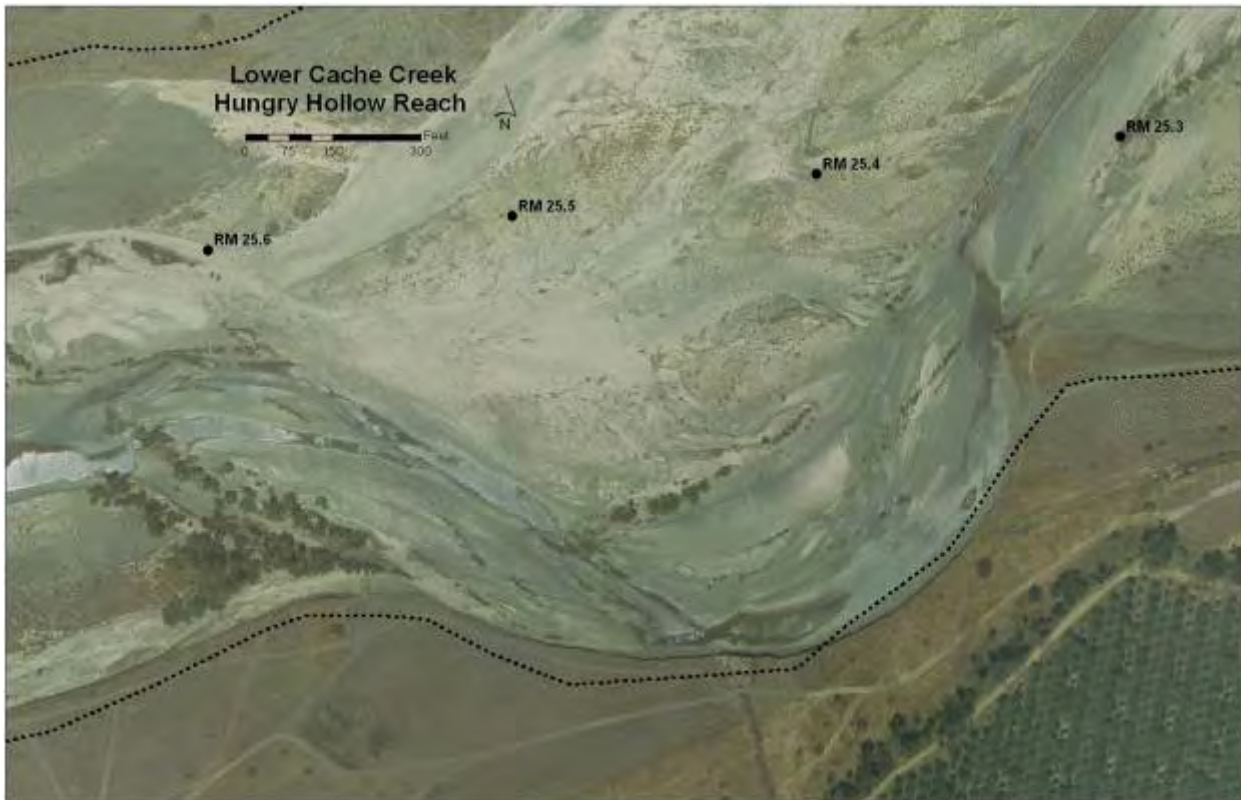
**Figure 29 Hungry Hollow Reach RM 25.5-25.4 detailed photos showing bank migration  
The top photo is from 2010, the bottom photo is from 2011.**

A similar process is occurring, to a lesser degree, near RM 24.0 in this reach.

18. Coordinate with full TAC in 2012 to **identify areas and sites best suited for natural regeneration of riparian habitat conditions** due to changing physical conditions (e.g. see geomorphologist's discussion of channel shift near RM 25.4-25.5).

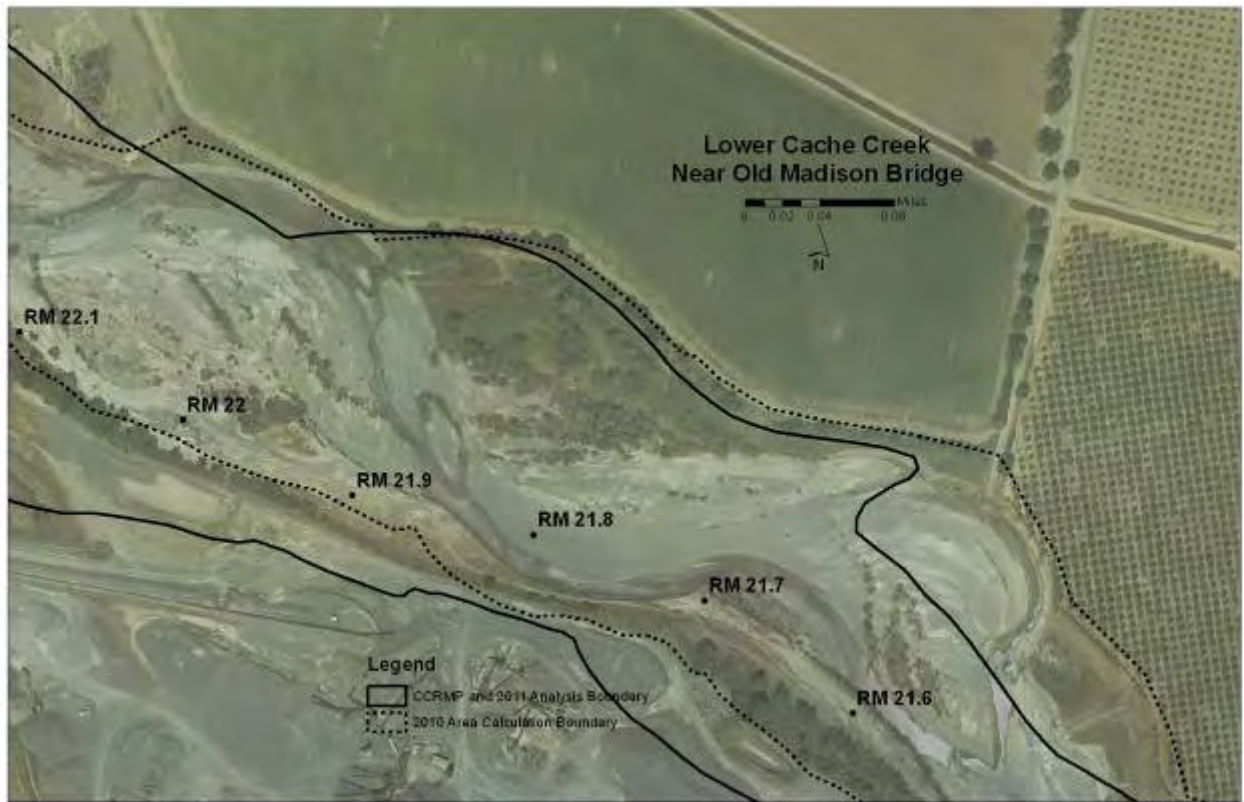
Figure 36 Old Madison Bridge site 2011 aerial photo

An additional observation is that there is an area upstream near RM 22.0 on the north bank that is experiencing active bank retreat (Figure 36.) This can be seen on the cut/fill maps that were made from the Towill 2011 data (Figure 38). Figure 37 (upper image) represents 5 years of bank erosion and Figure 37 (lower image) represents a single year of bank erosion. The area near RM 22.0 has eroded significantly, and the meander modeling and the cut and fill maps suggest that the bank retreat will continue near RM 22.0. This bank retreat is occurring in a low flood plain terrace (Figure 38) and the curved bend is likely to continue to move downstream. As it progresses over the course of many years, it is likely to develop and build a new floodplain terrace (in its “wake”), which could create habitat for riparian vegetation, either actively restored or naturally regenerated.

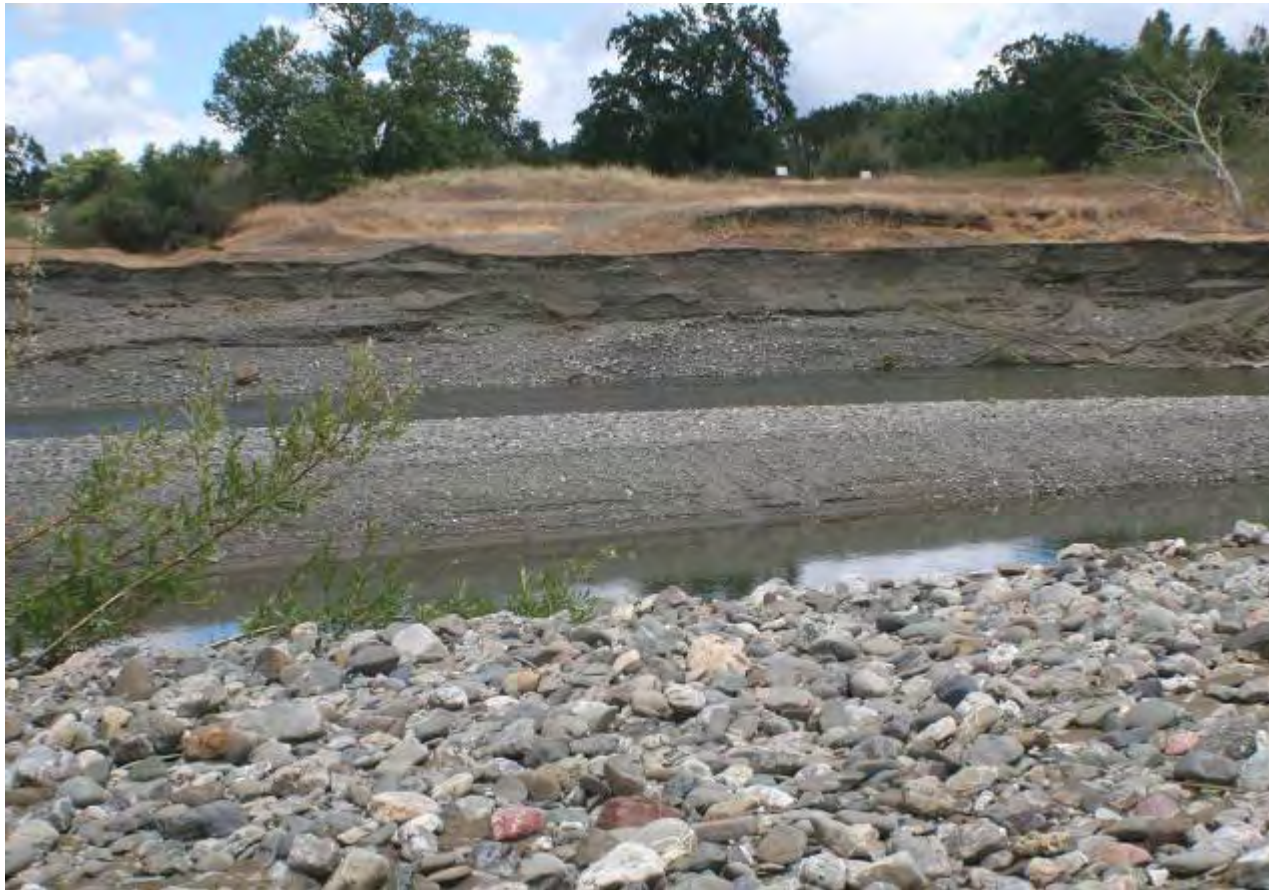
**Figure 47 Bank retreat upstream from Moore's Siphon (Horner photo)**

During the 2011 Creek Walk, the TAC visited a site where a local landowner expressed concern about the channel dynamics and bank retreat at the bend immediately upstream from the Moore's Siphon (Figure 47).

- Channel **bank retreat** upstream from Moore's Siphon near RM 18.1 was noted and should be monitored. No remedial action is recommended at this time.

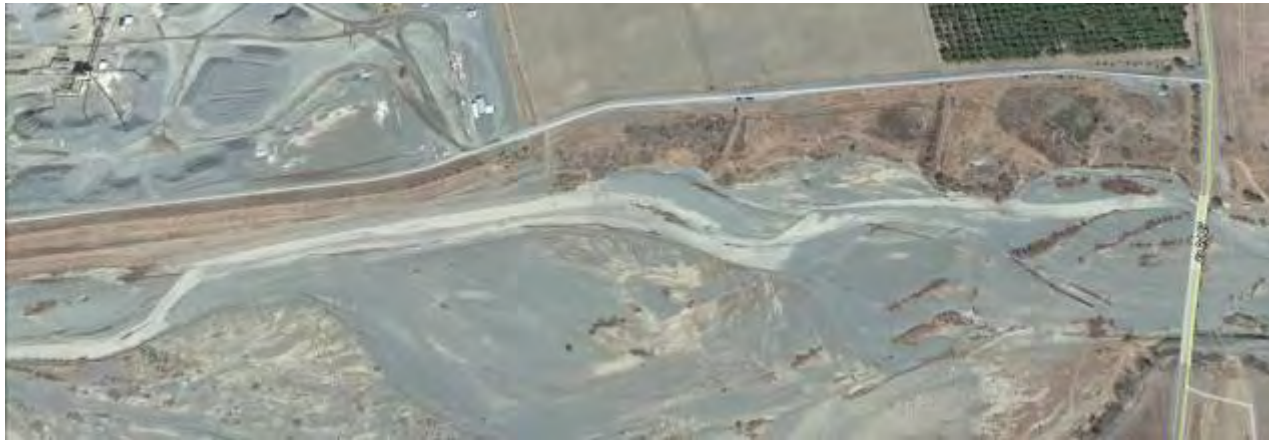
Figure 59 a Esparto Bridge (County Road 87) River Mile 24.4

Low spur dikes are located upstream from the bridge, on the north bank. These spur dikes have trapped fine sediment, are vegetated, and seem to be working as control structures. The river's width is constricted by a factor of 0.3-0.5 as it flows under the bridge. Four large concrete abutments are located in the active channel. In this location, the north bank pier has eroded with a scour hole observed. Other piers seem to be buried under 6-10 feet of mobile stream gravels. It was observed that the main active channel of the creek at the bridge was on the south side of the channel boundary until four years ago, and during the last four years the channel was on the north side. The west (upstream) cross sections show some degradation between 2010 and 2011.

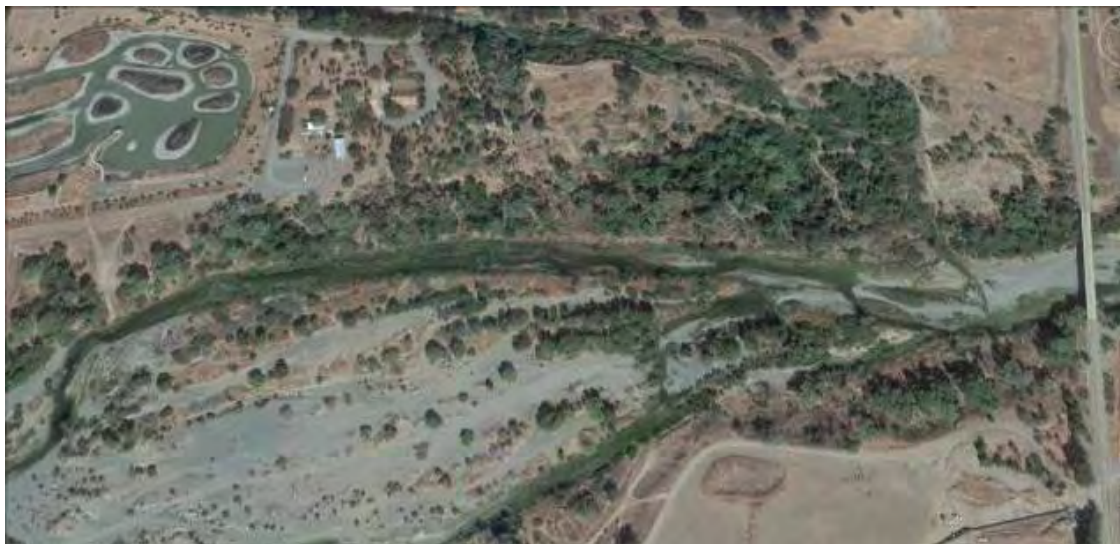
Figure 68 a County Road 94b Bridge

At the County Road 94b Bridge near the Cache Creek Nature Preserve, the cross section profiles looking upstream show that there is no significant pattern of erosion or deposition between the surveys of 2001 and 2010. There is a slight indication that there is a minor shift in the direction of the right bank and some slight indication that there is aggradation. Looking downstream the conditions are similar. Overall the channel is extremely stable over the last 10 years, with the banks in the same location over that time period.
