# GEOMORPHIC CHANGES IN LOWER CACHE CREEK 2012

## *Technical Memorandum*

Cache Creek Technical Advisory Committee  
Natural Resources Program  
Yolo County Board of Supervisors

2012

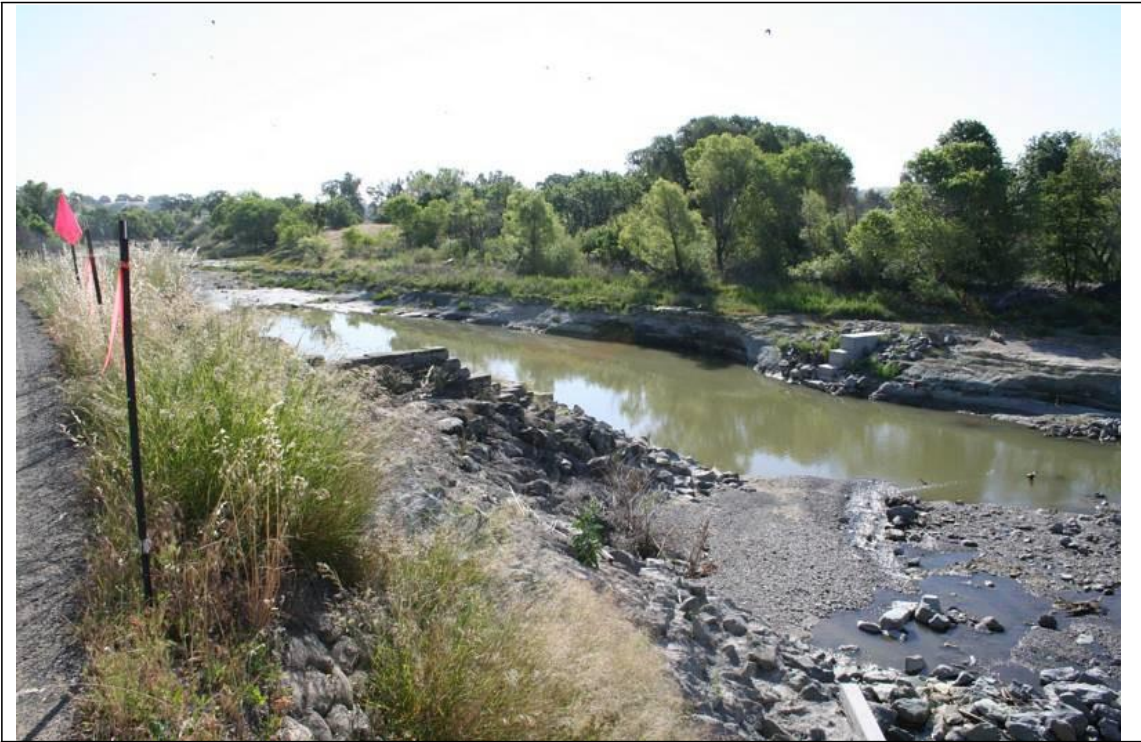
Figure 1 Grade control structure downstream of Capay Dam

At the dam site itself, we observed the grade control structure that was installed as part of the recent repair project. We could only see the end abutments of the grade control structure (Figure 1), as the rest of the structure was underwater. An important consideration for the TAC is to determine the form of this grade control structure, and how it functions with respect to high flow patterns. We should consider the possible implications for the channel dynamics at high flows, and the possibility of “end-cutting”.

**Action:** It would be beneficial to have pictures and drawings of the entire grade control structure including the portions under water and buried in the banks. In addition, the TAC should monitor the channel dynamics related to the grade control structure. In particular, it is important to examine any tendency for “end-cutting”, where the water could go around the abutment and erode the bank.

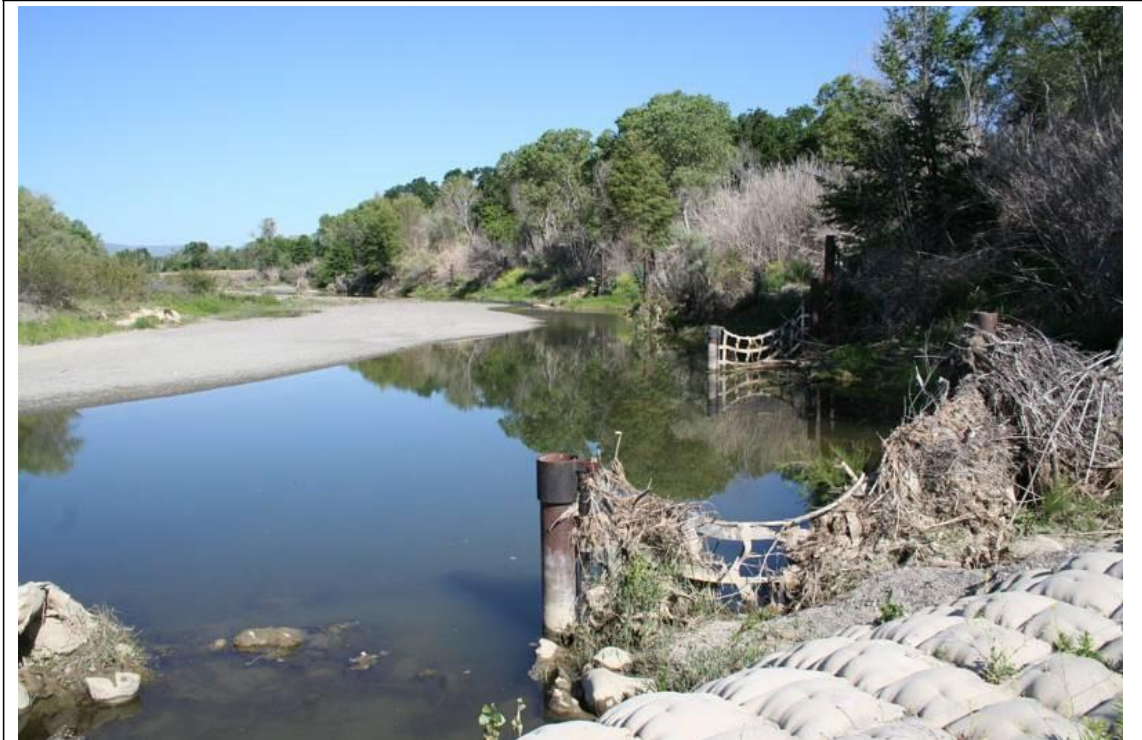
Figure 2 Palisades with debris north bank

A description of the goals for which the palisades were built would be useful in order to assess the success or failure of the palisades in meeting their goals. If we are to learn from past actions, it is important to evaluate the success or failure in meeting defined goals. One of the actions that we understand PG&E are going to take is that the upstream and downstream palisade netting (Figure 2) would be cleared of debris. If we assume that one of the goals was to collect sediment in order to protect against and prevent retreat of the bank in this vicinity, then this action seems like it is counter to the imagined goals of the palisades.

**Action:** Continue to evaluate PGE plans for this site.

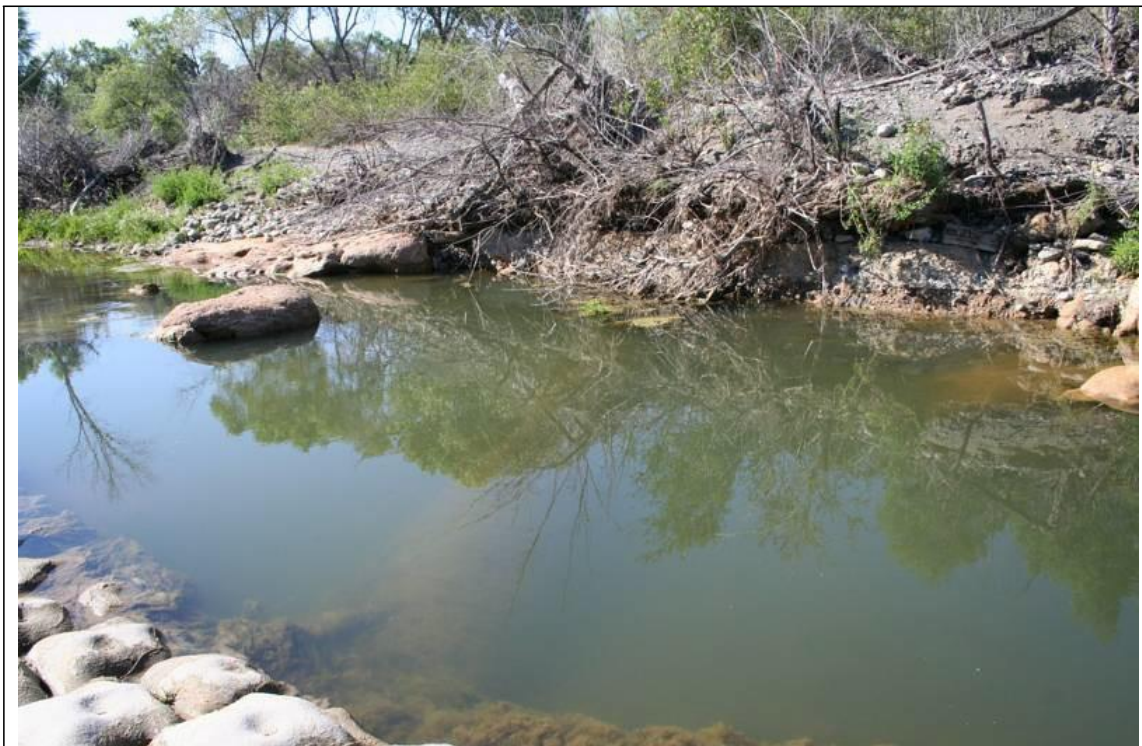
Figure 3 Palisades area - erosion on south bank

The design and orientation of the cement pillows in the creek are causing high velocity flows to move to the south side. This is exacerbating the existing bank retreat on the south side (Figure 3). An important question to ask is “what are the consequences of allowing bank migration to continue on the south bank?” We anticipate that the south bank will continue to erode due to the flow pressure on the south bank which is caused by the pillow placement. The consequences of that bank migration may be negative, neutral, or positive. Therefore, it is

important to evaluate the consequences of the continued erosion.

In addition, it will be important to understand how they plan to excavate on the south bank. Excavation could also tend to destabilize the bank.

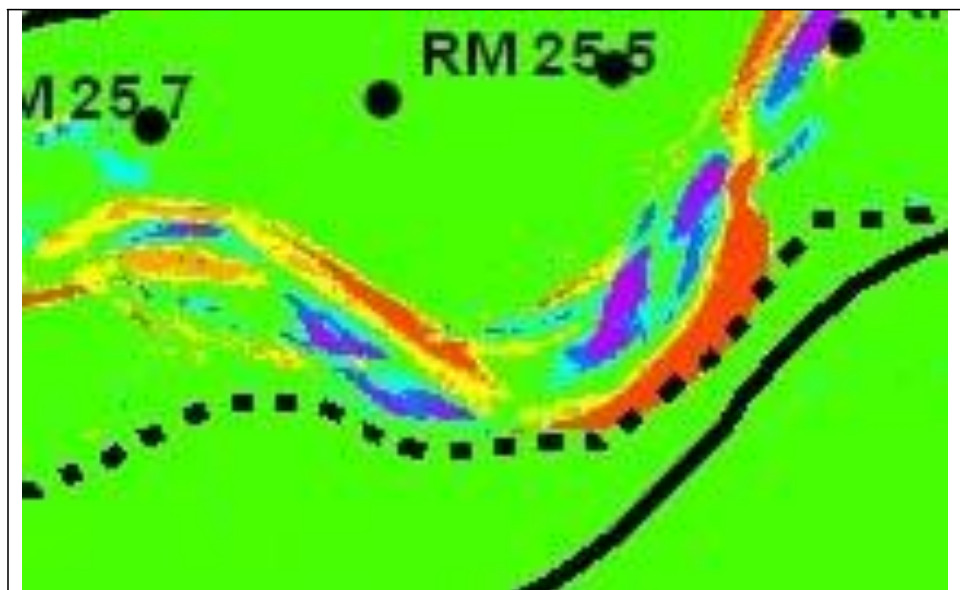
The bank retreat patterns near RM 25.4 -25.5 show that the channel bends in this location are evolving in a typical pattern for stream channel evolution. The 2010-2011 DTM maps show significant erosion in this location (Figure 4). Downstream from this, the bank is pinned in place by cement material that was placed to limit bank retreat. This constraint to the natural movement has probably caused the upstream bend to be curved more than it would be naturally and, in response, to erode more rapidly. One possible management action would be to remove the concrete constraint, and to allow more natural dynamics in this location. The consequences of this to downstream private land would have to be assessed. Removing the concrete might allow too much erosion onto the Jensen property where there is orchard land, and there would be concern about erosion in that direction. This is one area where evaluating the different management options would benefit from defining the location of the “test 3” line.

Another possibility is that the large bend will cut through and make a cut off in the flat area between the two limbs of the meandering course of the low flow channel, and the channel will move away from the bank naturally, with the rock left in place.

Figure 4 Erosion near RM 25.5  
The area in red shows significant erosion between 2010 and 2011.

**Action:** Determine the location of the “test-3” line in this location.

**Notes:** The TAC geomorphologist plans to assess 2011-2012 erosion patterns. In addition, the TAC geomorphologist plans to consider the historical migration by analyzing maps and aerial photos.

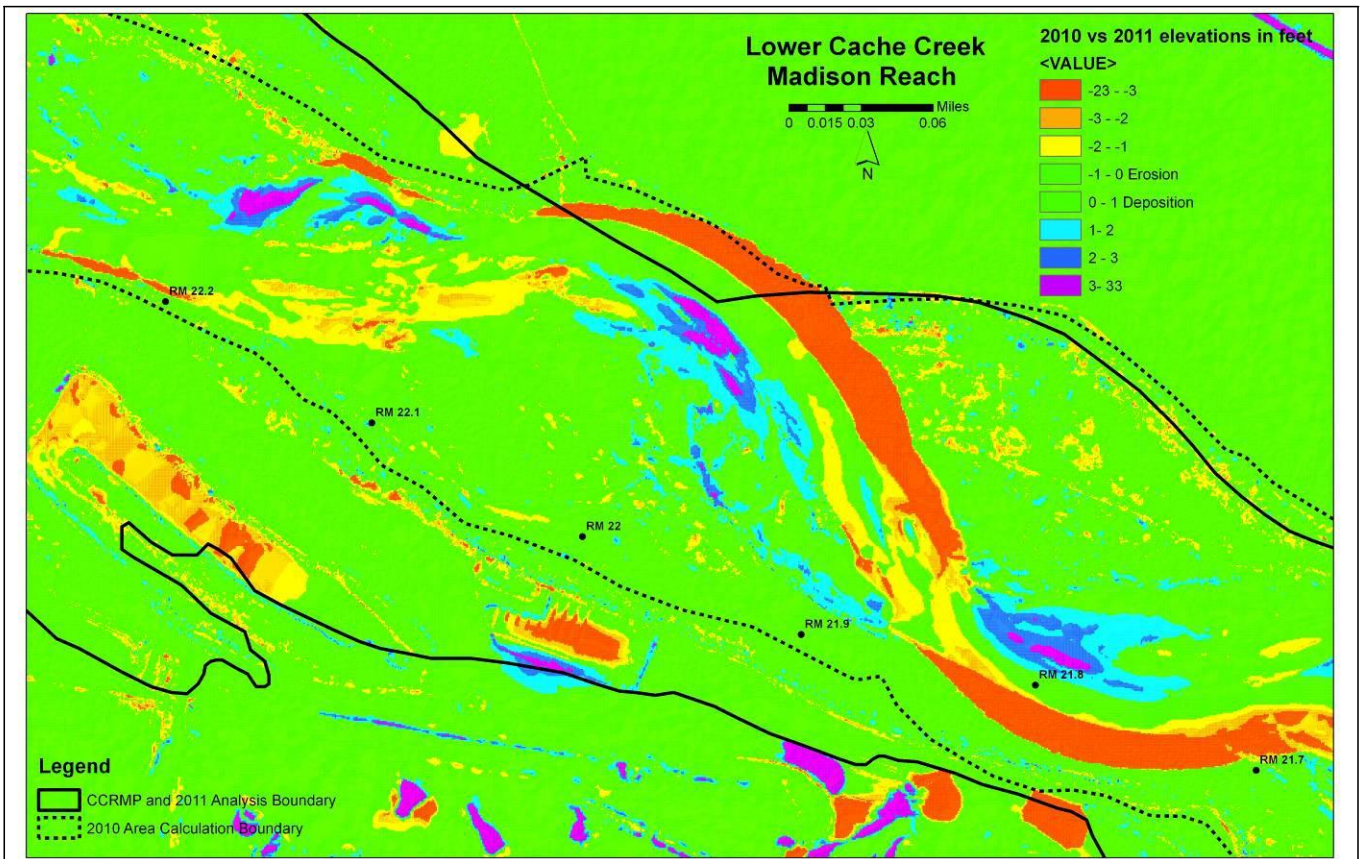
Figure 5 RM 22.0 bank retreat

At RM 22.0 there is bank retreat as shown in the cut and fill maps (Figure 5). A former hypothesis was that the meander migration and bank retreat would leave in its wake a created floodplain on which natural regeneration of riparian vegetation could occur. When observing this area in the field, we observed that this is possible only in a long time period, because the adjacent cut bank is almost 20 feet high and, as the locus of erosion tends to move downstream, it will be a relatively long time before the area could develop a floodplain. This is probably not a site that could be relied on for short-term natural regeneration. We should continue to observe the channel processes as they occur at this site. Another important aspect of this site is that it is an area where the bank retreat has taken the current bank of the stream outside the CCRMP boundary. No management action is currently recommended.

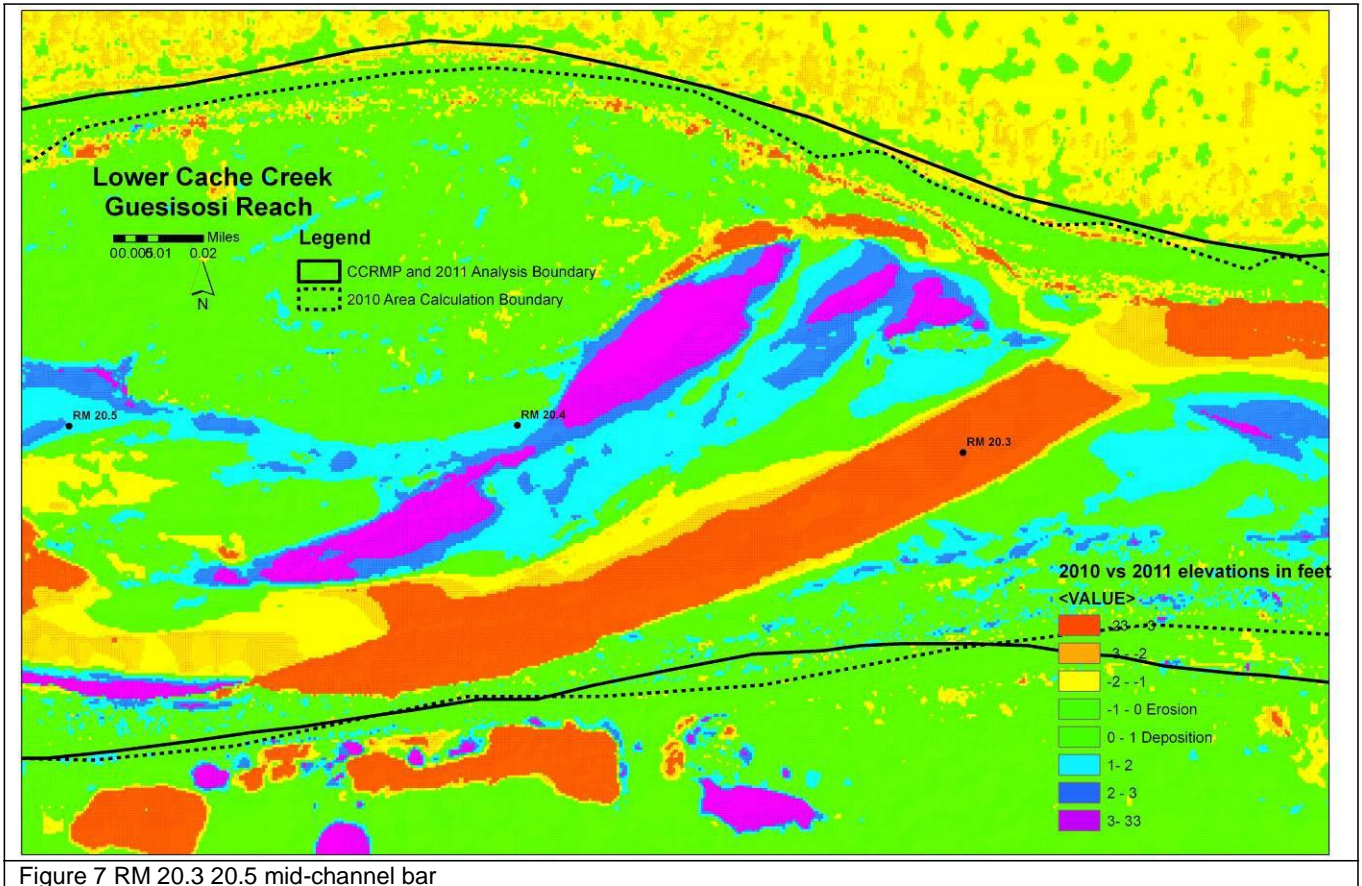
In the vicinity of the most upstream of the CEMEX repair sites (called site F) there is evidence of a mid-channel bar that has deposited, which is shown in purple on the figure (Figure 7). If the bar were removed, there would be less erosive pressure on the south bank. This is a possible location for “bar-skimming.”

**Action:** Discuss this possibility at a future TAC meeting.

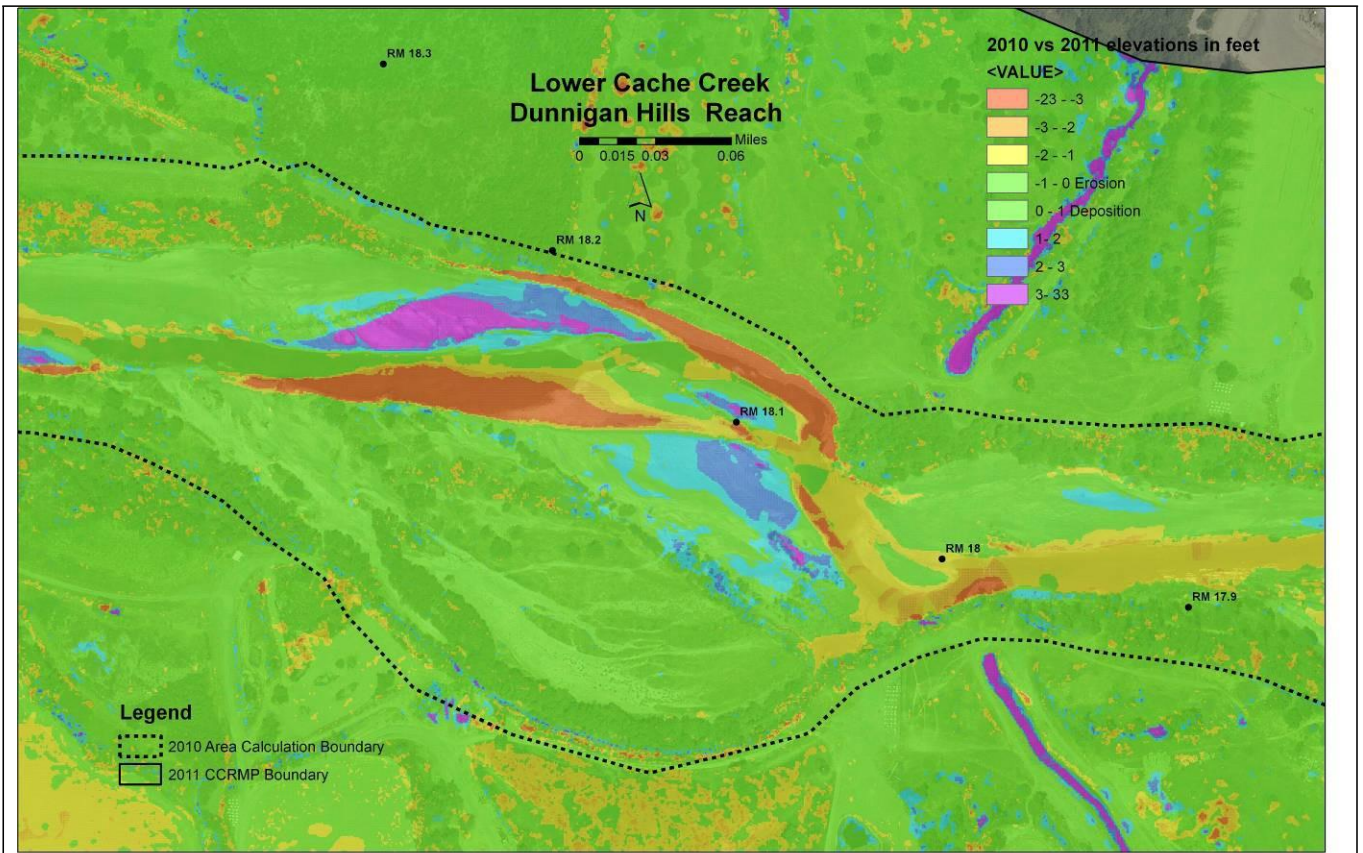
Figure 8 RM 18.2-18.0 upstream from the Moore Siphon

Immediately upstream from the Moore Siphon, there is bank retreat and a large curved scallop in the bank configuration where the downstream cottonwood forest has restrained the migration. The scallop creates a scour hole in the channel that promotes a diversity of in-channel habitats. There are deep-pool habitats. Large wood is falling into the scour hole (pool), which also contributes to in-channel habitat diversity. WE understand that the local landowner is in favor of allowing this process of bank erosion to occur as a natural process.

**Action:** Observe the natural processes as they occur, and document the benefits that we currently see and that we expect to see in the future.

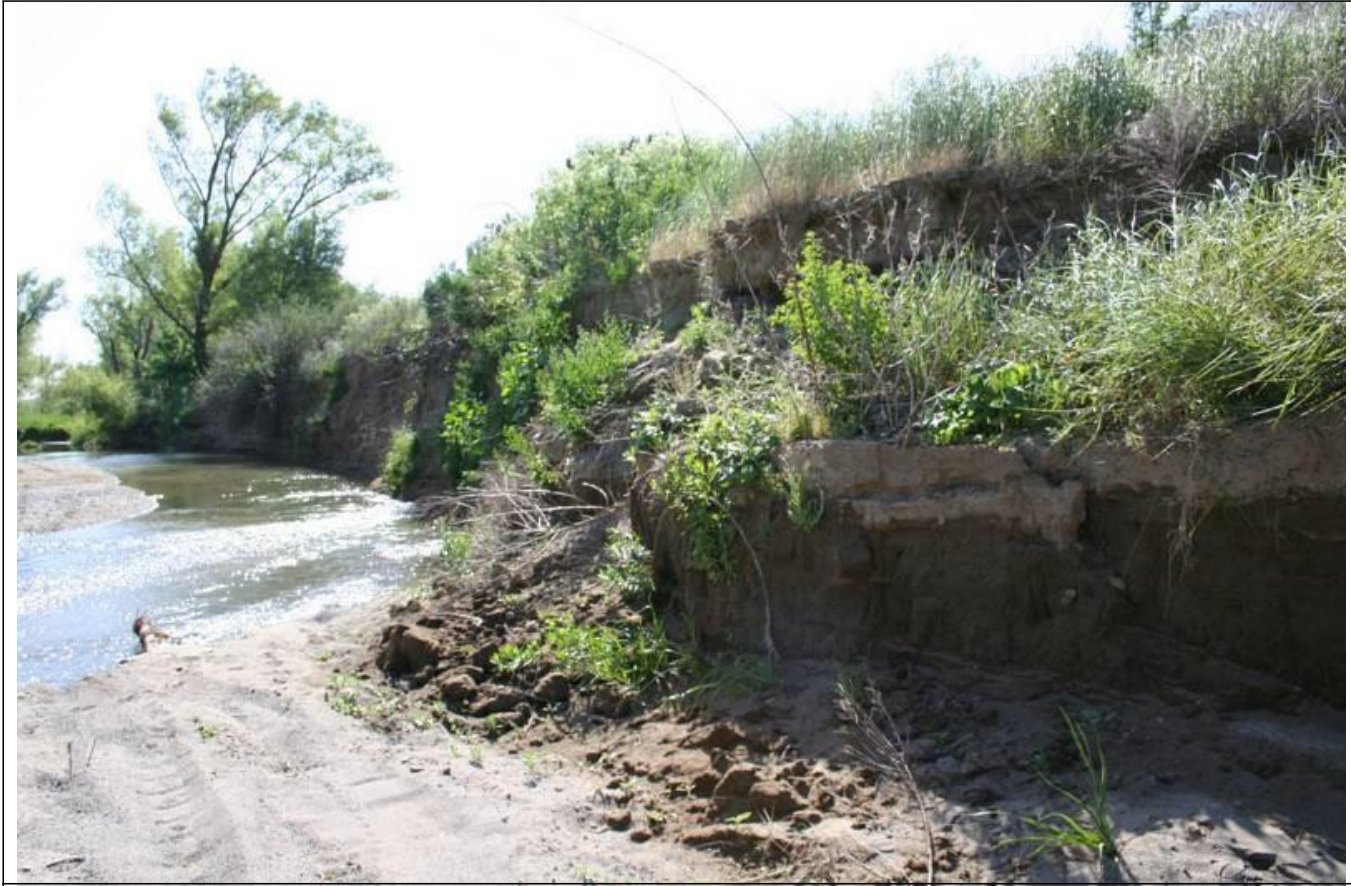
Figure 9 RM 15.4 bank retreat

In the Hoppin Reach, there are two locations of site-specific channel bank retreat. Both areas have no negative impact. It is possible that the continued bank retreat will provide bank swallow habitat. It would good to continue to observe the bank retreat in these areas, and to document if bank swallows use the area.

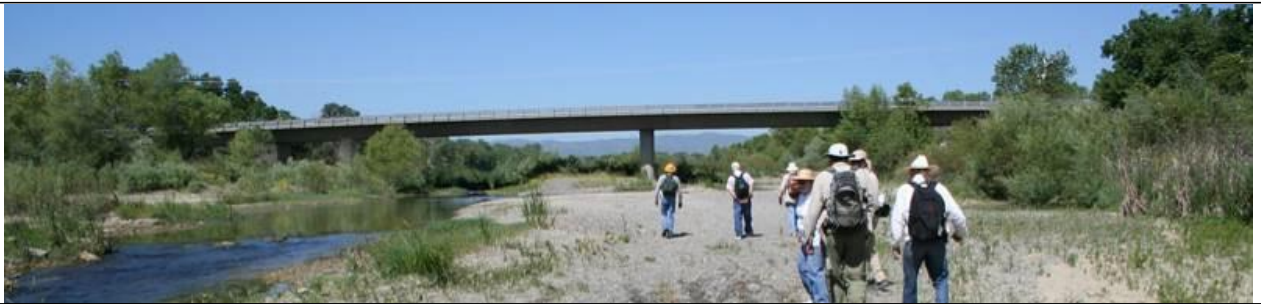
Figure 10 Capay Bridge - view from downstream

2010-2011 DTM maps show significant erosion upstream of the bridge on the south side (Figure 10). This seems like appropriate channel retreat that is widening the constricted area, which provides benefit by lowering the flood levels. We observed this in the field, and confirmed that there are no observable negative consequences of this erosion. No action is recommended at this time. We will continue to observe the bank retreat patterns here.

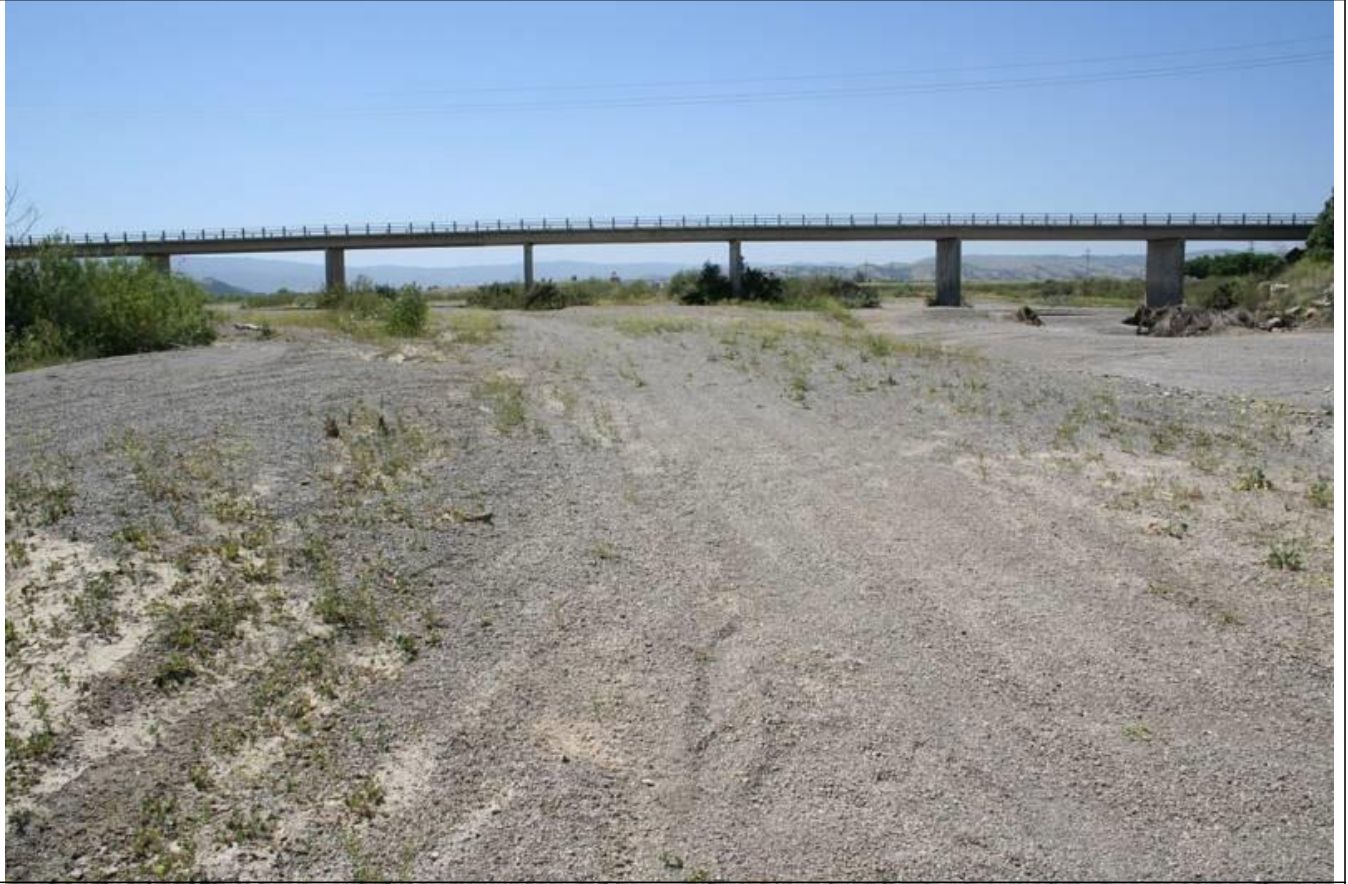
Figure 12 Esparto Road 87 Bridge

The bridge (Figure 12) appears to be in generally good condition. After the bridge was constructed, there was fill placed on the south side (left hand side in the photo). Syar Industries placed the fill for public works, in order to protect the piers. That fill restricts the cross sectional area available for flow and increases the velocities. It might have been better to leave the area clear of fill.

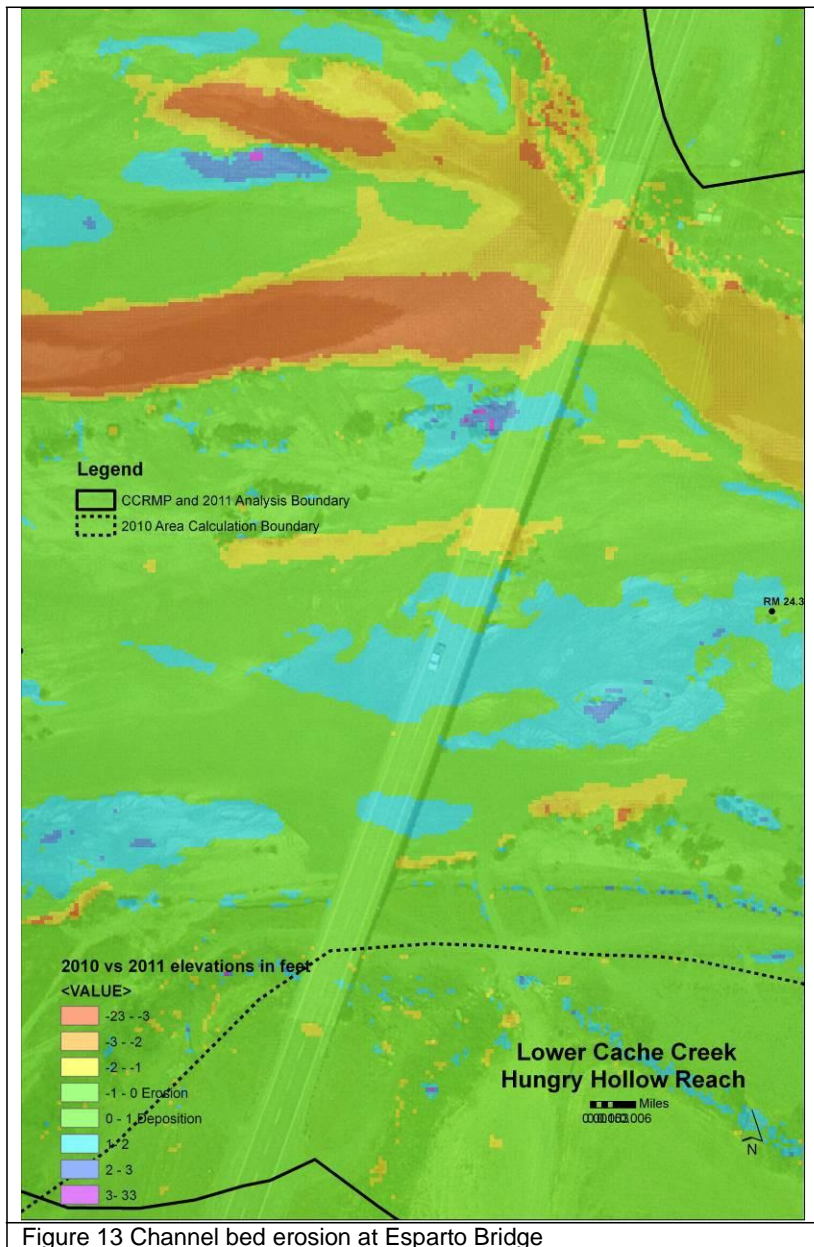
Figure 13 Channel bed erosion at Esparto Bridge

The 2010-2011 DTM analyses (Figure 13) and the cross section plots which were analyzed (not shown here) show some erosion on the north side on the upstream cross sections. This erosion was also observed on the northern-most pier (Figure 14).

It is possible that the erosion on the northern side of the bridge will continue. Observations should be continued, but no action is recommended at this time.

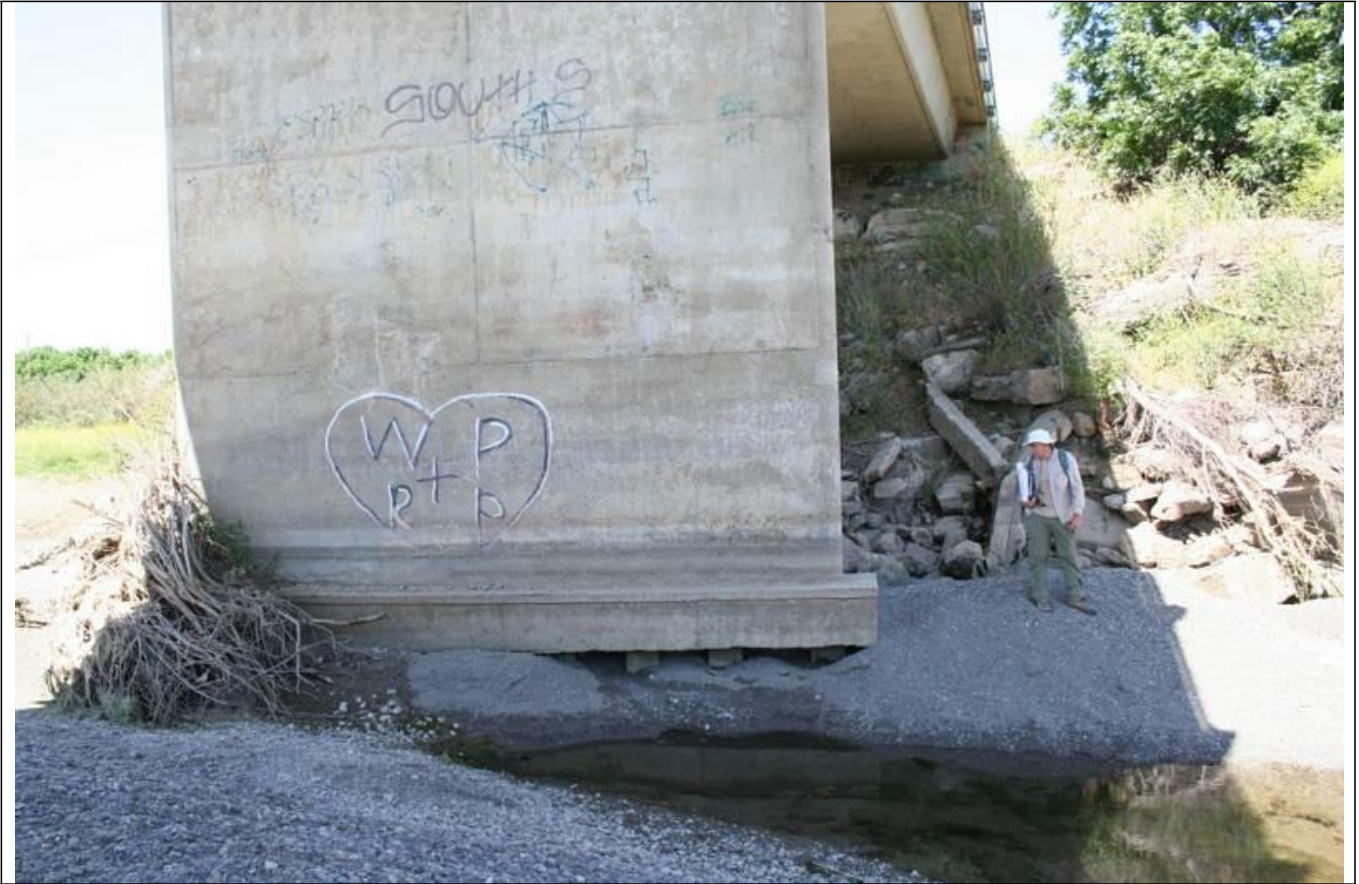
Figure 14 Bridge pier erosion at Esparto Bridge

- At the Esparto Bridge (RM 24.35), there appears to be a tendency for erosion on the north side, and the northern-most pier is slightly undercut. This seems to have stayed roughly the same since last year.

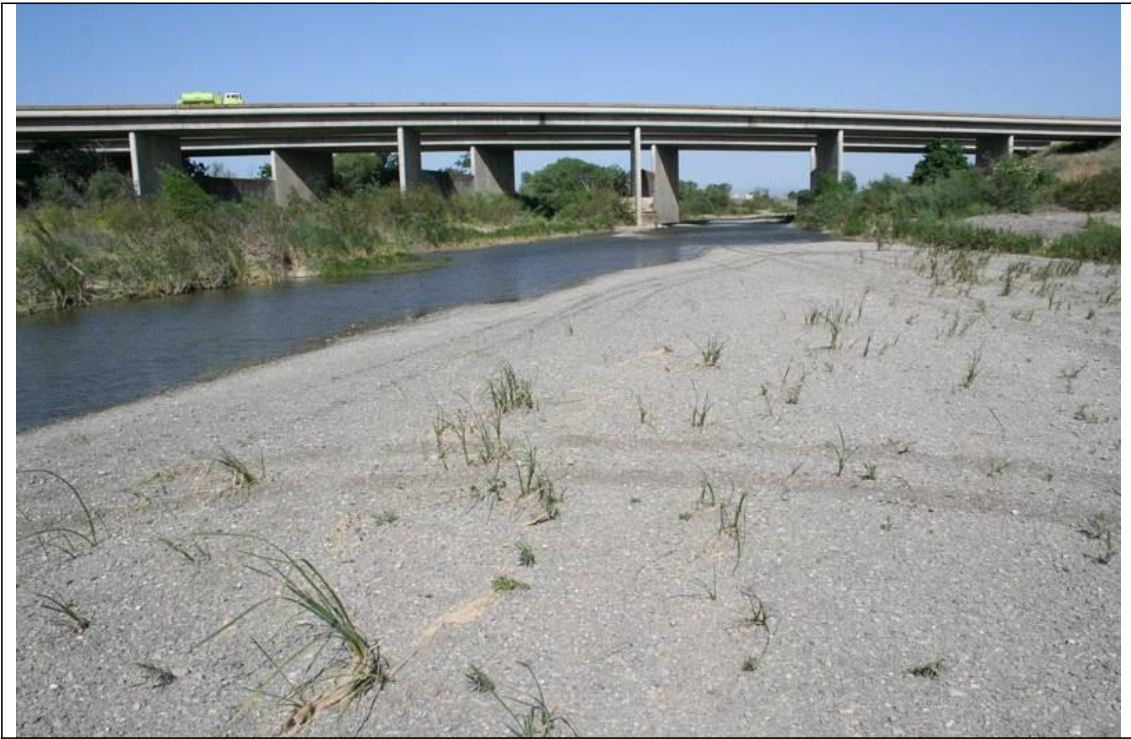
Figure 15 Highway I-505 Bridge from downstream

We observed evidence of 2-10 feet of sedimentation around the piers in the two south side bays; they are filled with sediment and vegetation so that they appear to carry little flow at moderate recurrence-interval flows. This sedimentation appears to reduce the capacity of the bridge by 30% or more. Much of the vegetation appears to be Sand Bar Willow and Mule Fat, both of which do not cause much restriction to high flows.

The cross sections that we have at this area show no change in bed elevations upstream and downstream from the bridge.

We do not recommend any action at this time, but do recommend continuing to observe the area. One possible management action would be to remove vegetation, which might help in increasing the flow velocities (therefore lowering the flow stage) under the bridge. One effective way to examine this would be to examine the HEC-RAS model of this area, and to see how much the sedimentation actually affects the flow.

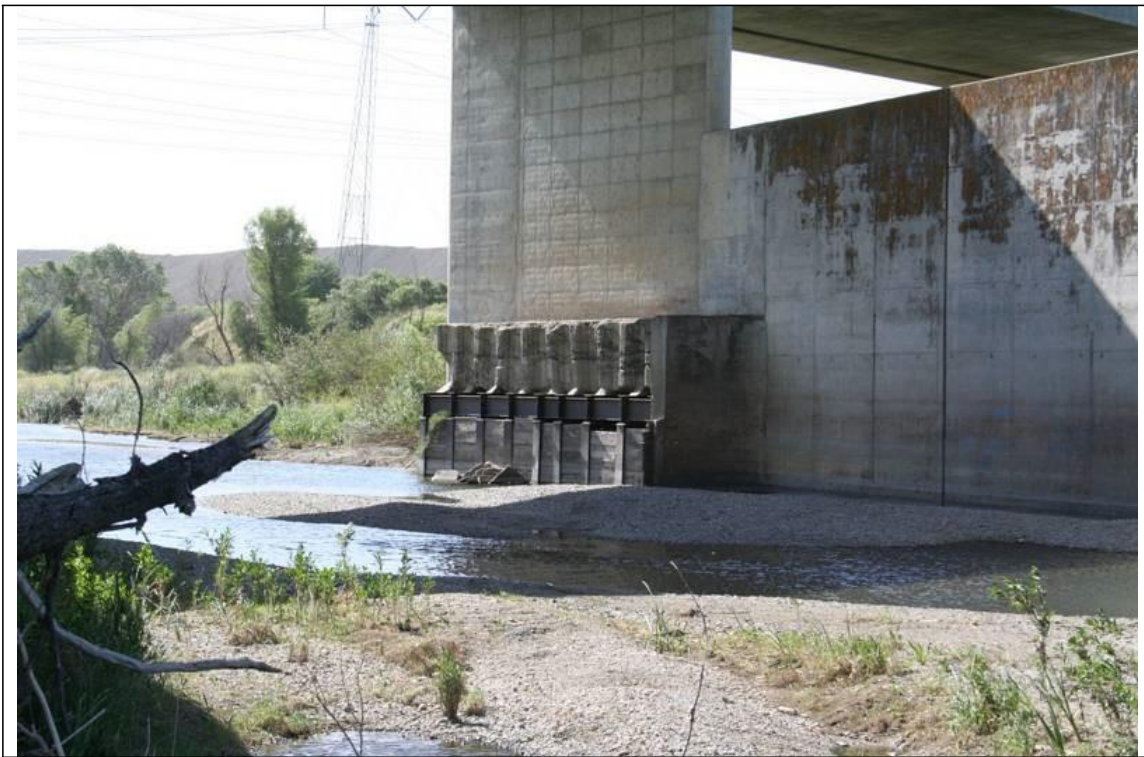
Figure 16 Highway I-505 Bridge - Evidence of two-stage building  
Former degradation as accounted-for in second stage

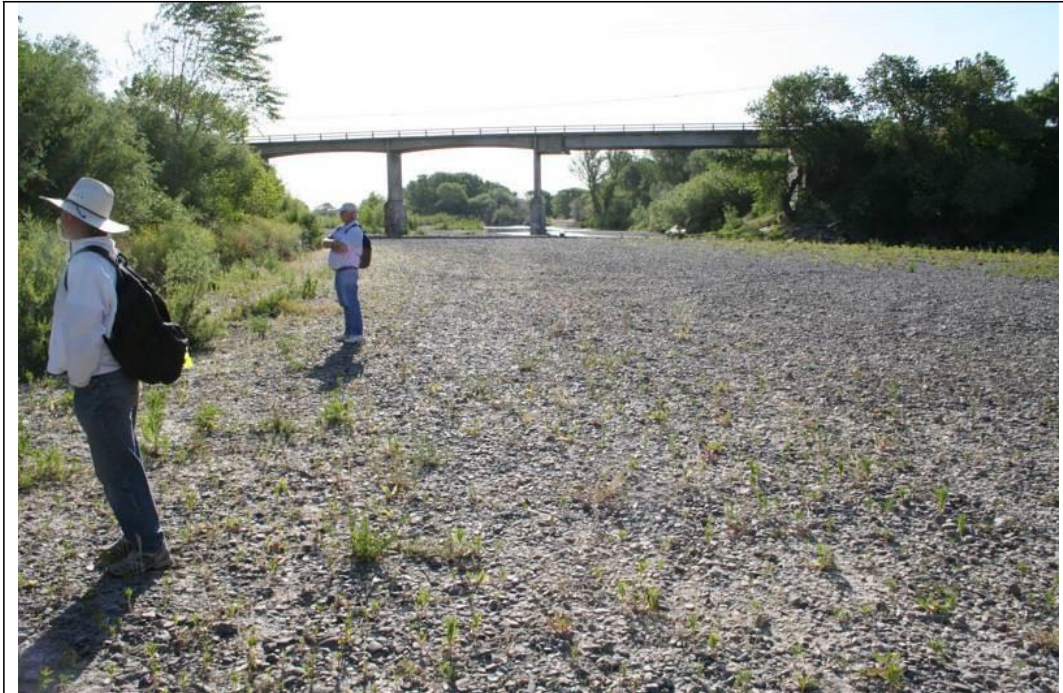
Figure 17 Bridge at Road 94B looking downstream

Between 2010-2011, there was no aggradation shown on the cut and fill analyses. Since 2001, it appears that there has been 2-3 ft of aggradation. There is not a significant amount of narrowing of the channel width at the bridge (Figure 18). The channel width upstream and downstream are similar, and do not differ much from the channel width directly under the bridge. It is possible that there is some effect from vegetation and backwater from Highway I-5 downstream, which would tend to cause bed aggradation, but there is no evidence of that in the recent longitudinal profiles that show the bed elevations over the past few years.

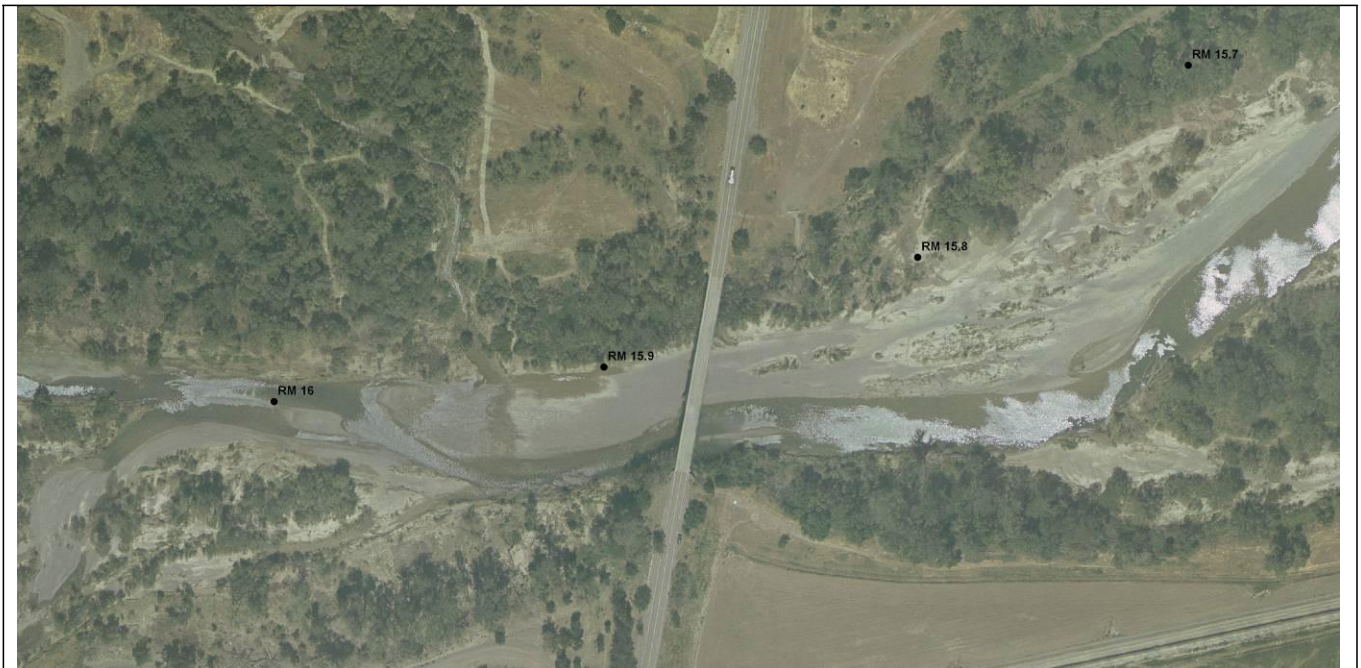
Figure 18 Bridge at Road 94B showing little constriction
