2013 CACHE CREEK ANNUAL STATUS REPORT

For the period of
October 1, 2012 to September 30, 2013

CACHE CREEK TECHNICAL ADVISORY COMMITTEE:

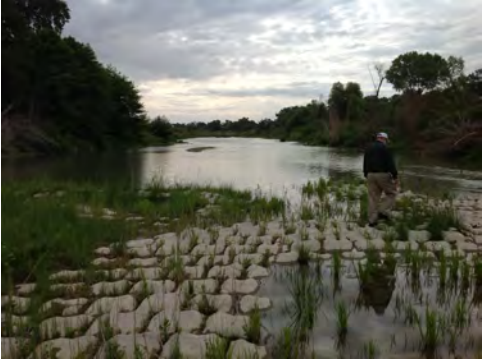
Tompkins	Looking US.	Looking upstream from a position on the concrete sack revetment. Channel conditions in 2013 very similar to 2012.	Capay Reach	RM 26.9

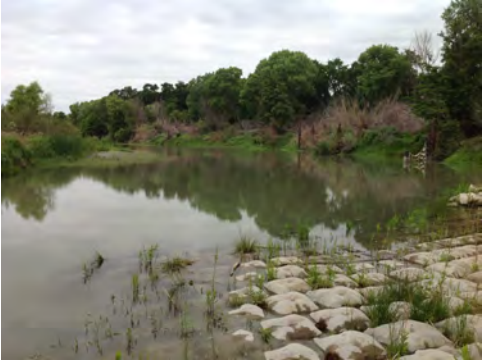
Tompkins	LB to RB	Looking from left bank to right banks. The concrete sack revetment looks the same as in 2012.	Capay Reach	RM 26.9

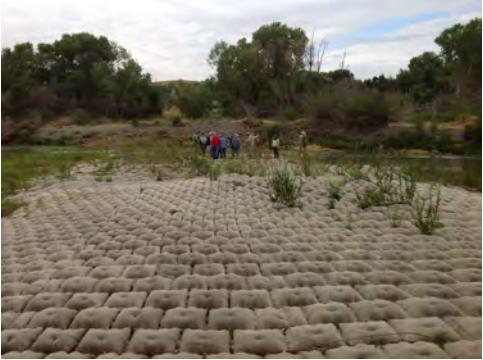
Observer	Comments	Verbose Comments	River Reach	River Miles	Image
Tompkins	Palisades looking US	<p>This photo looking upstream of the Palisades shows that there was higher flow in Cache Creek in 2013 than in 2012, but that channel conditions had not changed significantly. There was more debris present on the Palisades in 2013 than 2012 but they appear to still be functioning as designed.</p>	Capay Reach	RM 26.9

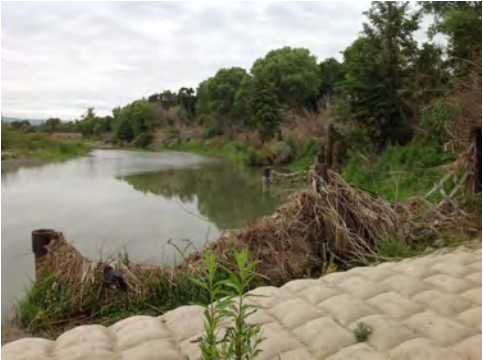
Tompkins	Possible beaver dam US of palisades near RB	<p>Looking upstream towards right bank from concrete sack revetment at PGE Palisades. There appeared to be a beaver dam spanning the channel between the concrete sack revetment and the right bank. This beaver dam was not present in 2012 and could cause problematic hydraulics downstream at the exposed pipeline.</p>	Capay Reach	RM 26.9

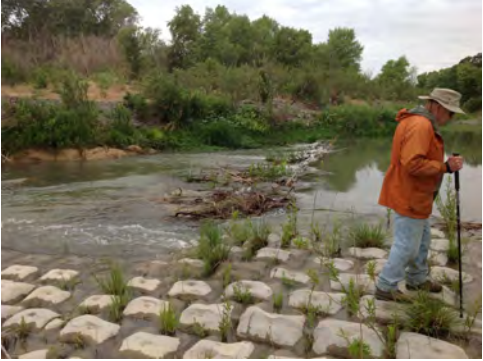
Observer	Comments	Verbose Comments	River Reach	River Miles	Image
Larsen	South bank runoff	There appears to be runoff from the south bank that appears to have cut into the bedrock of the channel.	Capay Reach	RM 28

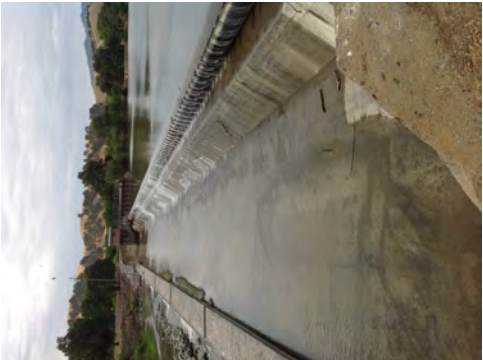
Observer	Comments	Verbose Comments	River Reach	River Miles	Image
Tompkins	Riprap migrating downstream of dam.	We observed riprap that had migrated a short distance downstream of dam face where it was originally placed. The riprap does not appear to have moved significantly since the 2012 Creek Walk.	Capay Reach	RM 28.4

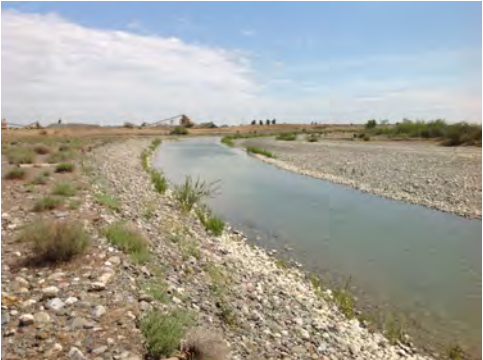
Observer	Comments	Verbose Comments	River Reach	River Miles	Image
Tompkins	Looking US. Eroding RB. US end of long straight reach pointed at Granite. Land ownership issues for skimming.	Looking upstream at eroding right bank. This bank was already eroding in 2012. The eroding right bank is at the upstream end of the long, straight reach of the main channel that flows directly at the Granite plant. The TAC discussed bar skimming in this location and land ownership issues that would complicate bar skimming were raised.	Hungry Hollow Reach Hungry Hollow Reach	RM 25.3

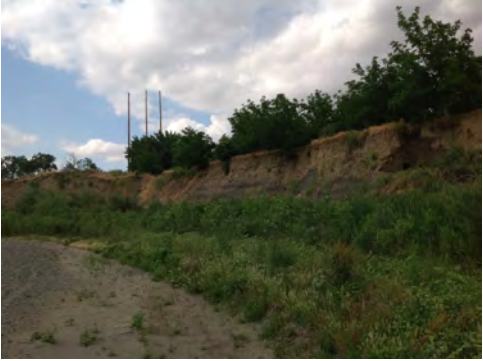
Martin	Bank swallow nesting colony at downstream end of exposed vertical bank. At least four nesting pairs observed in 2013.		Madison Reach	RM 21.6

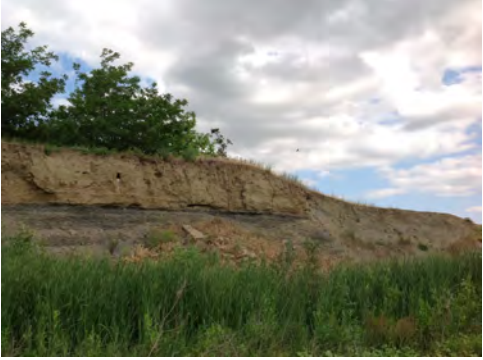
Observer	Comments	Verbose Comments	River Reach	River Miles	Image
Martin	Bank swallow nesting colony at downstream end of exposed vertical bank. At least four nesting pairs observed in 2013.		Madison Reach	RM 21.6

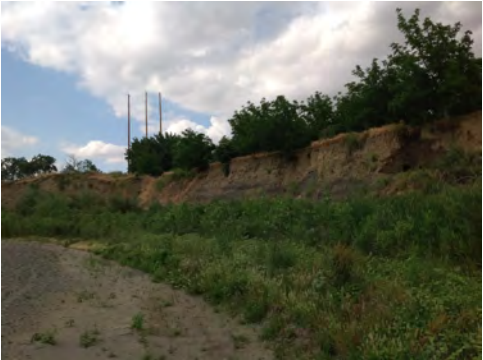
Martin	Tamarisk clumps at top of bank near Syar plant off Road 89.		Madison Reach	RM 21.6

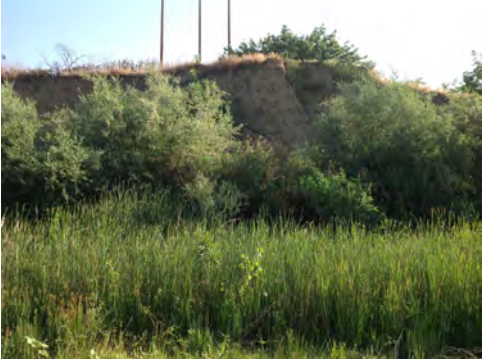
Observer	Comments	Verbose Comments	River Reach	River Miles	Image
Tompkins	At LB note possible active erosion at top of bank orchard and irrigation return flow seep.	Looking at left bank where there is possible active erosion at top of bank orchard and irrigation return flow seep.	Madison Reach	RM 21.6

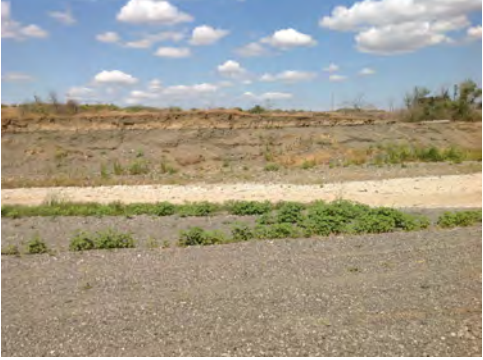
Tompkins	LB exposed pipe in bank	Small exposed irrigation type hose / pipe on left bank. Does not appear to have been active recently and does not appear to be influencing water quality. However, this should be added to the database of potential water quality contaminant sources.	Madison Reach	RM 22.5

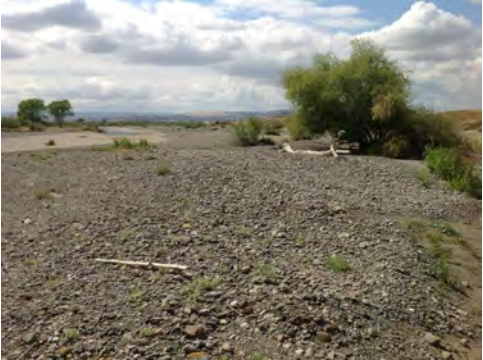
Tompkins	Rough wing swallow bank holes LB	Rough wing swallow bank holes on left bank. Bank swallows require steep eroding banks, so this bank condition is not always a bad thing.	Madison Reach	RM 22.7

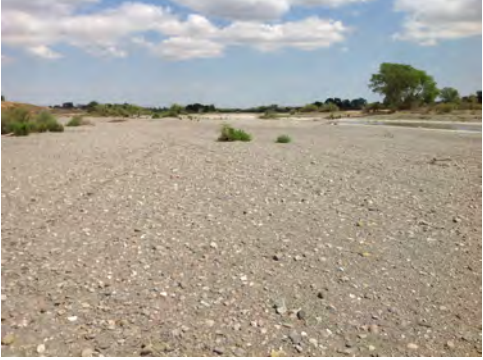
Observer	Comments	Verbose Comments	River Reach	River Miles	Image
Tompkins	Root wad bank stabilization along Teichert.	Root wad bank stabilization along Teichert plant on left bank. This structure has been compromised but hasn't changed significantly since 2012. It should be observed on each Creek Walk, especially after high flow winters.	Madison Reach	RM 22.9

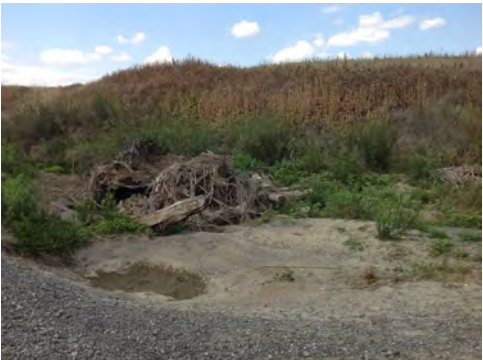
Tompkins	Root wads LB Teichert	Root wad bank stabilization along Teichert plant on left bank. This structure has been compromised but hasn't changed significantly since 2012. It should be observed on each Creek Walk, especially after high flow winters.	Madison Reach	RM 22.9

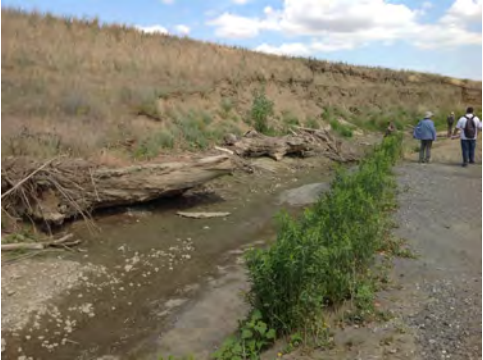
Tompkins	LB toe of slope along Teichert. Concrete k-rail exposed at toe. Scour holes.	Concrete k-rail exposed at toe of slope along left bank of Teichert plant. Scour holes in adjacent channel. This revetment hasn't changed significantly since 2012 but should be monitored on all Creek Walks.	Madison Reach	RM 22.9

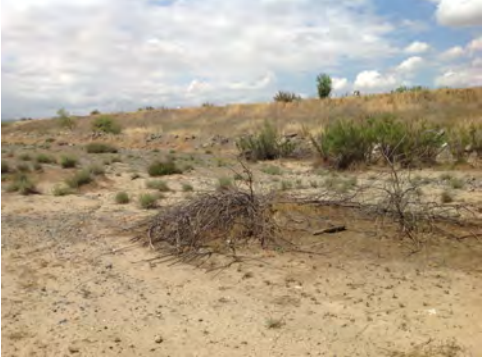
Observer	Comments	Verbose Comments	River Reach	River Miles	Image
Martin	More tamarisk observed along channel.		Madison Reach	RM 23.4

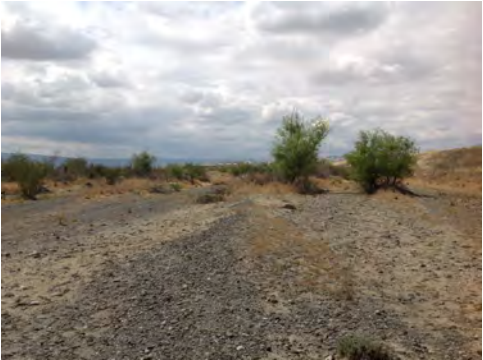
Martin	More tamarisk observed along channel.		Madison Reach	RM 23.4

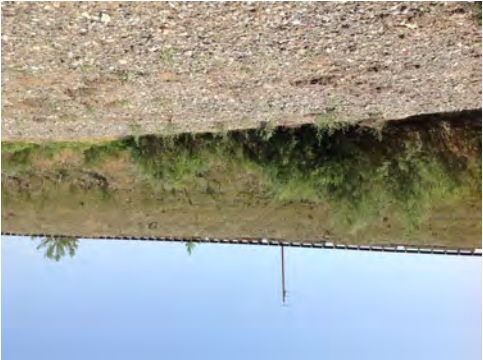
Tompkins	Right bank along cemex property note repair showing willows and cottonwoods planted in the bank	Right bank along Cemex property. Note repair showing willows and cottonwoods planted in the bank.	Guesisosi Reach	RM 20.1

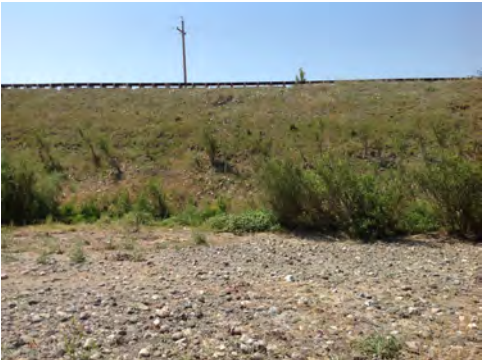
Martin	Exposed vertical bank with regeneration at base of slope and exposed dead willow tree.		Guesisosi Reach	RM 20.2

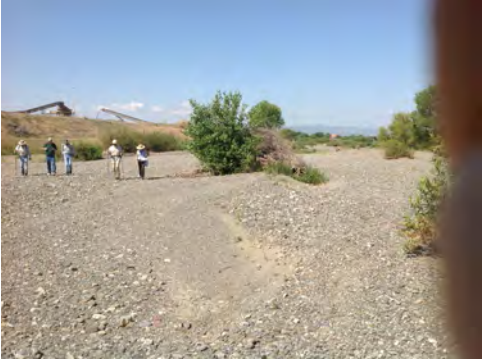
Observer	Comments	Verbose Comments	River Reach	River Miles	Image
Larsen	Gully filled on bank.	Site of gully erosion on the South Bank. Fully has been filled with gravel and cobble.	Guesisosi Reach	RM 20.4	 
Larsen	Toe erosioni	Area of erossion on bank at CIMEX site.	Guesisosi Reach	RM 20.4	 
Larsen	Near bar skimming area	Bank that will benefit from bar skimming. Photos from Jim of bank conditions	Guesisosi Reach	RM 20.4

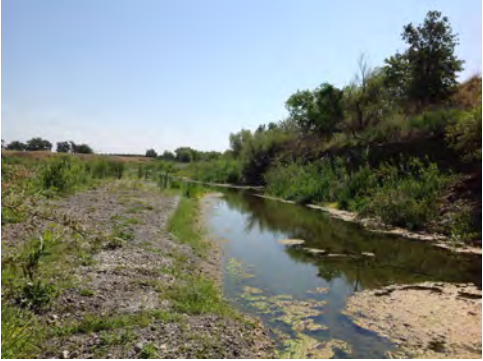
Larsen	More area that will benefit	Vulnerable bank at CEMIX site where bar skimming in center of creek is proposed.	Guesisosi Reach	RM 20.4

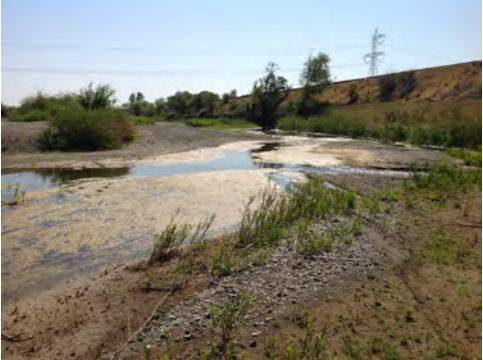
Tompkins	Looking upstream along RB repair where prograding bar filled deep pool in 2012/2013	Looking upstream along right bank repair where prograding bar filled deep pool in 2012/2013	Guesisosi Reach	RM 20.5

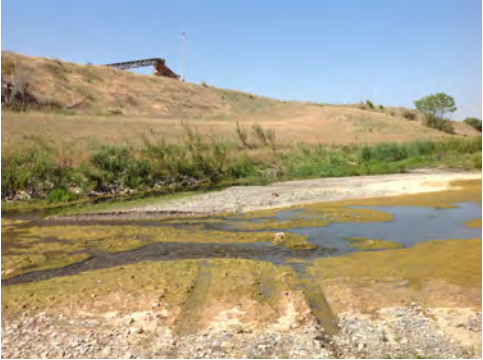
Observer	Comments	Verbose Comments	River Reach	River Miles	Image
Tompkins	Looking DS along eroding RB just DS of cemex RB repair note exposed roots of mature trees also note 1 to 2-year-old Willow Along the bank. Potential for extension of repair with bar skimming.	Looking DS along eroding right bank just downstream of Cemex right bank repair. Note exposed roots of mature trees and 1 to 2-year-old willows along the bank. Potential for extension of repair with bar skimming.	Guesisosi Reach	RM 20.5

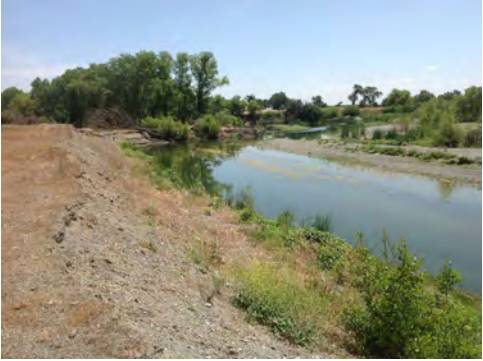
Larsen	More of the habitat created by erosion	In this area we saw the largest school of fish we have seen in the creek including a big largemouth bass. This underscores the value of this small area for habitat including the wood in the stream.	Dunnigan Hills Reach	RM 18.1

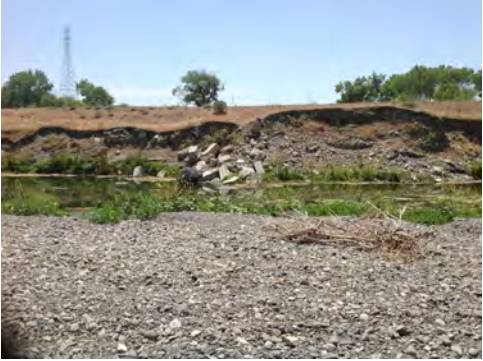
Larsen	Dike nose erosion	Exposed concrete rubble where erosion has moved into a former spur dike. This area has degraded habitat value. This is a good example of the degraded habitat that occurs with cement rubble is used to make spur dikes.	Dunnigan Hills Reach	RM 18.7

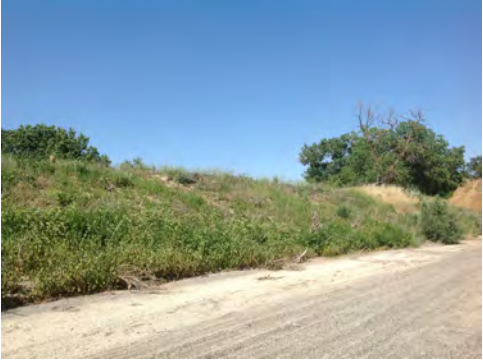
Martin	Deeply incised channel with heavy tamarisk removal evident. Very little replacement groundcover in the vicinity of removed tamarisk.		Rio Jesus Maria Reach	RM 11.8

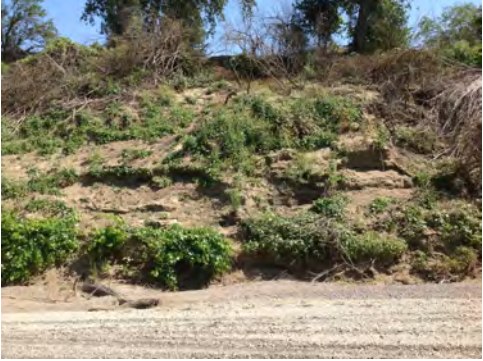
Tompkins	Looking upstream. Narrow confined reach. Right bank structure falling into Creek.	Looking upstream. Narrow confined reach. Right bank structure falling into creek.	Rio Jesus Maria Reach	RM 12.1

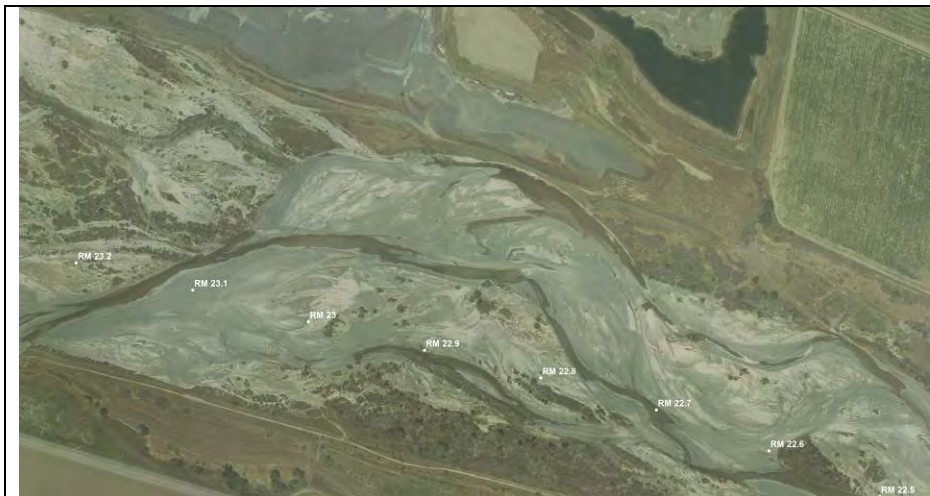
*Figure 1. RM 23 - 22.8
Area of concern in on the north bank near RM 23 to 22.8*
