# CACHE CREEK ANNUAL STATUS REPORT 2011

Cache Creek Technical Advisory Committee:

**February 28, 2012**

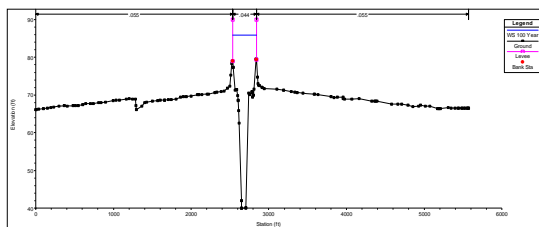
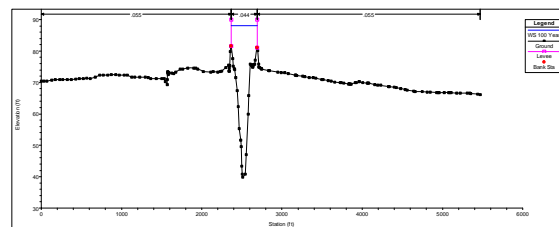
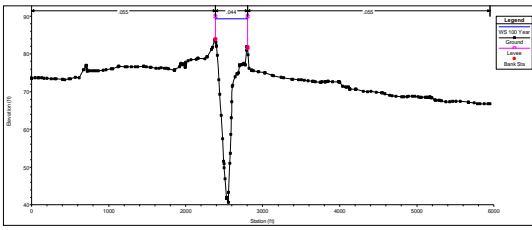
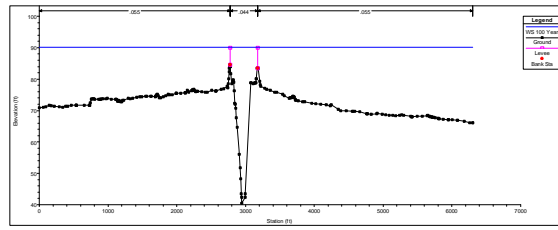
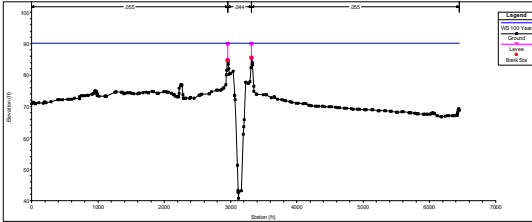
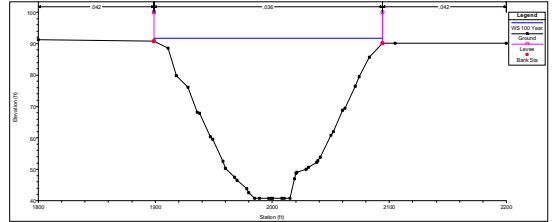
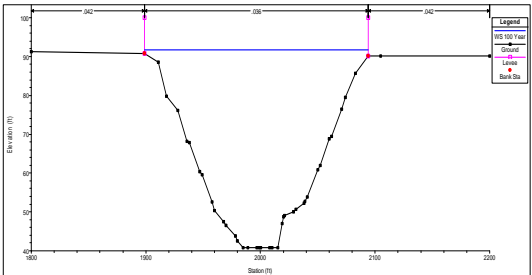
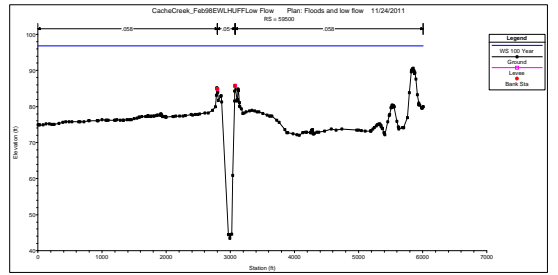
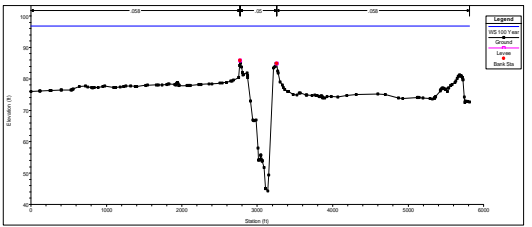
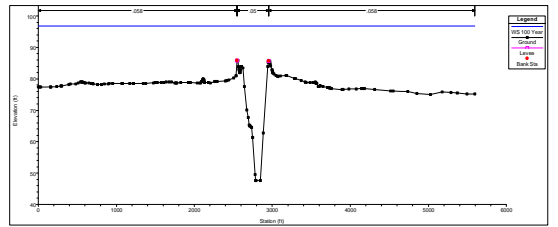
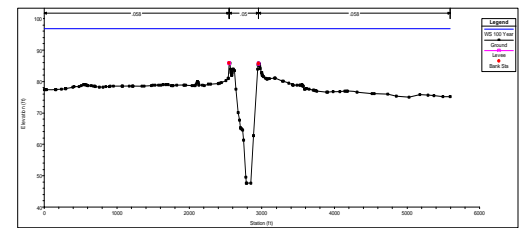
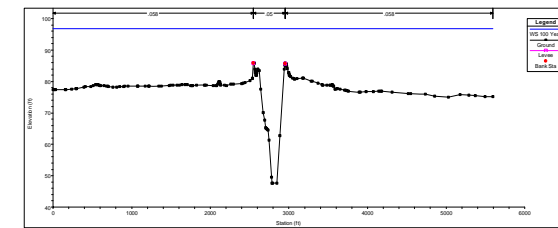
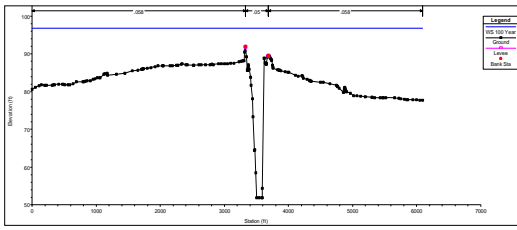
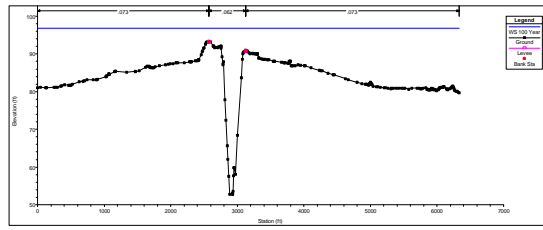
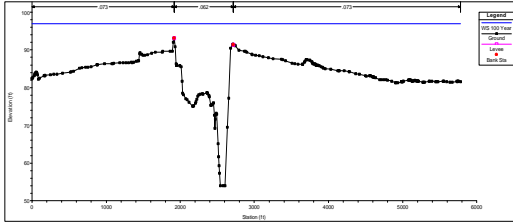
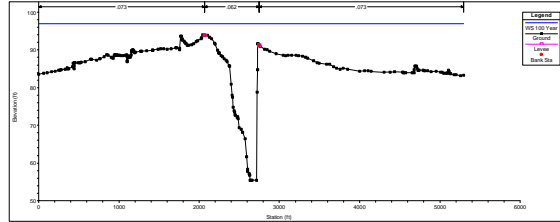
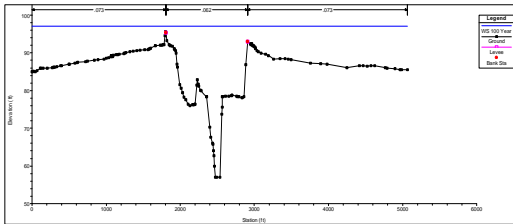
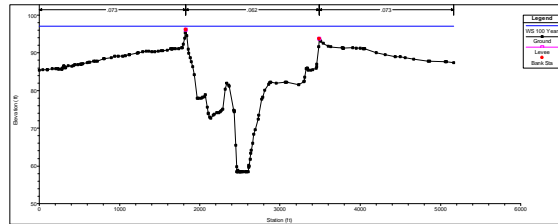
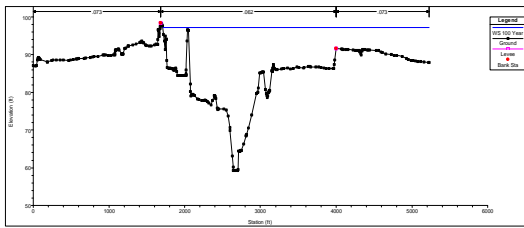
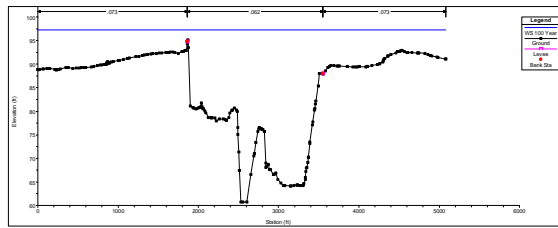
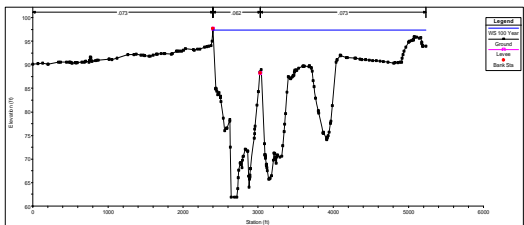
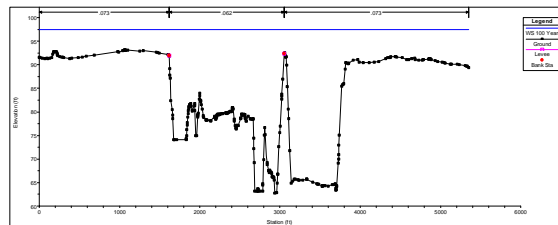
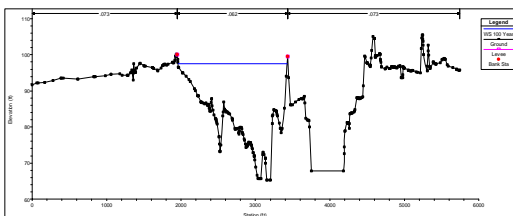
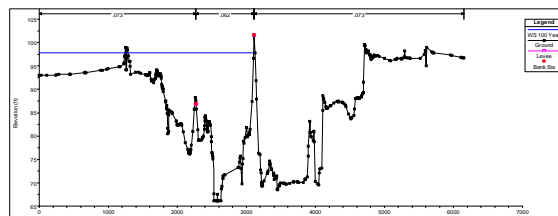
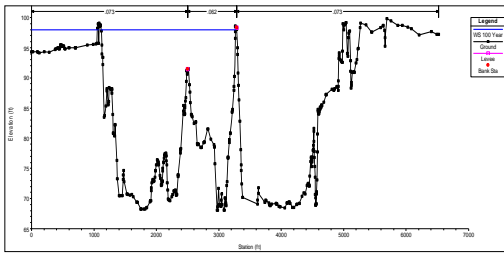
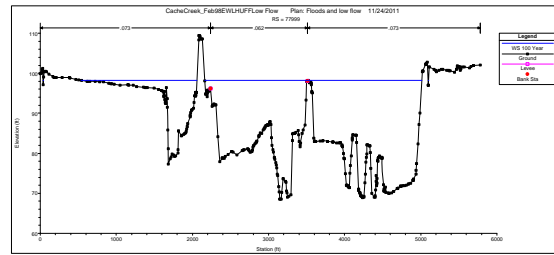
**Figure 3 HEC-RAS plots showing the cross section bed profile and flood elevations**

Figure 3 shows cross section bed topography and water surface elevations for the 100-year recurrence interval flood. The axes scales are not included at the small scale of the plots in the report, but the main point of showing the graphs is clear. The axis (y or vertical axis) that represents the depth ranges have plots that range from a total of 30 feet to a total of 50 feet. The 100-year recurrence interval flood is shown with the straight (blue) line. Levees are shown with straight vertical lines.

Station 53000 is the furthest downstream cross section, located approximately one mile downstream of Interstate 5. All of the cross sections from 53000 to 56000 (a little more than half a mile) show that the 100-year flood is contained within the channel, or, more accurately, within the levees. At station 57000, the 100-year flood overtops the banks on both sides, a condition that continues, except in the immediate vicinity of the bridge (see Stations 58300 and 58530). From the next cross section, at station 59500, to station 68999, the 100-year flood overtops the banks on both sides. The flood continues to overtop one or more banks (with a few exceptions) up to roughly station 77900. From there up to station 84500 (the upstream end of the model), the model shows that the 100-yr flood is contained, but comes very near the top of the banks. Upstream from there, the 100-yr flood will generally stay within the banks.

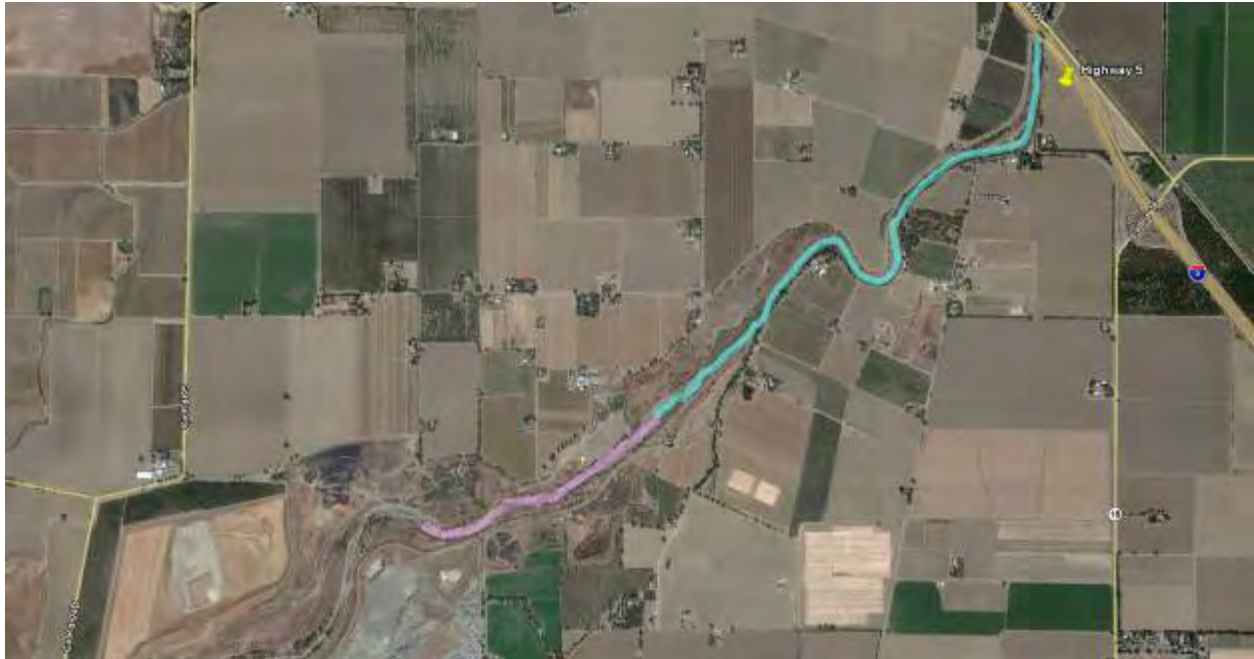
**Figure 5 Areas of complete and partial flooding in the vicinity of Huff's corner (HEC-RAS)**

The light blue line shows the extent of channel where the model shows that the 100-year flood overtops both banks. The pink line shows the extent of channel where flooding generally overtops one bank.

In general, the results show that the 100-year flood overtops the banks in the vicinity of Huff's corner, but does not overtop the banks both upstream and downstream from Huff's corner. This has been observed and reported anecdotally (Pers. Com. Pollock, Adamo.)

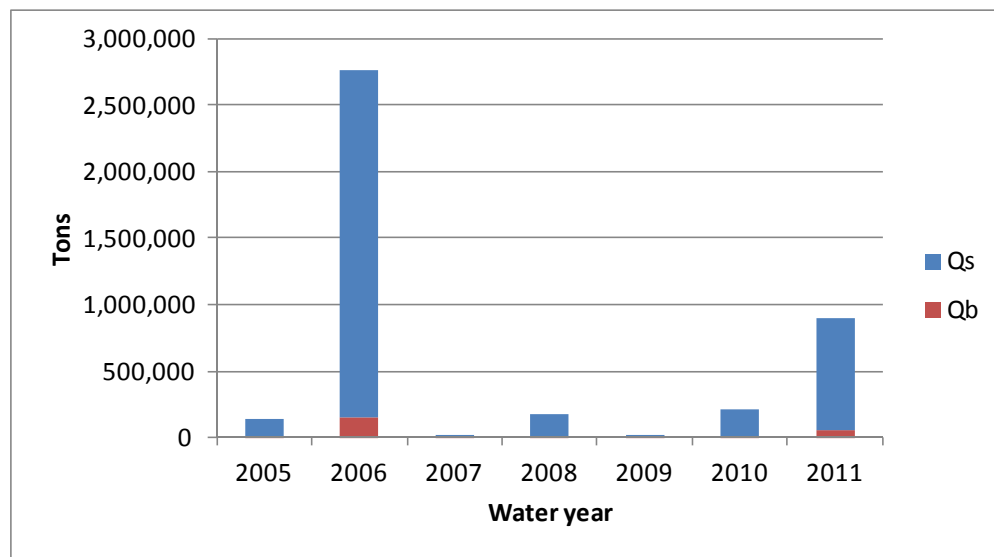
**Figure 13 Total sediment transport in tons**

Based on these data and the empirical relationship in the suspended load rating curve, total sediment transport was calculated in tons. The results for 2005-2011 are shown in Figure 13. As Figure 13 shows, 2006 had considerably more total sediment load transport than the other years, and 2011 was second in quantity. In order to compare these results with the flow values, the mean annual flow (determined from the same flow records) was plotted for 2005-2011 (Figure 14).

QB is bedload; Qs is suspended load. The red represents the bedload portion of the total load.

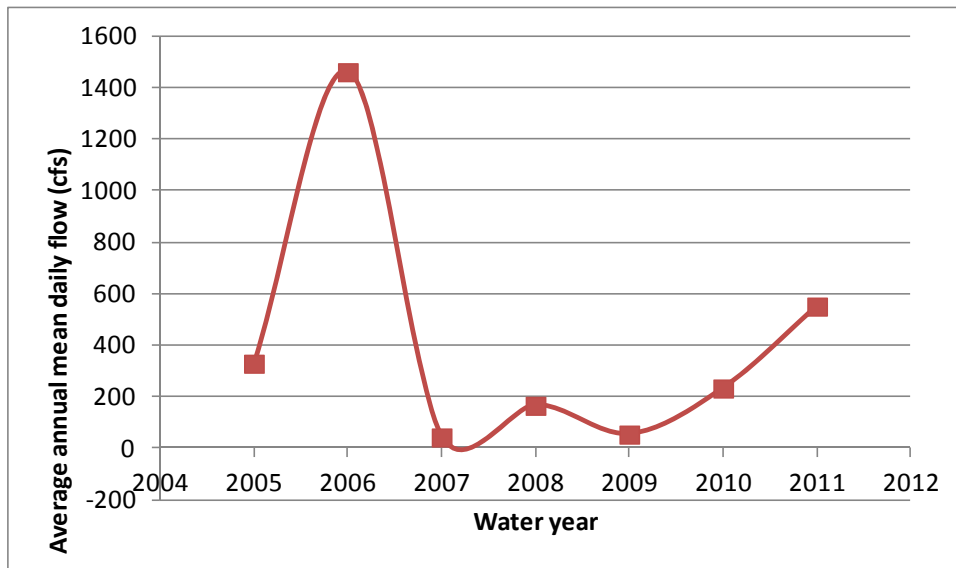
Figure 14 Annual average mean daily flows on Cache Creek at the Yolo gage

It is clear from the two graphs that the sediment transport follows the same pattern as the flow, as represented by the annual average of the mean daily flow.

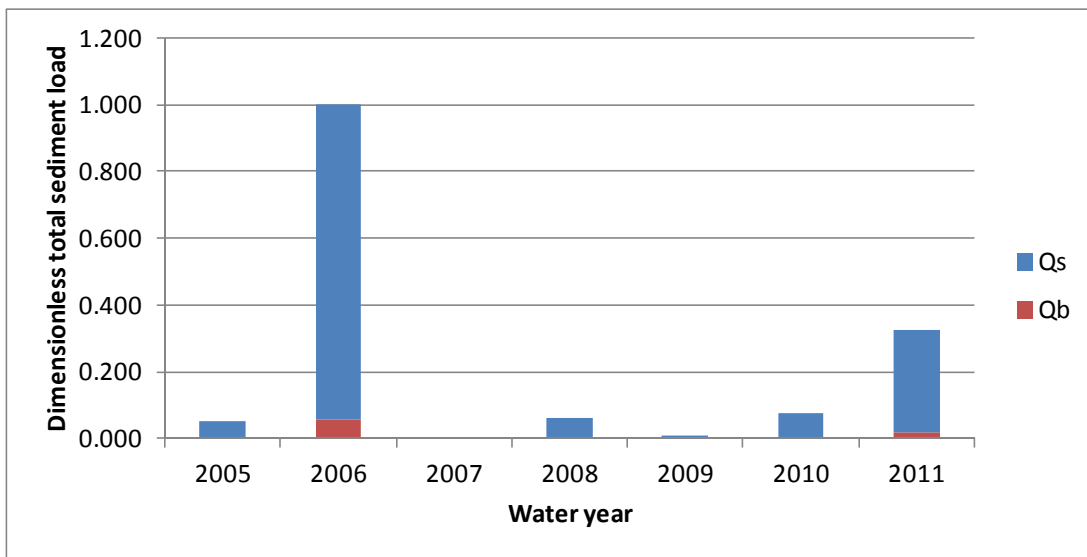
Figure 15 Total dimensionless sediment transport

The results (Figure 15 and Table 3) show the total load in 2006 was 10 to 20 times the load in most of the other years.

The sediment transport calculations above show that 2011 had the second highest rate of sediment transport since 2006 (Figure 15 and Table 3). This suggests that there was enough material for deposition and sediment replenishment, but at this time additional work is necessary to document whether this occurred in 2011.

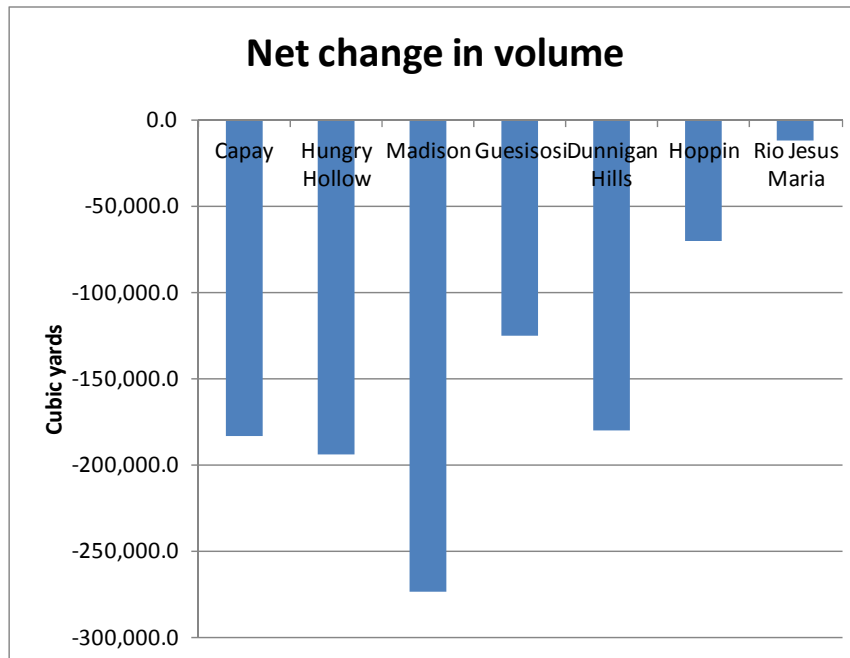
Figure 16 Net change in volume by reach 2010-2011

Net change in volume as reported for 2010-2011 was plotted for each stream reach in the CCRMP area (Figure 16). Because some reaches are significantly larger than others, the spatial/temporal rate of volumetric change in cubic yards/acre/yr was also calculated (Figure 17).

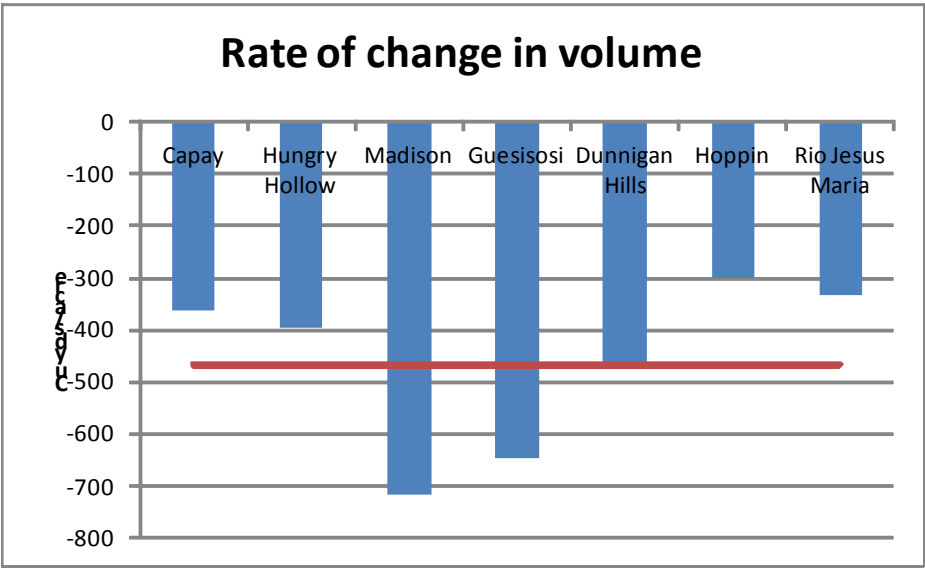
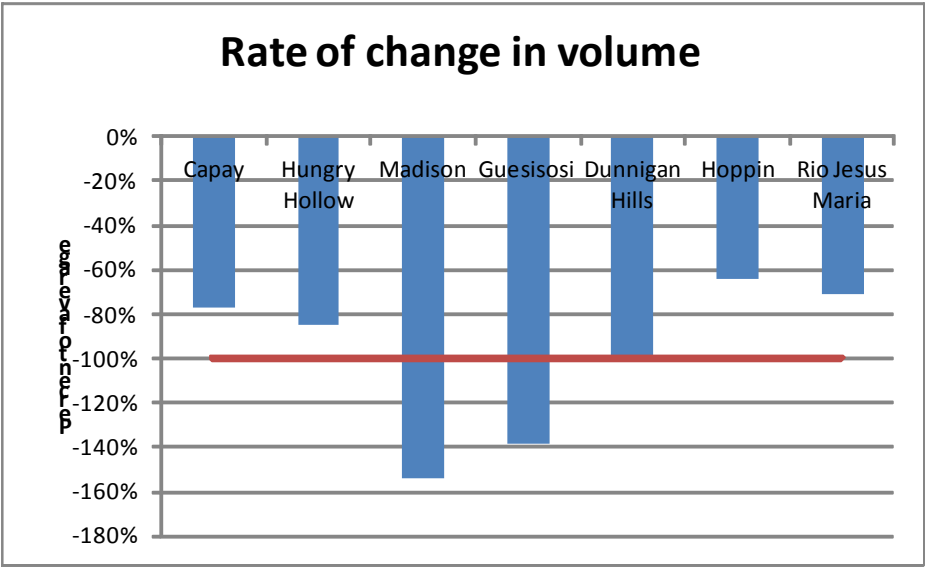
**Figure 17 Rate of change in volume per acre by reach 2010-2011**

The red line is the average value.

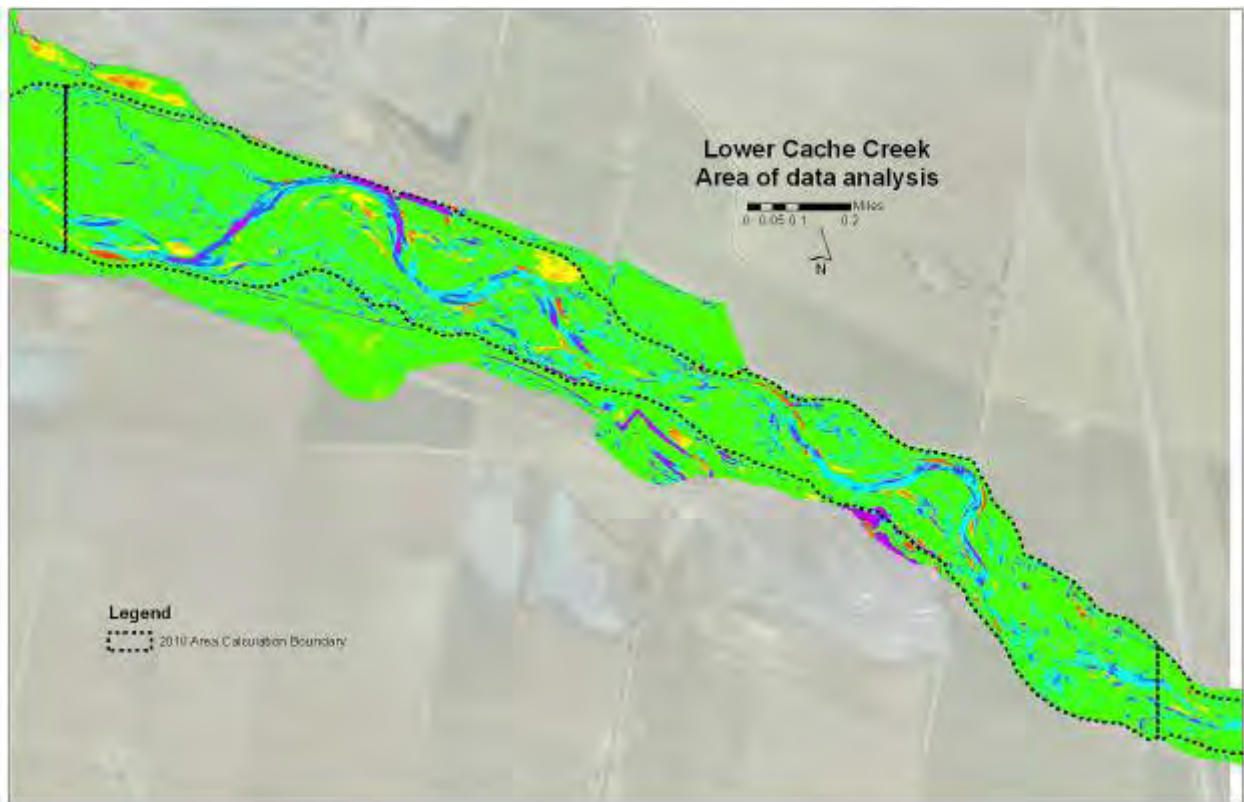
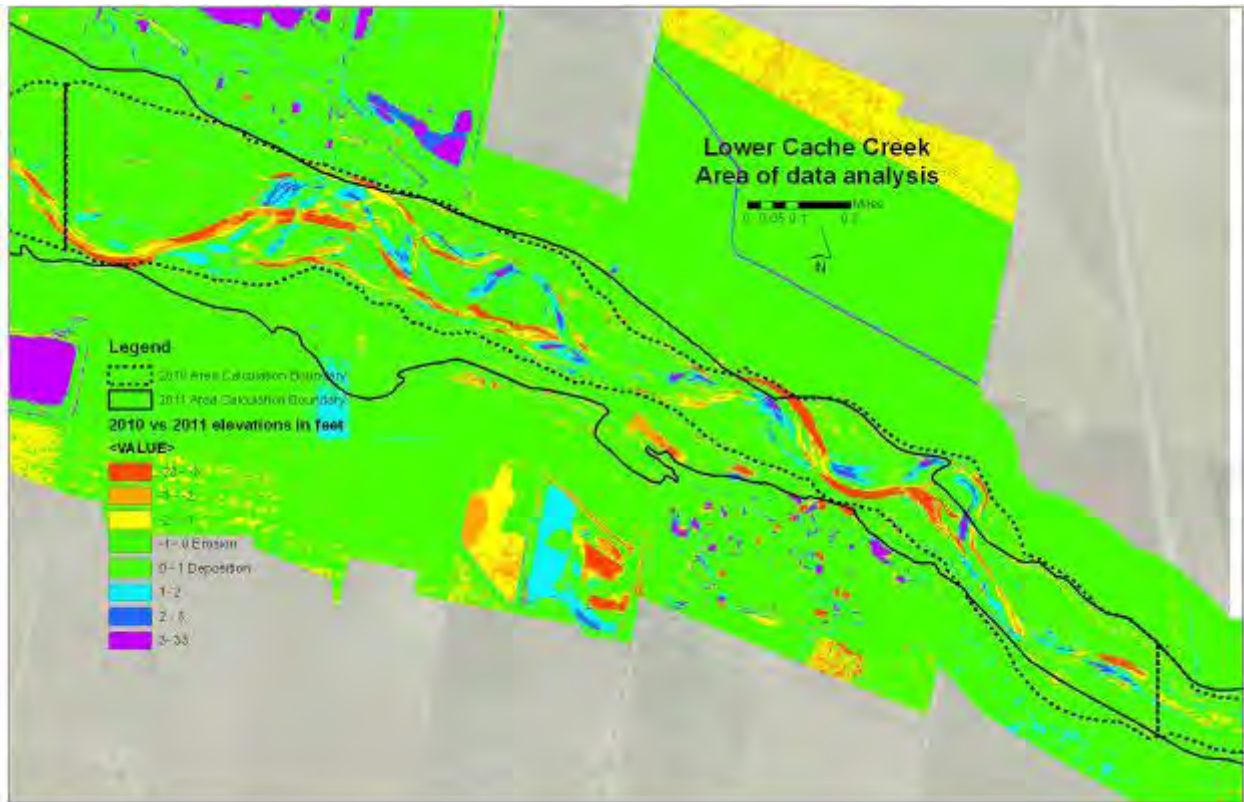
**Figure 19 RM 22-21 Detailed example of different extents for volume change calculation**

Figure 19 shows a section of the CCRMP and the aggradation “cut and fill” analysis done in 2010 and in 2011 by Towill. The figures are shown to present two main points: 1) that the extents used for measuring the cut and fill were significantly different, and 2) that the locations that eroded/deposited can be seen graphically on each map.

Ideally, the data that was presented by Towill could be used directly for calculations of sediment aggradation or degradation. Because of the confounding effect of different water surface elevations in 2010 and 2011—which appears to have determined the elevations reported for “in-channel” cut and fill—the cut and fill data cannot be effectively used to analyze the annual sediment replenishment.

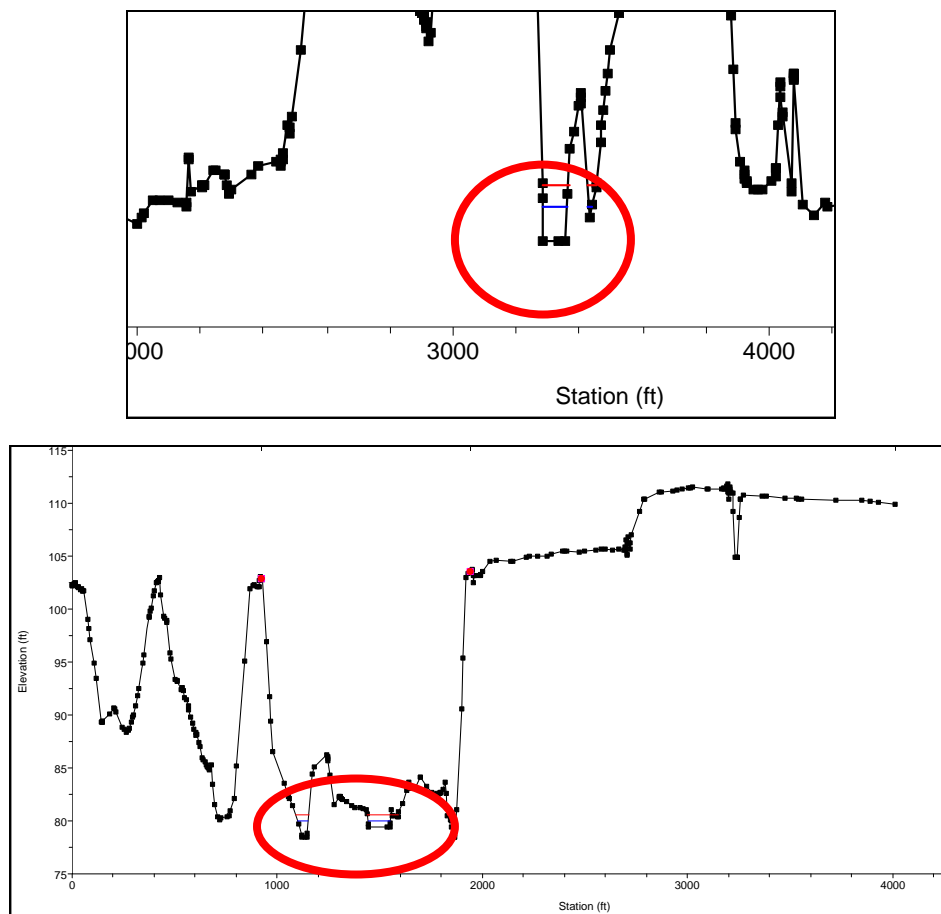
**Figure 20 Elevation changes in sample HEC-RAS cross sections**

Based on a HEC-RAS analysis of 153 cross sections extending from the Road 94B Bridge to the Highway 5 Bridge, the average difference in water surface elevation was 1.23 +/- 0.33 (standard deviation) feet (Figure 20 and Table 8). This means that the water surface elevation at 100 cfs (2011 data) would be slightly more than a foot lower than the water surface elevation at 300 cfs (2010 data).

The red line shows the water surface elevation at 300 cfs (2010) and the blue line shows it at 100 cfs (2011).

The comparisons suggest that the difference in elevations on the slope plots may be largely due to the water surface elevation difference between 100 and 300 cfs flow levels. Other analyses would be required to determine other possible causes, such as deepening of the thalweg.

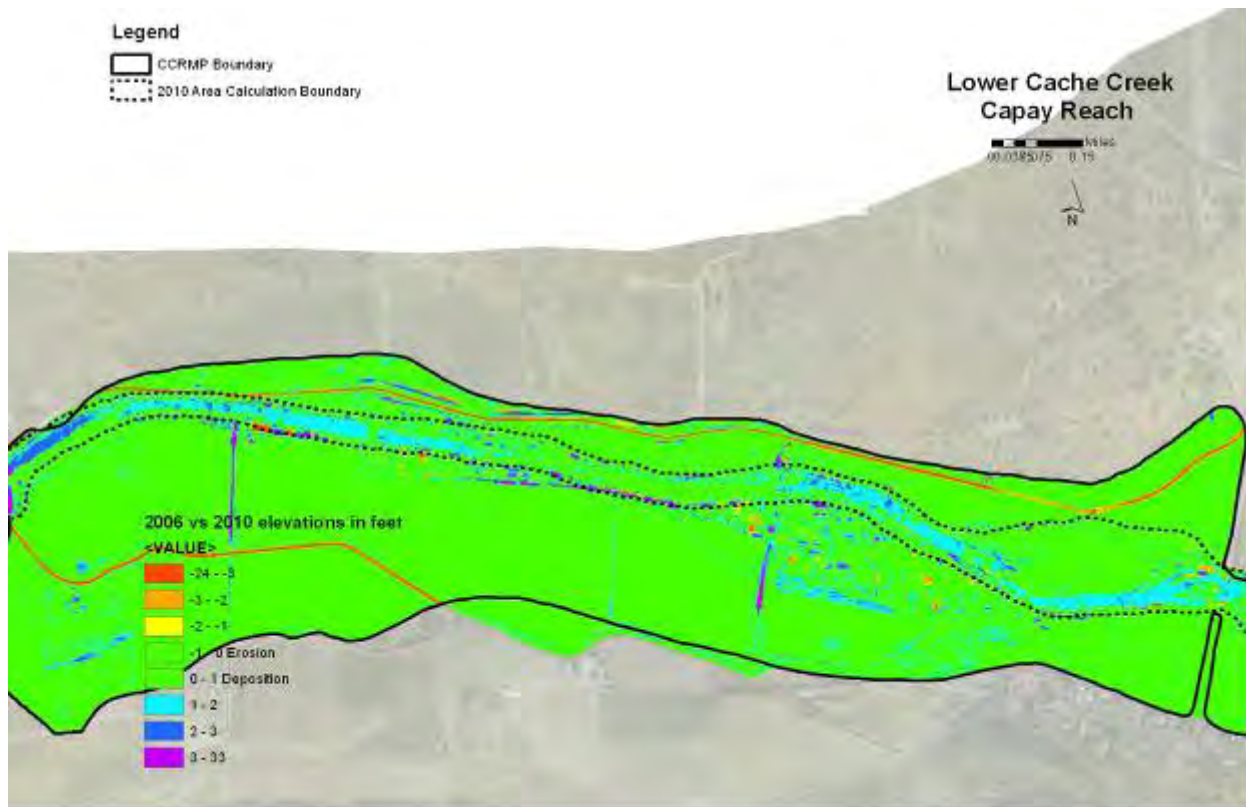
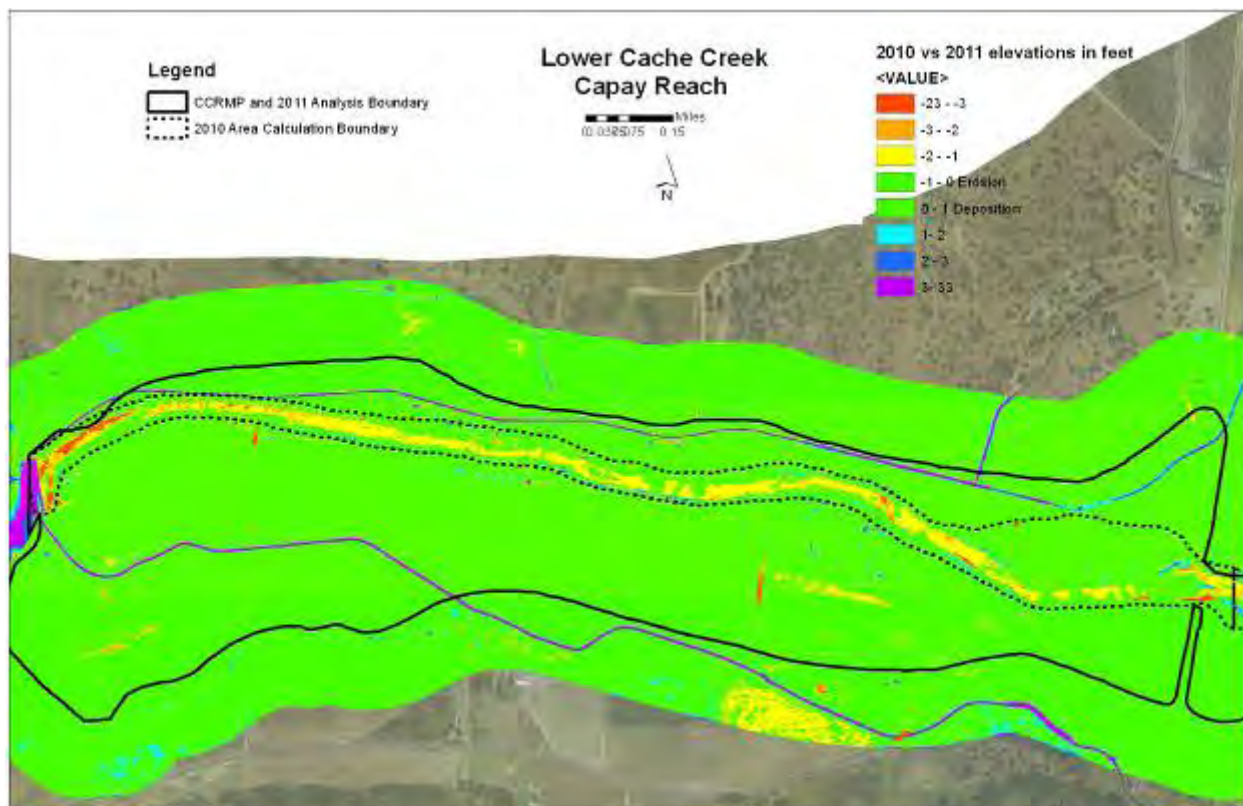
Figure 22 Capay reach RM 28.45 to 26.35 cut and fill maps

In 2006-2010 there was a reported 1-2 feet of fill along the river channel for most of the reach (Figure 22 upper image). In 2010-2011, a consistent 1-2 feet of cut was reported along the entire reach (Figure 22 lower image) and the rate of reported cutting was 361 cu. yds./acre/yr. Erosion reported in the bed of the channel may actually reflect the change in water surface level from one year to the next.

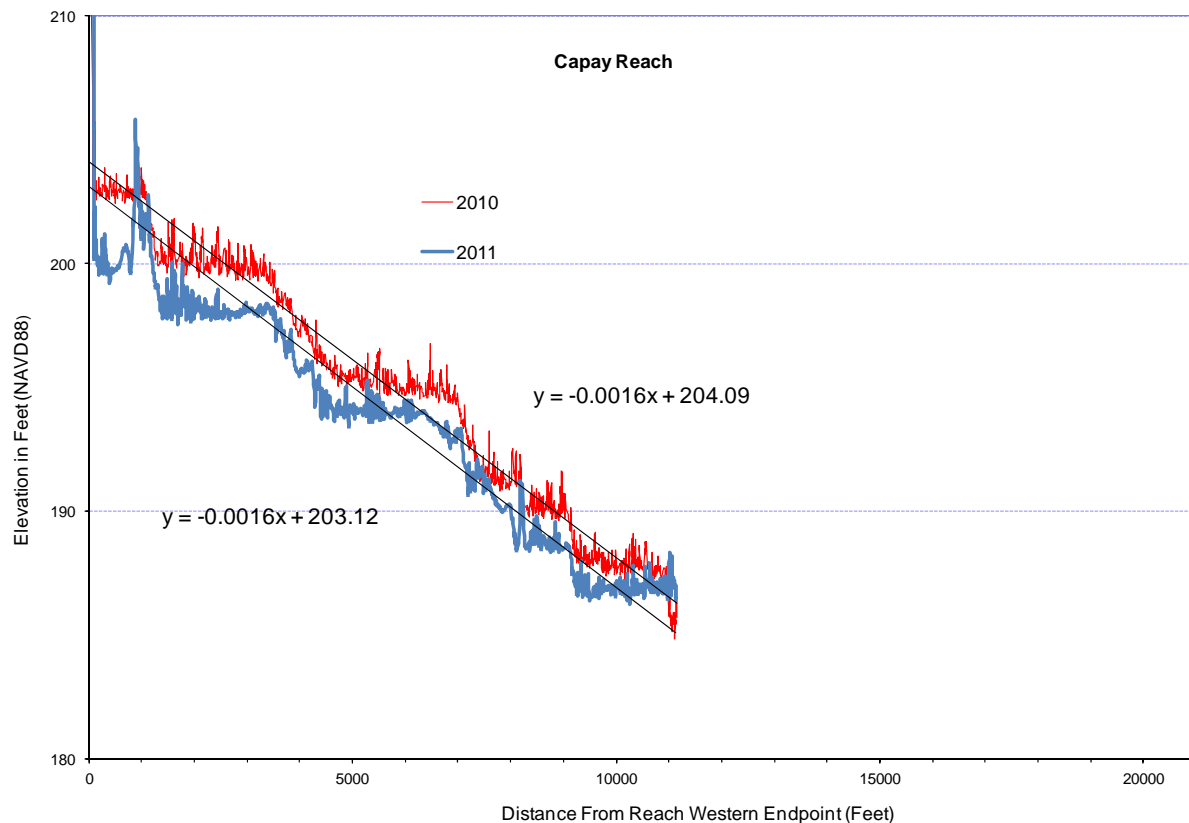
**Figure 23 Capay reach longitudinal profile (slope) with analyzed trend line**

The longitudinal profile (Figure 23) shows that there are 6 areas where the profile is essentially flat, with steeper sections in between. The difference in elevation in the two profiles may be due to the difference in water surface elevation.

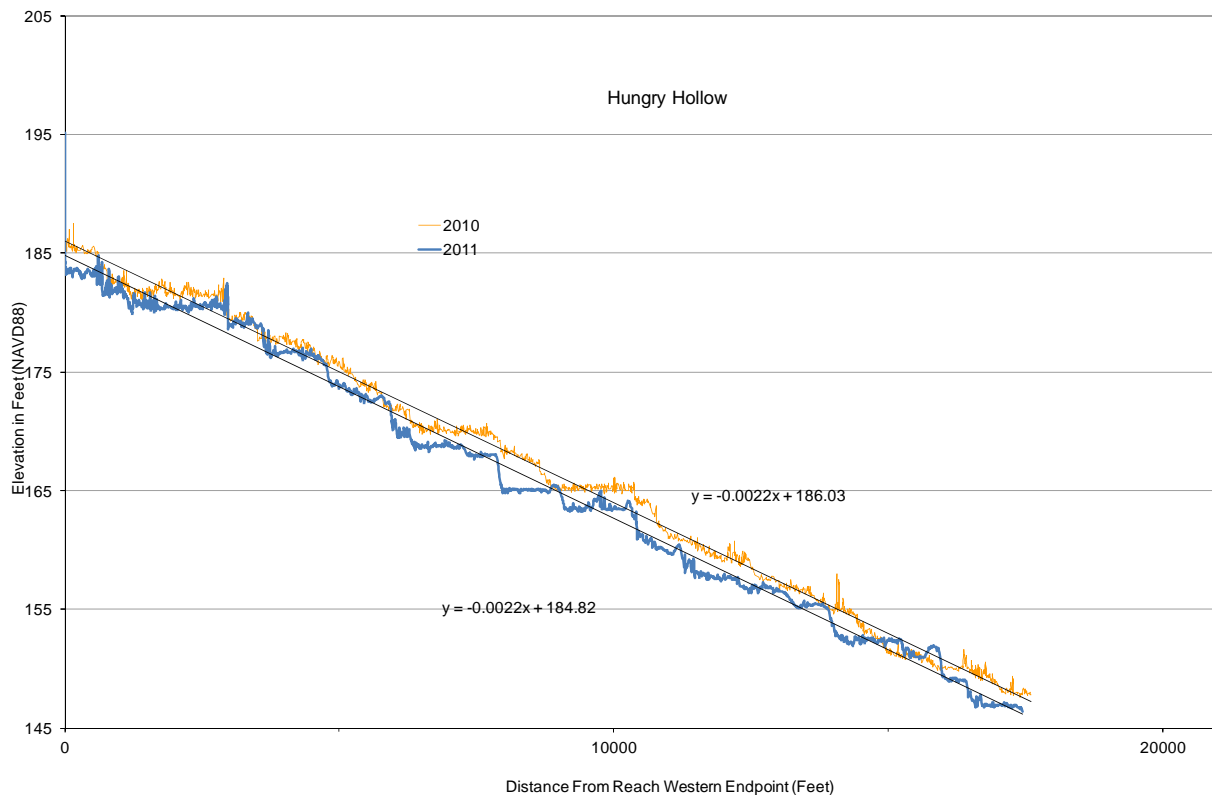
Figure 26 Hungry Hollow Reach RM 26.35 to 23.50 slope

The longitudinal profiles in the two time periods (Figure 26) are relatively parallel, with some minor changes in pattern. Near station 8000 in Figure 26 the elevation profile flattens where it was sloped in 2010.

The slope profiles show that the elevation was about 1.2 feet lower in 2011 than in 2010.

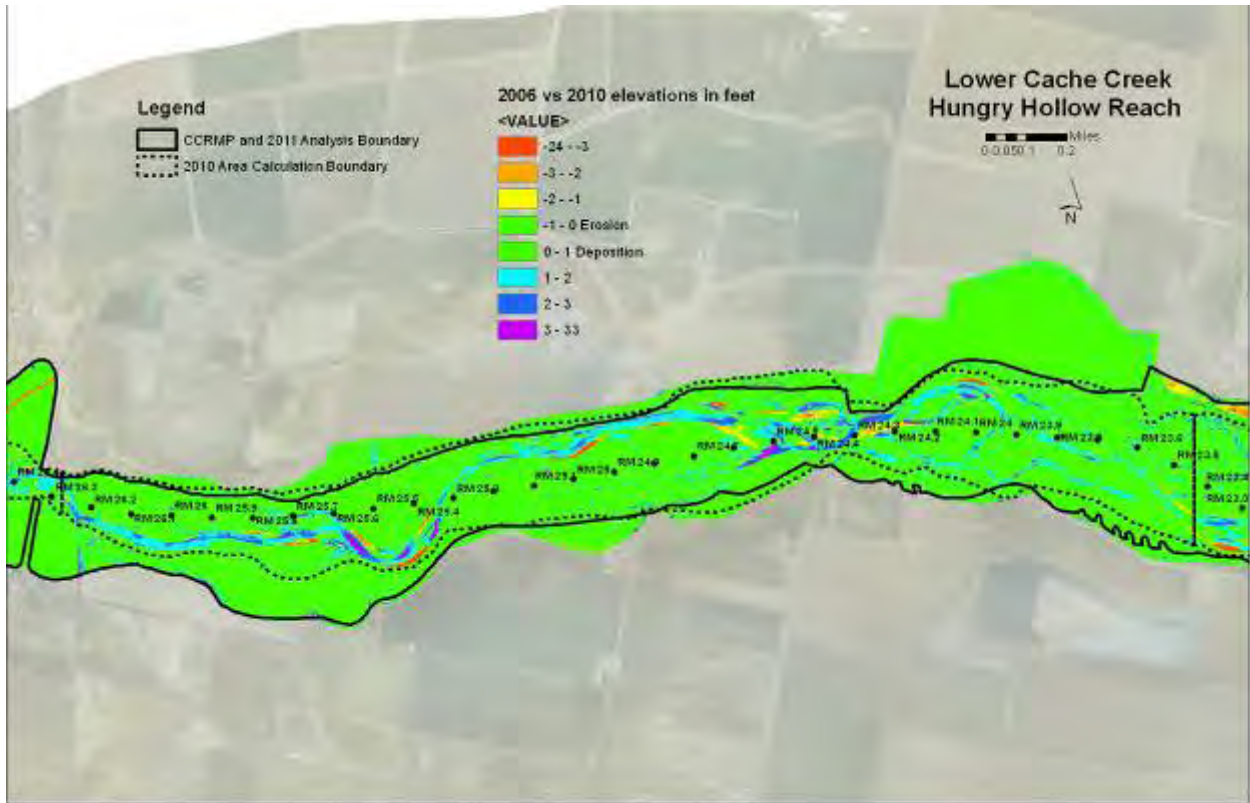
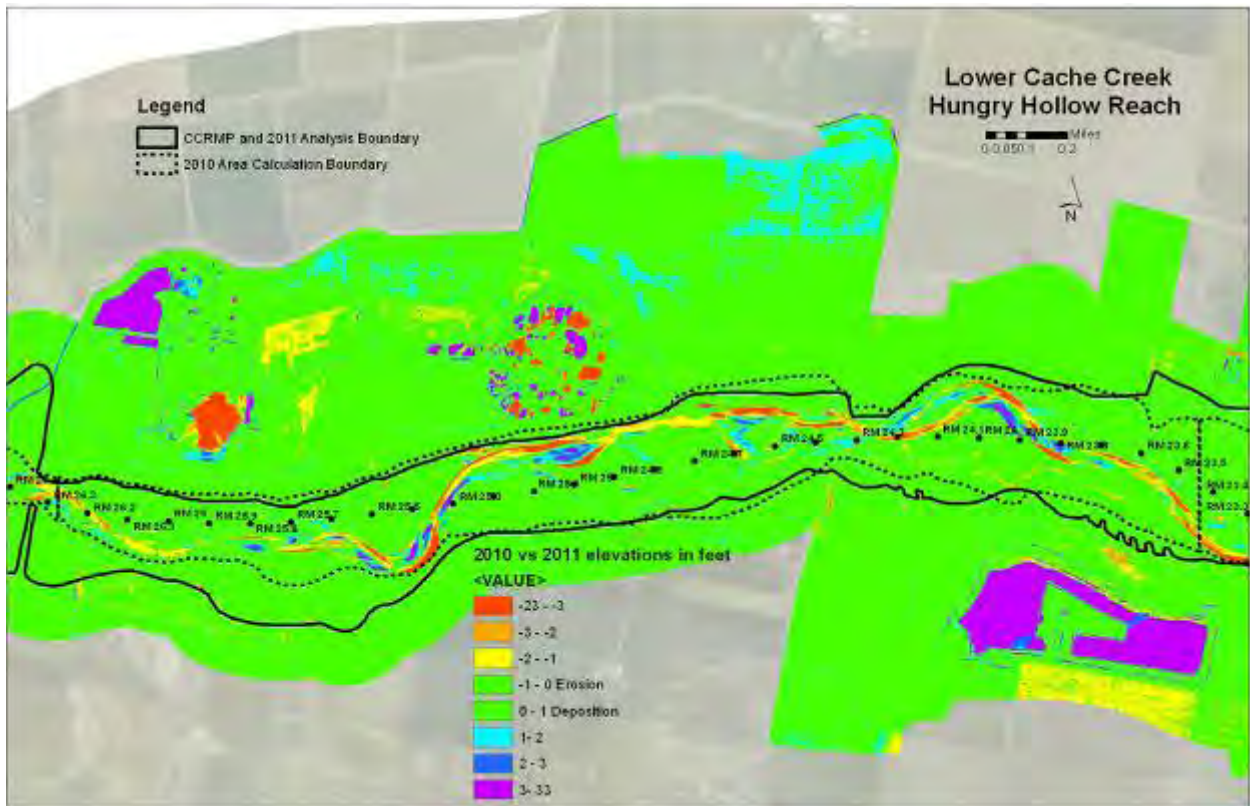
Figure 28 Hungry Hollow Reach RM 26.35 to 23.50 cut and fill maps

In considering volumetric change, the cut and fill maps (Figure 28) show much more yellow and red in the channel itself in the 2010-2011 time period, indicating that the elevations in 2011 were less than in 2010.

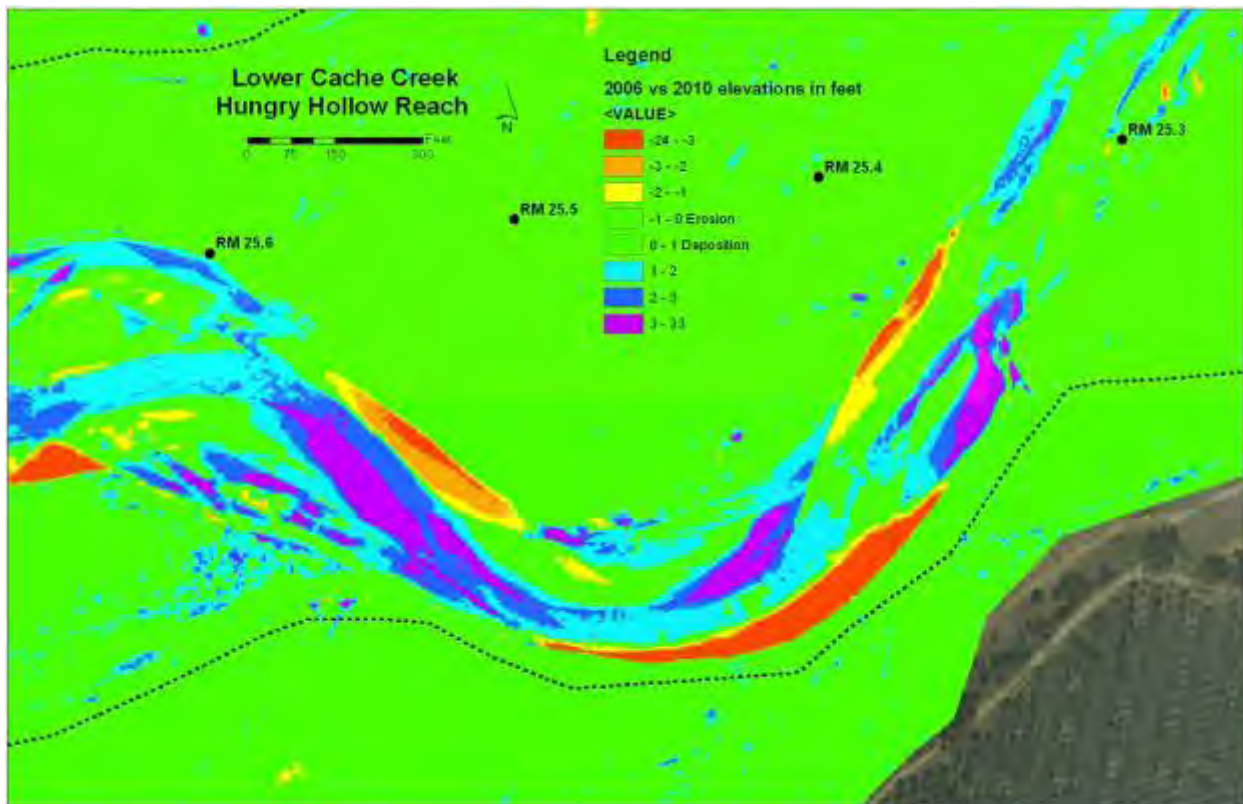
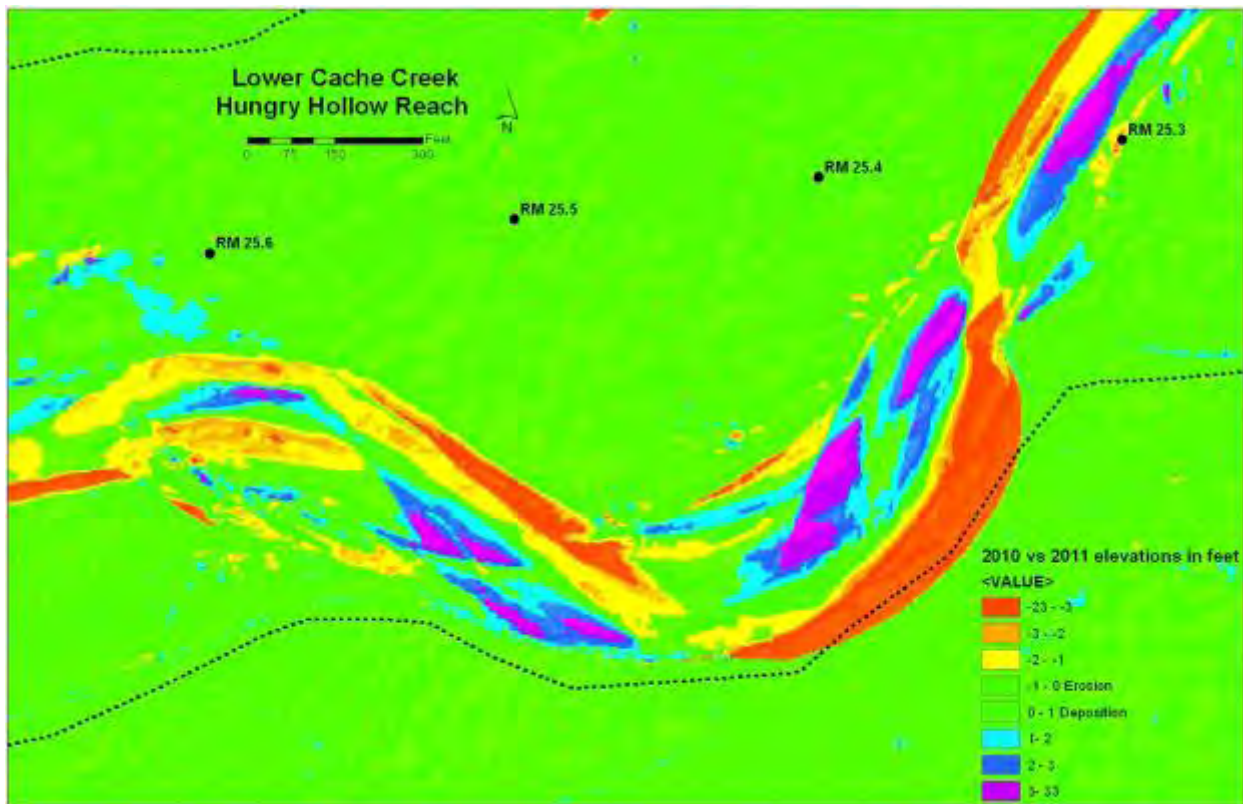
Figure 30 Hungry Hollow Reach RM 25.5-25.4 cut and fill maps

Cut and fill patterns for 2006-2010 and 2010-2011 show that the channel bend in this location is evolving in a typical pattern for fluvial bend evolution. The bend is translating downstream. As the forward limb of the bend moves downstream, there is a pattern of cutting into the terrace (red on Figure 30); as the rear limb moves downstream, it leaves a pattern of fill in its wake (purple on Figure 30). The fill makes newly created floodplain areas that are prime habitat for riparian vegetation. This is the type of dynamic process that can be utilized for natural regeneration of riparian habitat conditions.

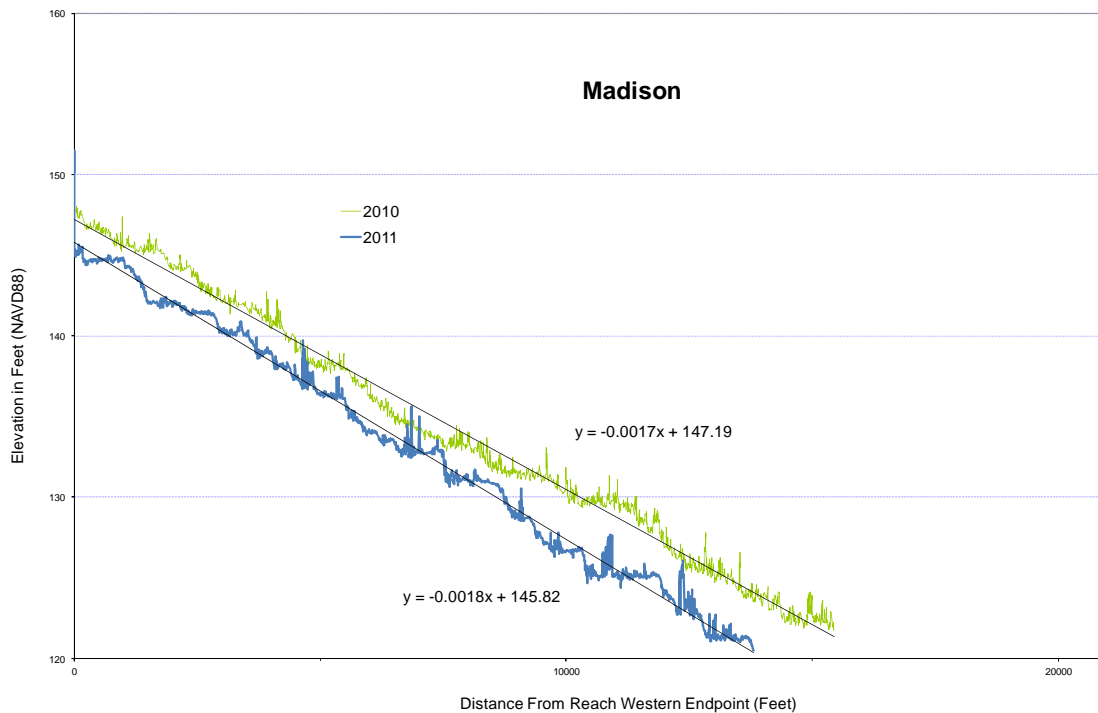
Figure 31 Madison reach RM 23.50 to 21.1 slope

The longitudinal profile (Figure 31) shows that there were two areas in 2010, which are nearly next to each other, where the profile is essentially flat, with steeper sections of relatively uniform slope in the rest of the reach. In 2011, the flat areas appear to have changed location. This is probably due to the shifting of location of the pools and riffles as the channel changes shape with time.

The slope profiles suggest that the elevation was about 1.4 feet lower in 2011 than in 2010.
