# CACHE CREEK ANNUAL STATUS REPORT 2011

Cache Creek Technical Advisory Committee:

**February 28, 2012**

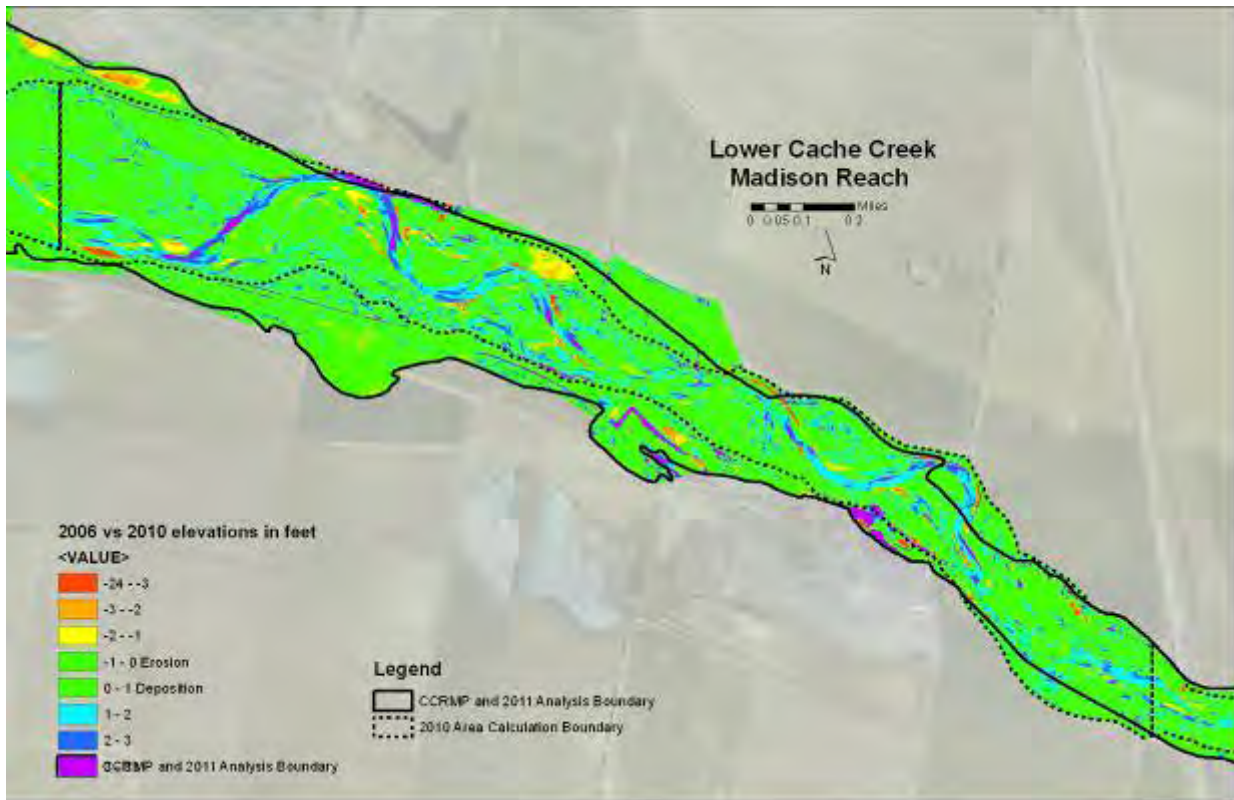
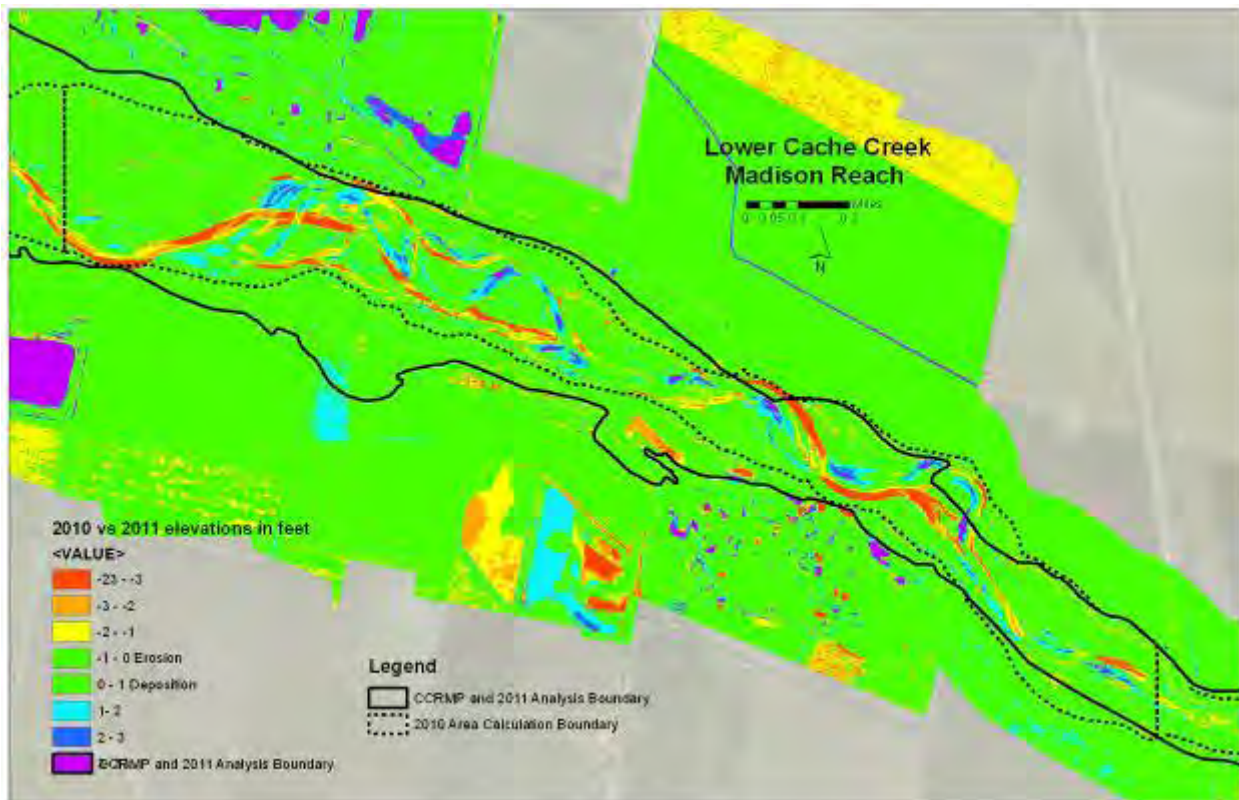
**Figure 32 a Madison reach RM 23.50 to 21.1 cut and fill maps**

As in the previous two reaches, the bed elevation changes show consistent 1-2 foot increase in elevation in the 2006 to 2010 time period (as shown by the blue colors in the mapping). The bed elevation changes in the 2010 to 2011 time period show 1-2 feet of lowering and even greater than three feet (red) in much of the reach. When the red color shows in the channel itself, it may represent erosion into the bed. In areas near a high bank, the red is interpreted to indicate the sloughing off of a rather high steep bank, and channel migration.

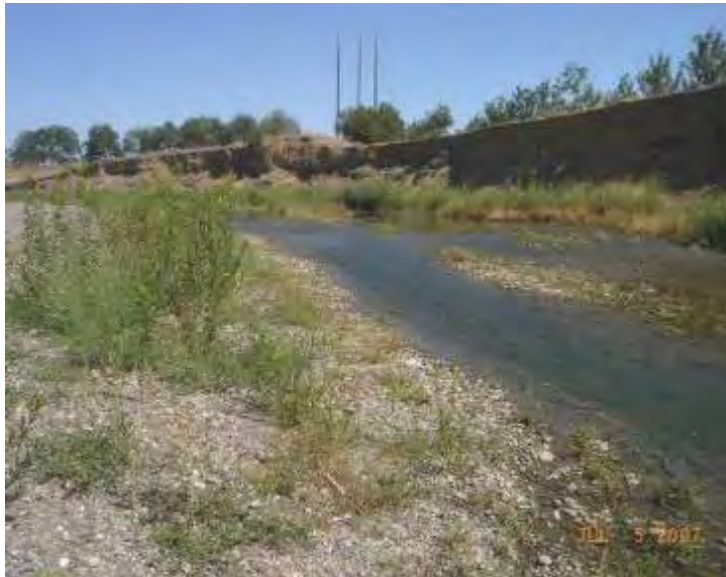
The South Bank has been restrained near RM 21.7 (upstream from this site) and due to the constriction of natural channel meandering to the south, may be promoting accelerated rates of migration onto the north bank. The curvature of the creek bend at RM 21.5 is tight and appears to be tighter than it would be if the spur dikes had not been installed. The north bank adjoining the local property has a sharply curved bank that causes stream velocities to be high adjacent to the bank. Part of this curvature may be exacerbated by the dike immediately downstream.

**Figure 33 Bank erosion at the outside bend of the meander near RM 21 (2008)**

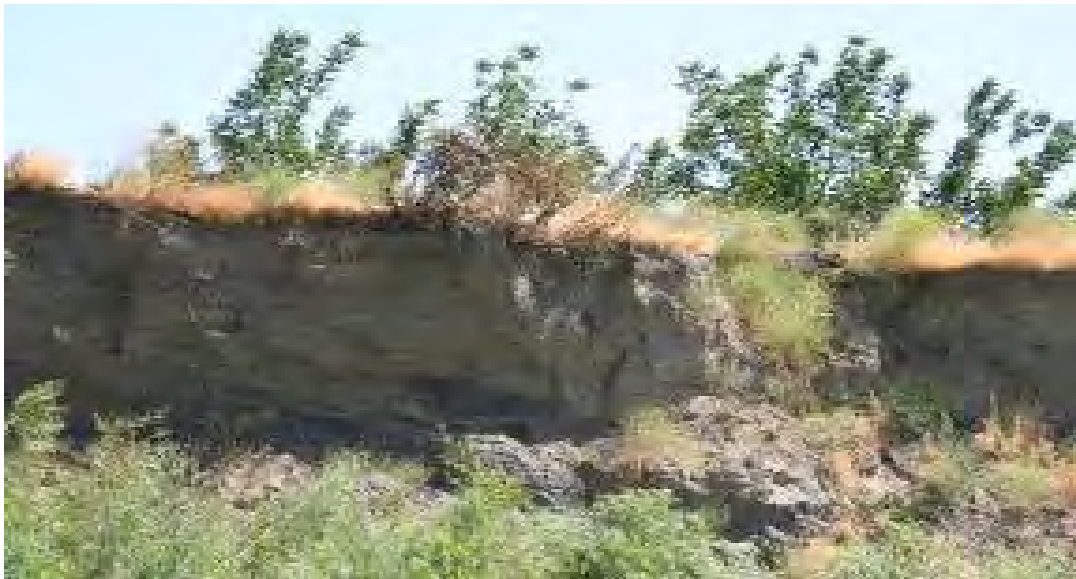
shift on the south bank near RM 21.8 and the restraint at RM 21.5 (causing an exaggerated curvature to the channel just upstream) will continue to accelerate bank erosion rates on the north side near RM 21.6.

**Figure 34 Active erosion at RM 21.6 north bank (2008).**

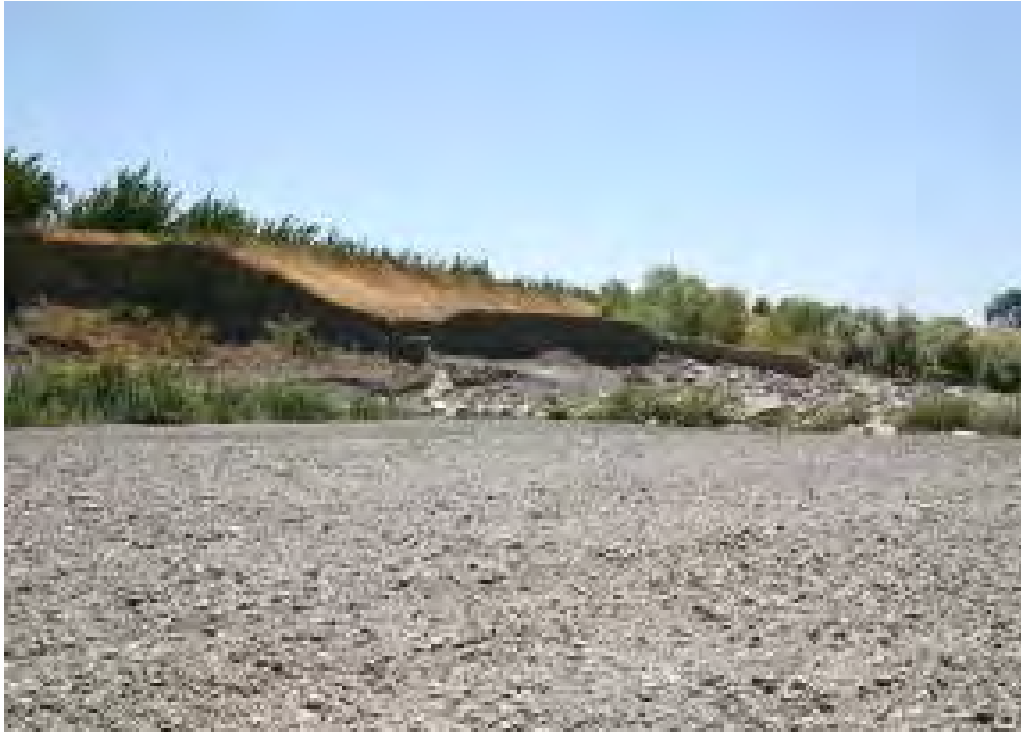
**Figure 35 Active erosion of upstream spur dike, RM 21.55 north bank (2008).**

The broken concrete core of the spur dike constructed here was disturbed although large pieces remained in place. The spur dikes downstream of the damaged spur dike showed little sign of erosion. Vegetation between the spur dikes is thriving and several inches of sediment have accumulated over the 2007-2008 season. The spur dikes are buried, covered with vegetation that dates back to 2002, and are barely visible. Loamy soil up to about 2 feet thick blankets the areas between the spur dikes along the north bank.

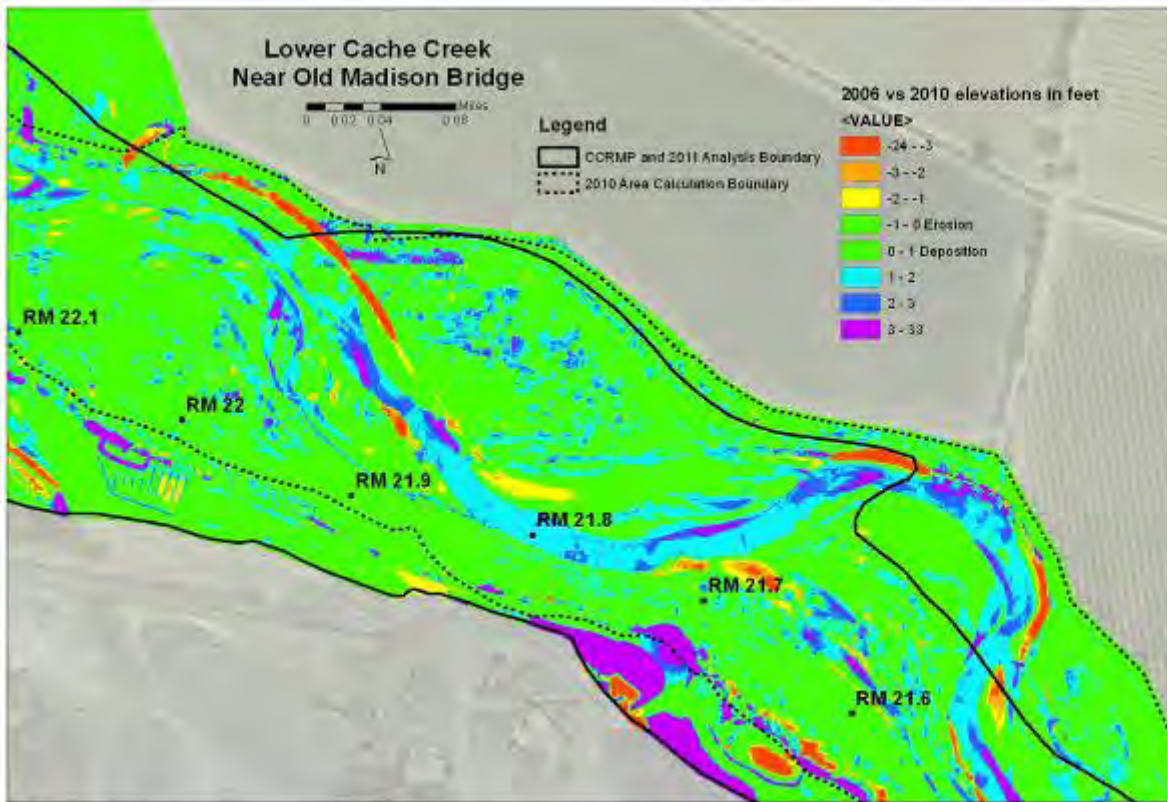
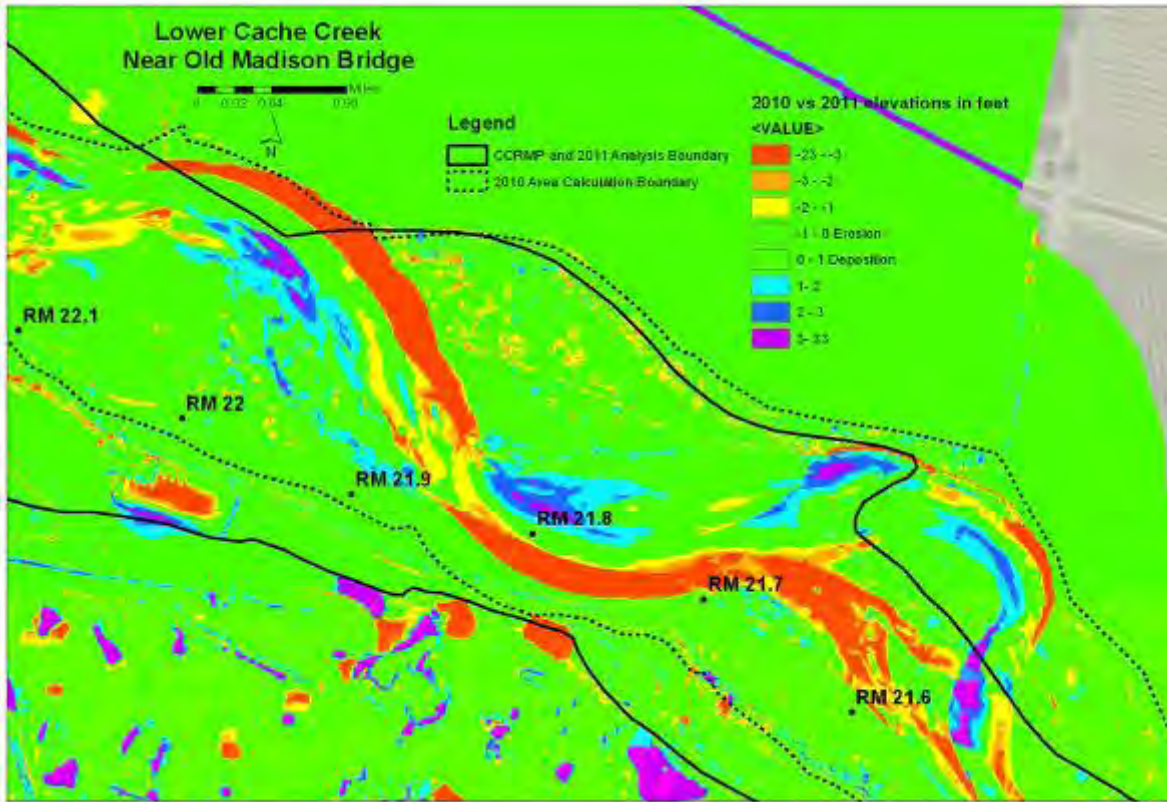
Figure 37 Old Madison Bridge site cut and fill maps

An additional observation is that there is an area upstream near RM 22.0 on the north bank that is experiencing active bank retreat (Figure 36.) This can be seen on the cut/fill maps that were made from the Towill 2011 data (Figure 38). Figure 37 (upper image) represents 5 years of bank erosion and Figure 37 (lower image) represents a single year of bank erosion. The area near RM 22.0 has eroded significantly, and the meander modeling and the cut and fill maps suggest that the bank retreat will continue near RM 22.0. This bank retreat is occurring in a low flood plain terrace (Figure 38) and the curved bend is likely to continue to move downstream. As it progresses over the course of many years, it is likely to develop and build a new floodplain terrace (in its “wake”), which could create habitat for riparian vegetation, either actively restored or naturally regenerated.

The observations made this year need to be evaluated. The current removal and potential rebuilding of the low floodplain terrace at this site is acceptable, and active management is not necessary at this time.

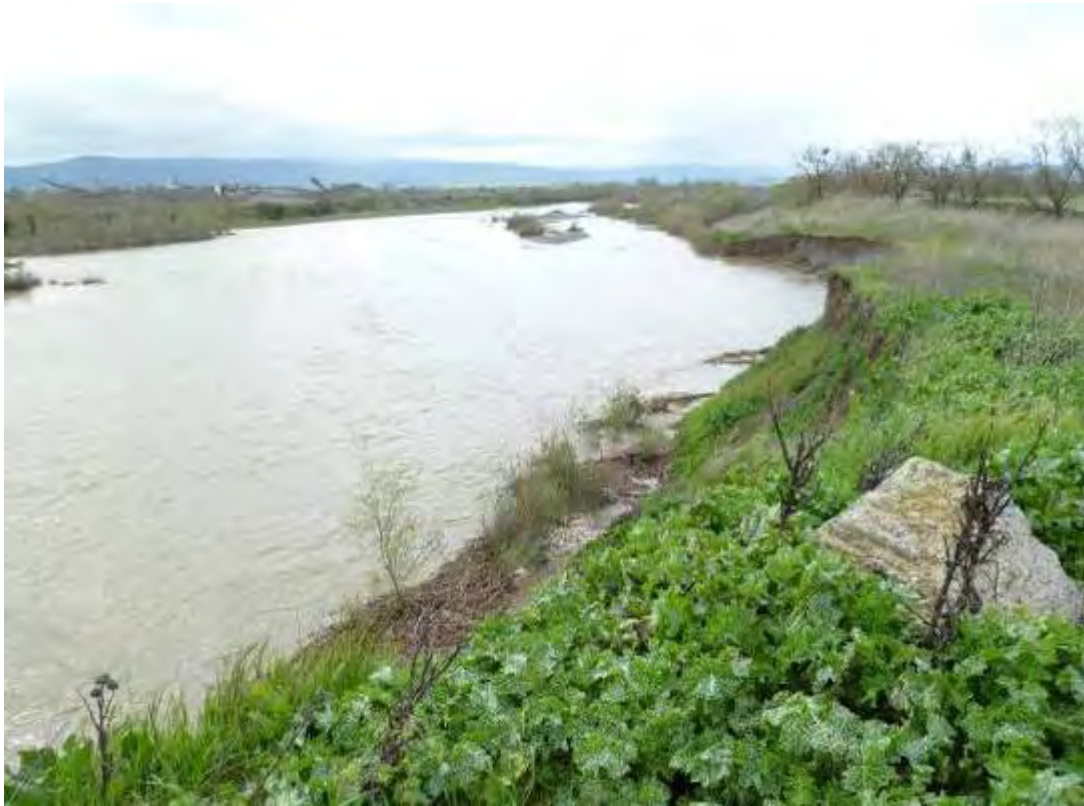
**Figure 38 From Road 84b Bridge site looking upstream toward RM 22.0 (2011)**

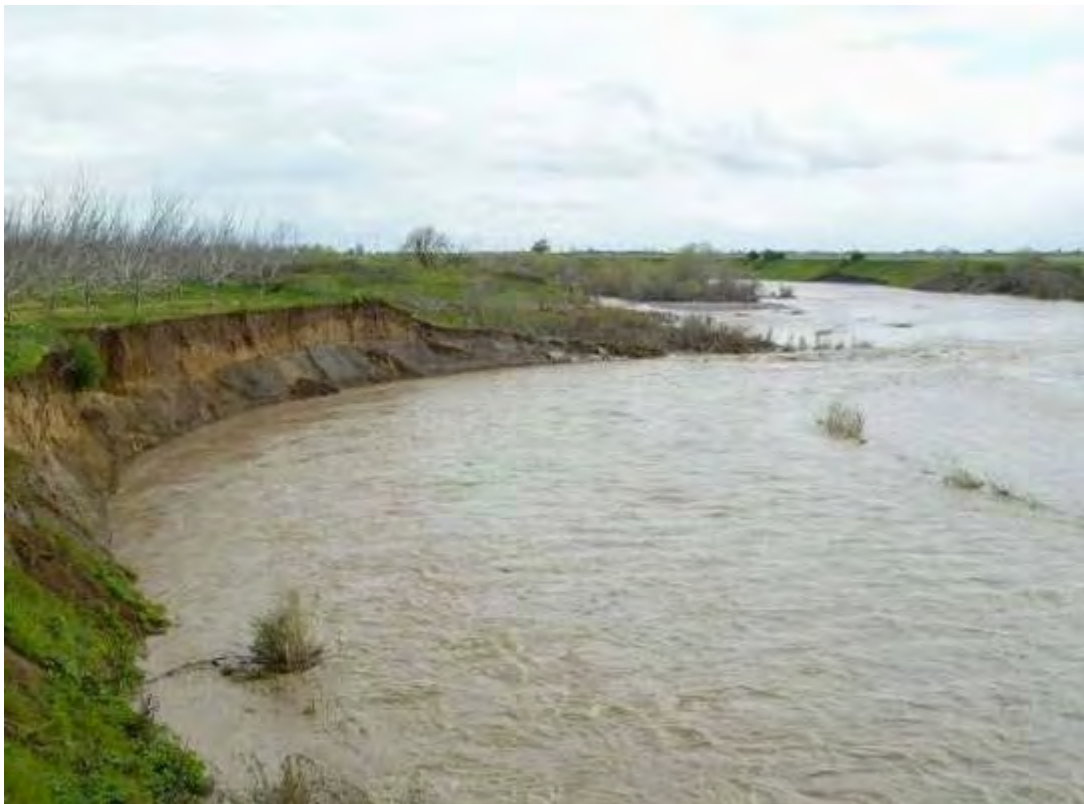
The preliminary results suggest that the active bank retreat near RM 21.6 (Figure 39) will not be large with moderately large flows like the ones experienced in 2011.

**Figure 39 Road 84b Bridge site looking downstream (2011)**

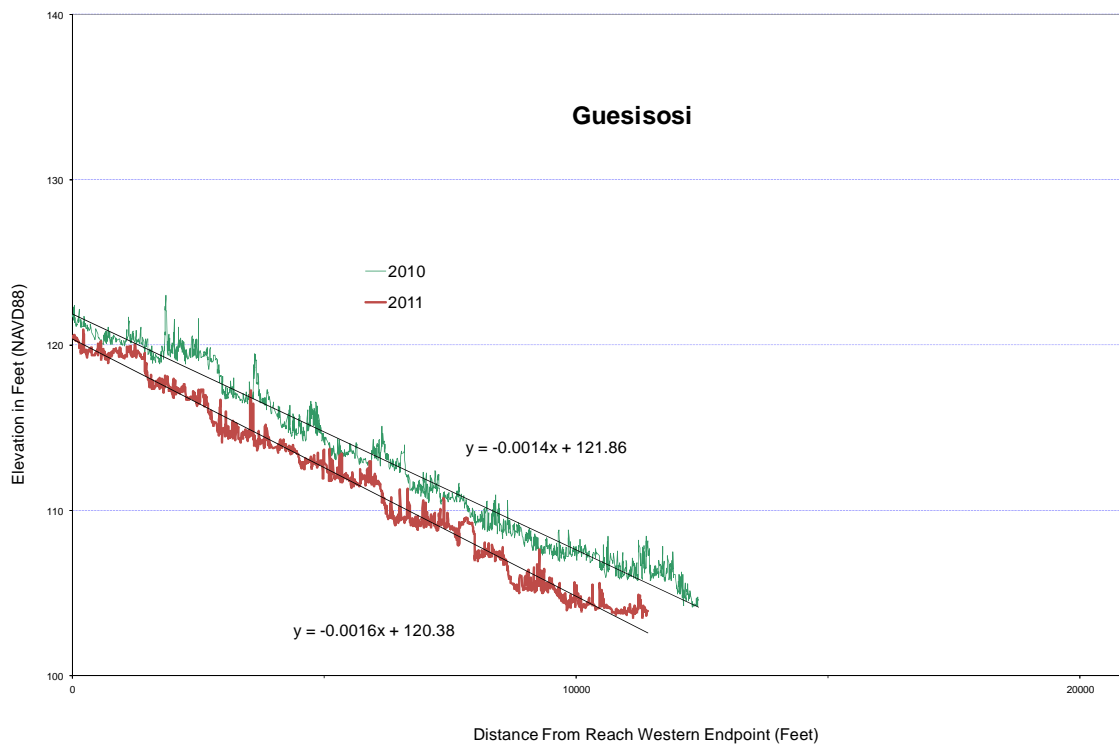
Figure 40 Guesisosi Reach RM 21.10 to 18.85 slope

The longitudinal profile (Figure 40) shows that the elevations in the two time periods were roughly parallel. The slope profiles suggest that the elevation was about 1.5 feet lower in 2011 than in 2010.

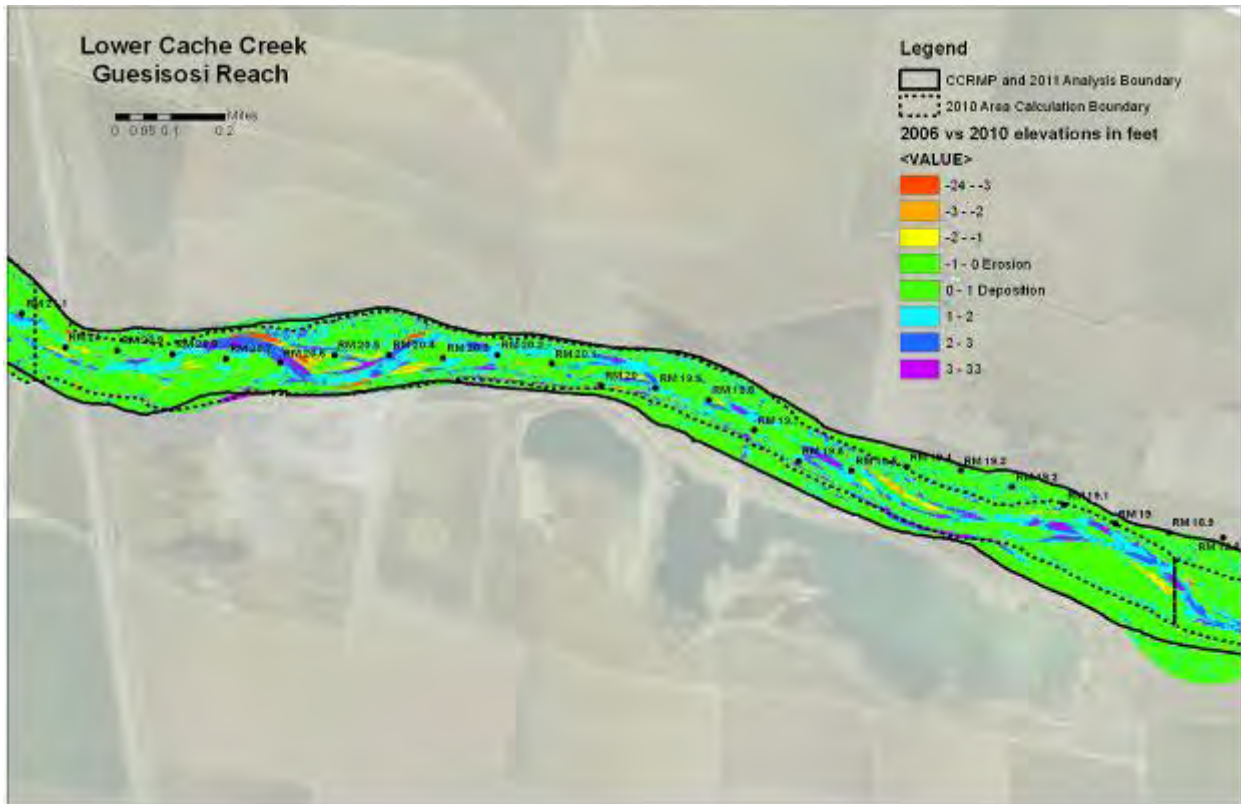
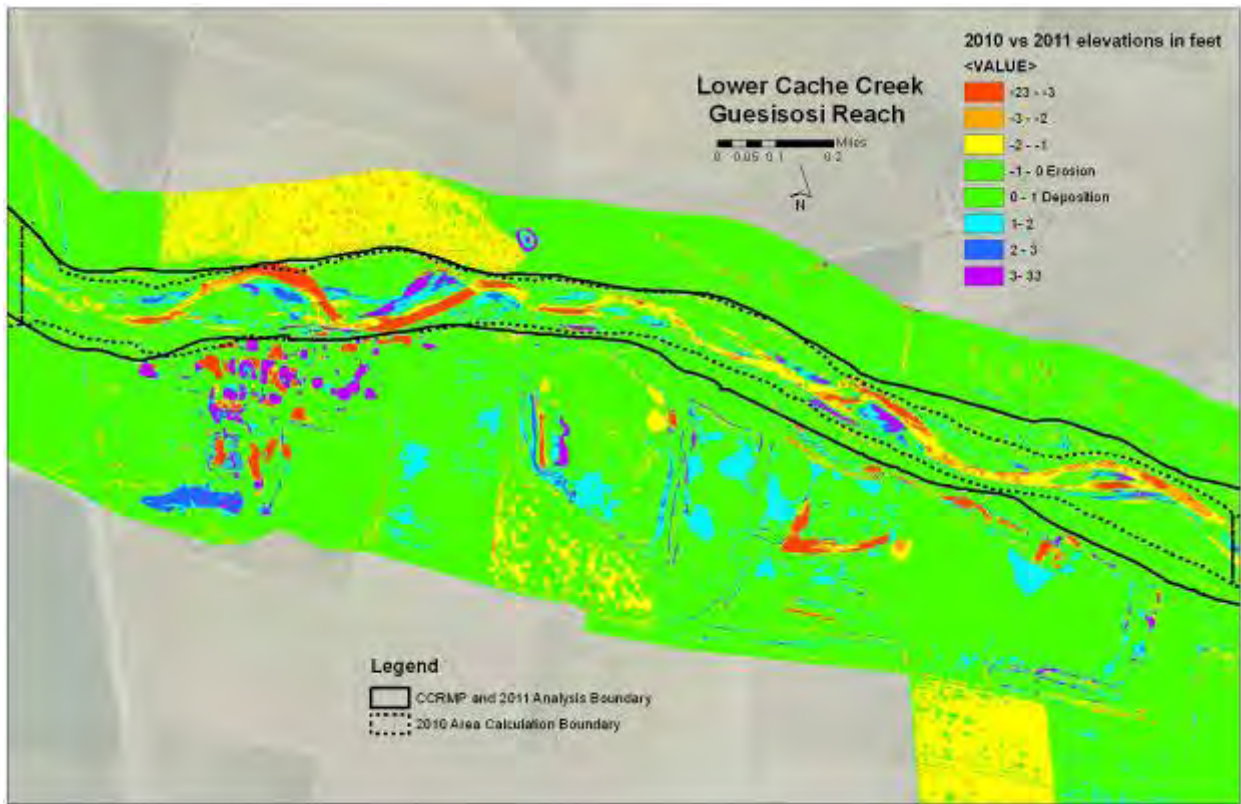
**Figure 41 a Guesisosi Reach RM 21.10 to 18.85 cut and fill maps**

The cut and fill images also show a consistent lowering of the elevation in the 2010-2011 time period, in contrast with the deposition seen in the 2006-2010 period.

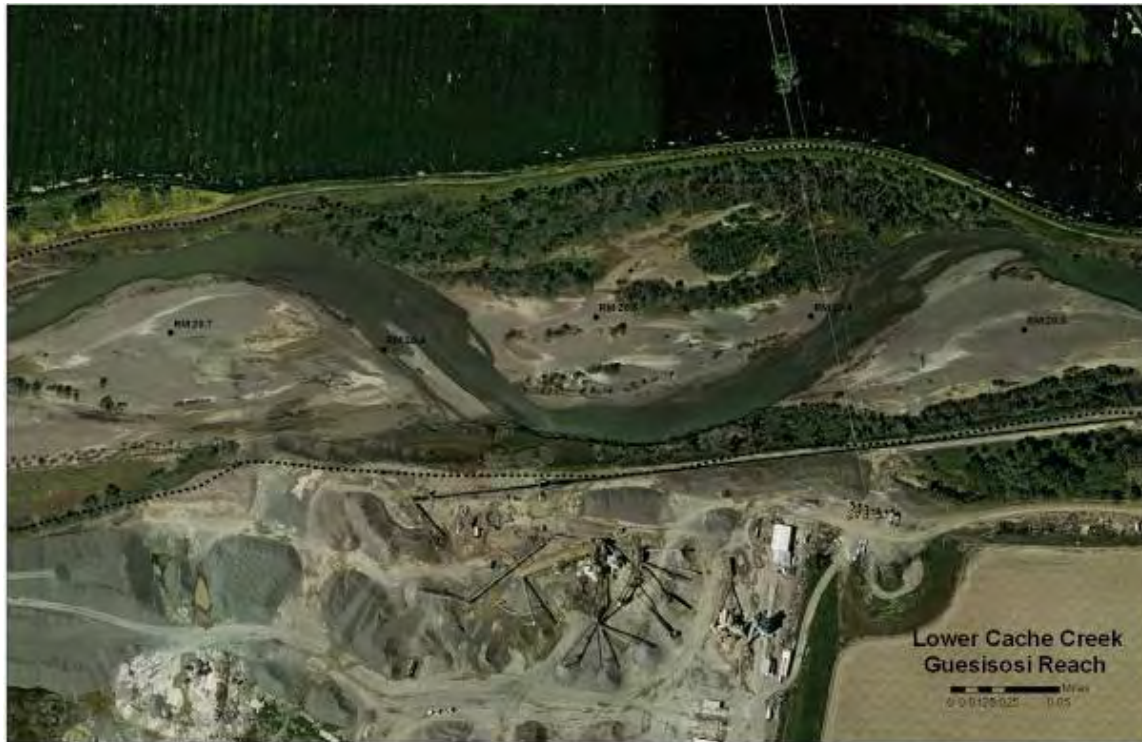
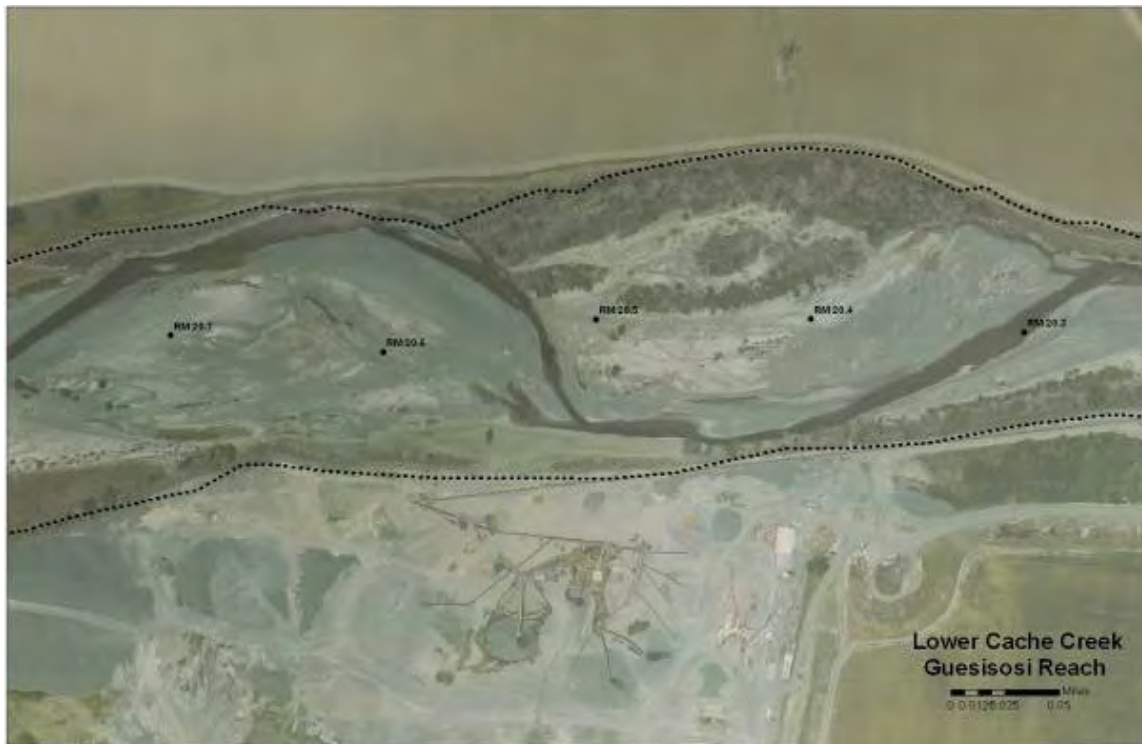
There is a significant area of bank retreat near RM 20.6 (Figure 42 and Figure 43), where the channel bends are migrating downstream. As in previous reaches, this migration consists of cut on the outside curve of the channel and fill on the inside of the curve, where the curved channel is leaving a deposited floodplain in its former location.

**Figure 42 Guesisosi Reach near RM 20.6**  
The 2010 aerial is on top, the 2011 aerial is on the bottom.

Because these patterns of channel shift have persisted since 2006, it is reasonable to expect that the channel shifting will continue, with cut on the outside of the curve and fill in the former trace left on the inside of the bend. This natural process does not require active management at this time.

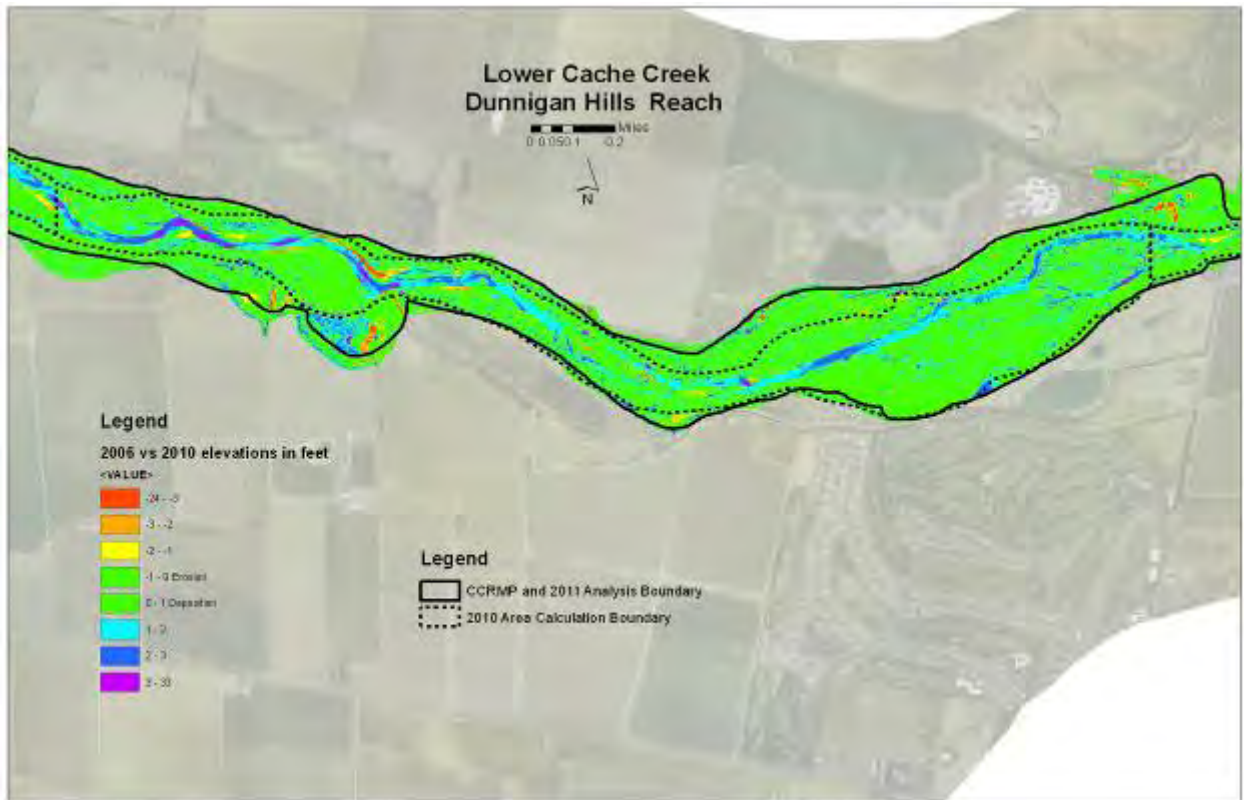
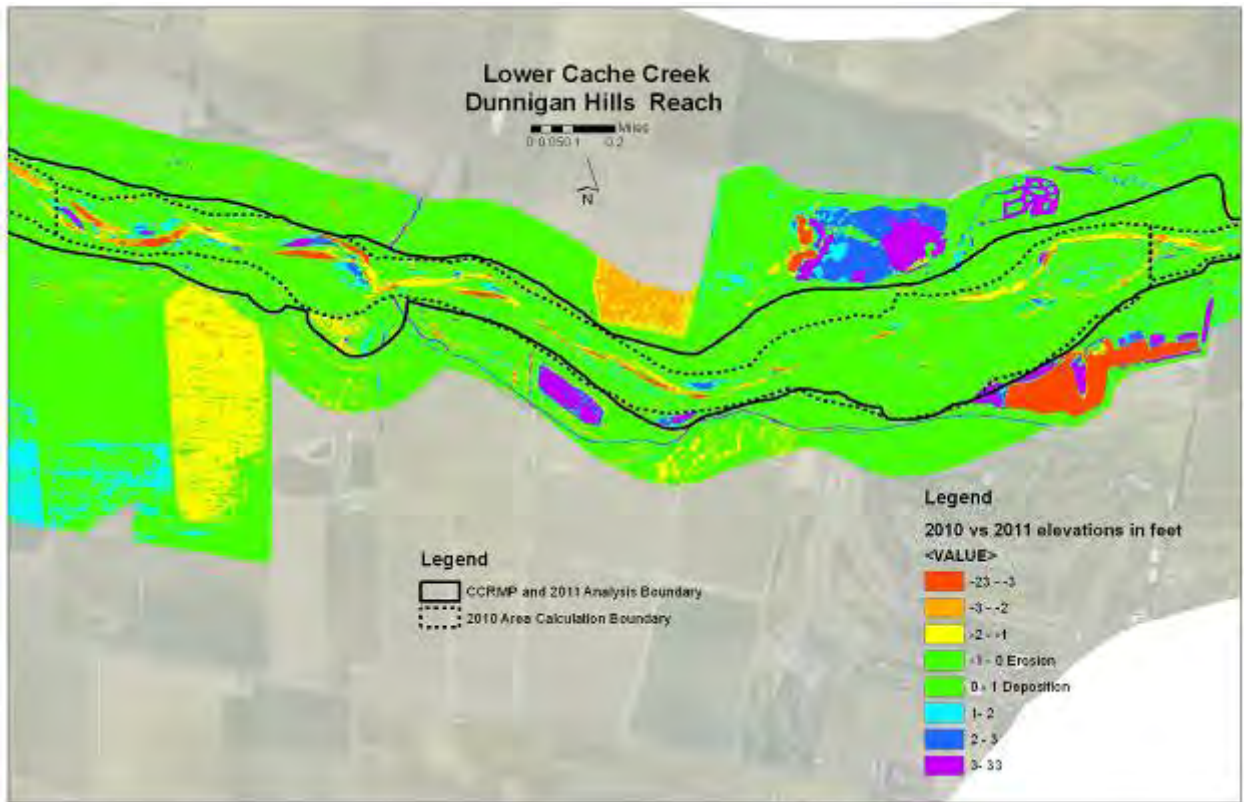
Figure 46 Dunnigan Hills RM 18.85 to 15.9 cut and fill

The cut and fill maps show the cut and fill patterns in the entire reach, where the 2010-2011 shows significantly more yellow and red in the channel, indicating that the elevation is less in 2011. The 2010-2011 cut/fill maps (Figure 46) show bank retreat immediately upstream from the Moore Siphon crossing near RM 18, which is discussed in detail below.

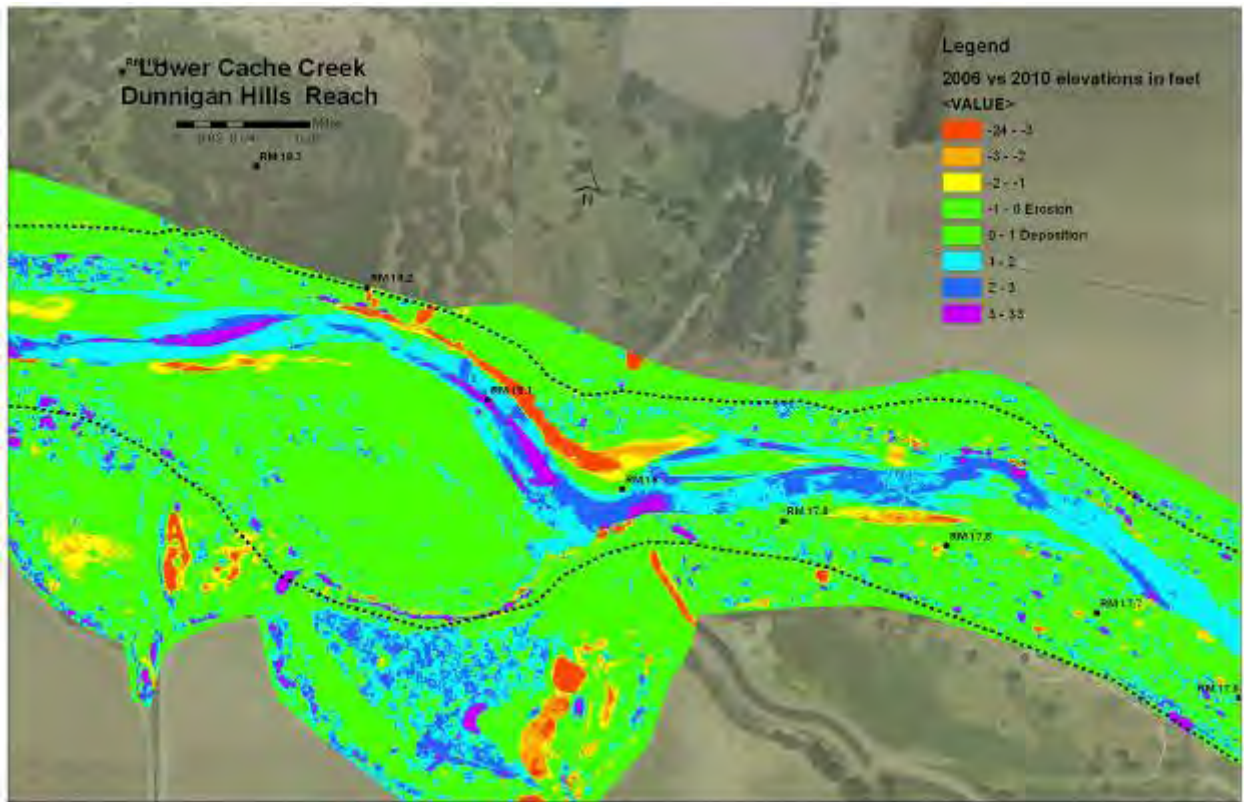
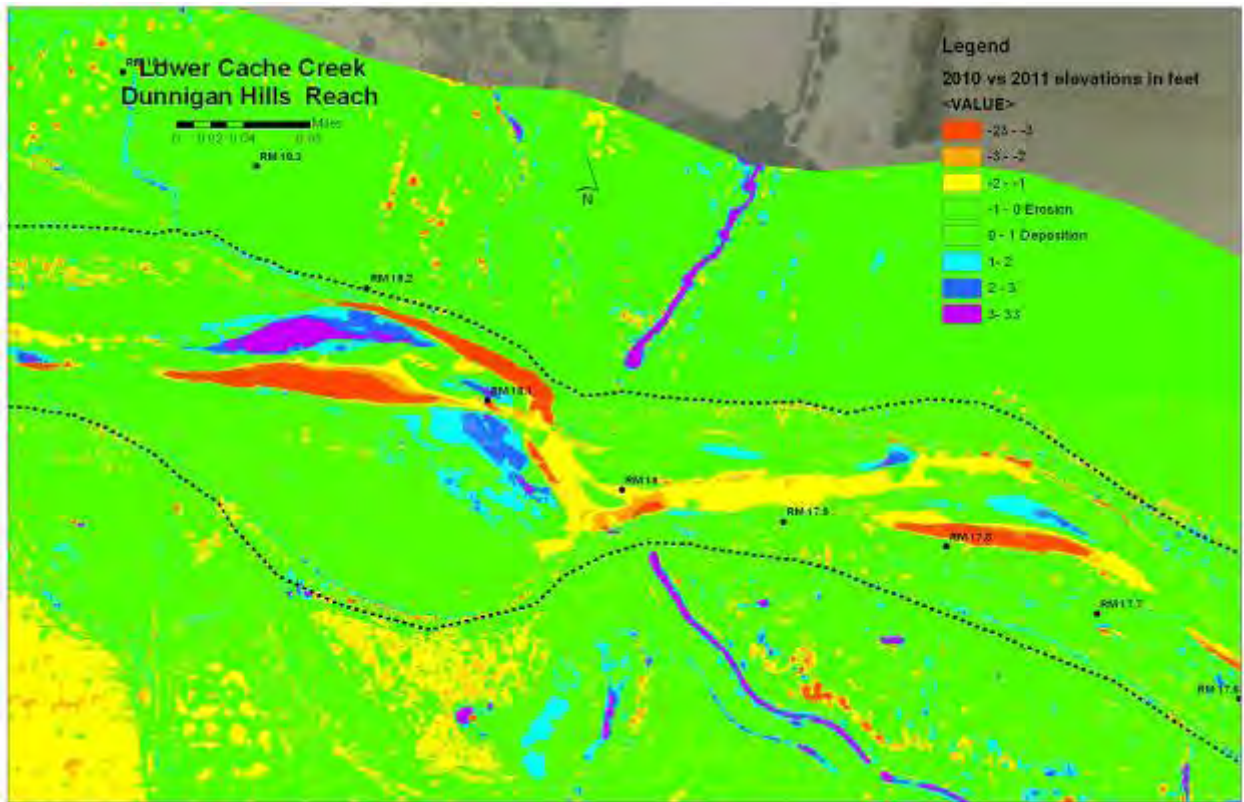
Figure 49 Moore's Siphon and upstream area – cut and fill maps

The land owner was concerned about the potential for further bank retreat of the channel on the north bank. A 10 to 12 feet tall vegetated bank forms a barrier on the north bank, separating the channel from a borrow pit that was originally dug as a passive restoration site (Figure 48) in 1986. As reported by a member of the aggregate industry, who was present at the time of the restoration, "It was just drug and scraped." This is an ideal example of passive restoration where cottonwoods have grown over the last 25 years. The passive restoration at this site is similar to the Hayes Bow-Tie site, immediately upstream of this site, which utilized a haul road. From the point of view of the structure of the creek and riparian ecosystem in the RM 18 to 18.5 location pictured above, the possibility of water inundating the area of passive restoration (due to bank retreat and the vegetated barrier at this point), would enhance the riparian vegetation and continue the pattern of passive restoration.

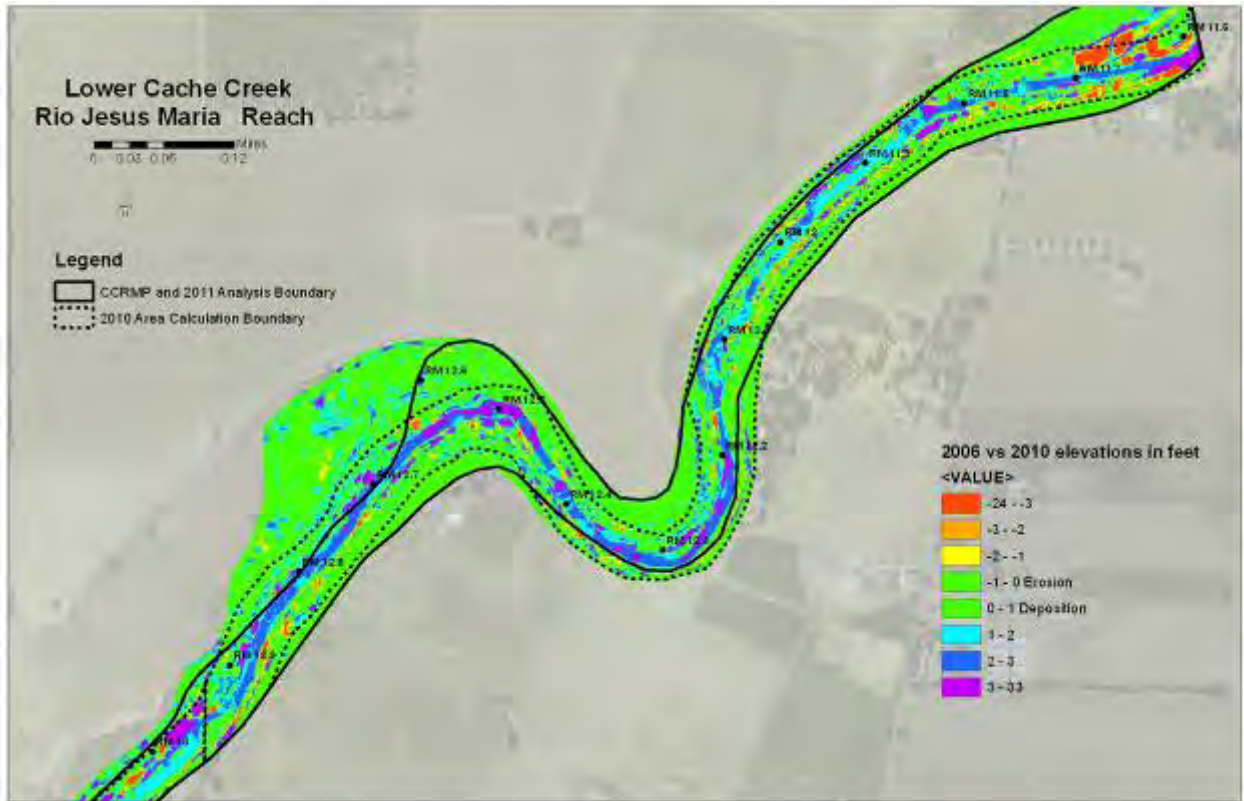
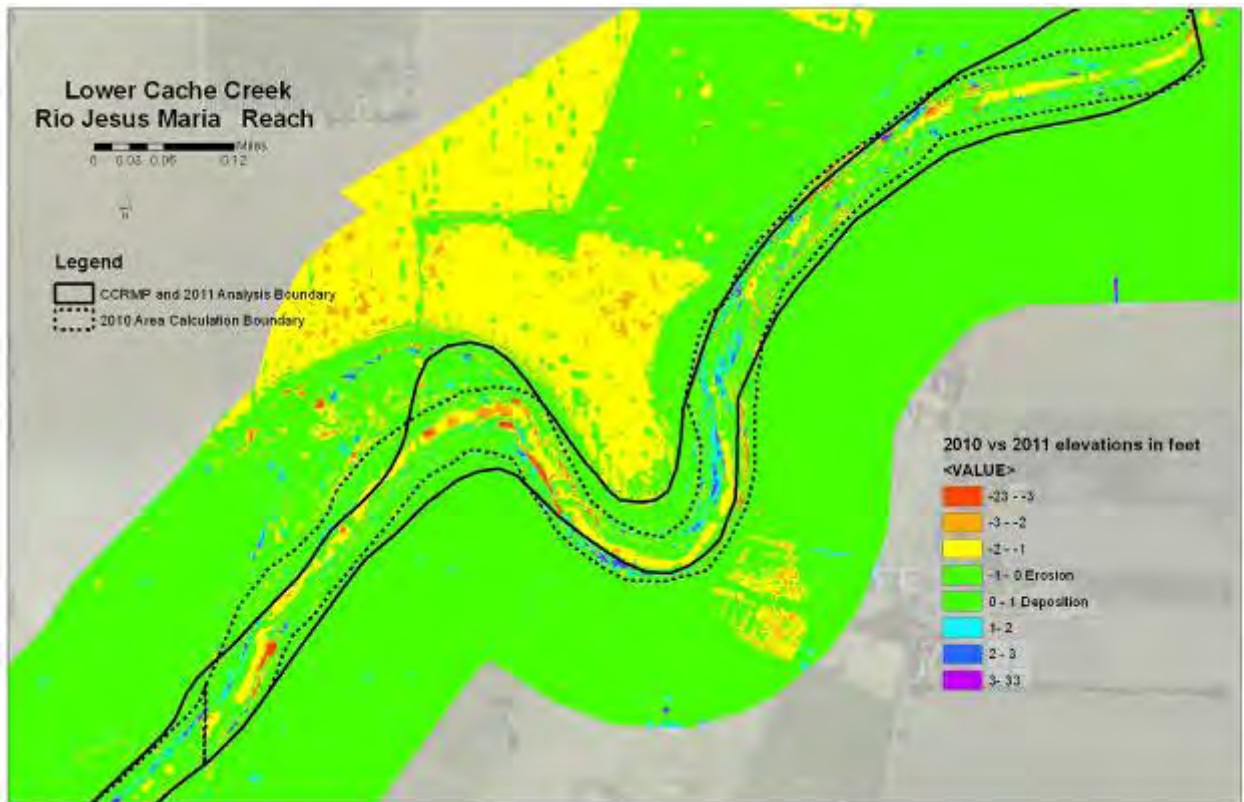
Figure 54 Rio Jesus Maria RM 12.6 to 11.7 cut and fill maps

The cut and fill patterns (Figure 54) show that the pattern is relatively uniform throughout this reach, which is not surprising for a confined, incised reach like this. The 2006-2010 data show a gain in volume and the 2010-2011 data show a decrease in volume.

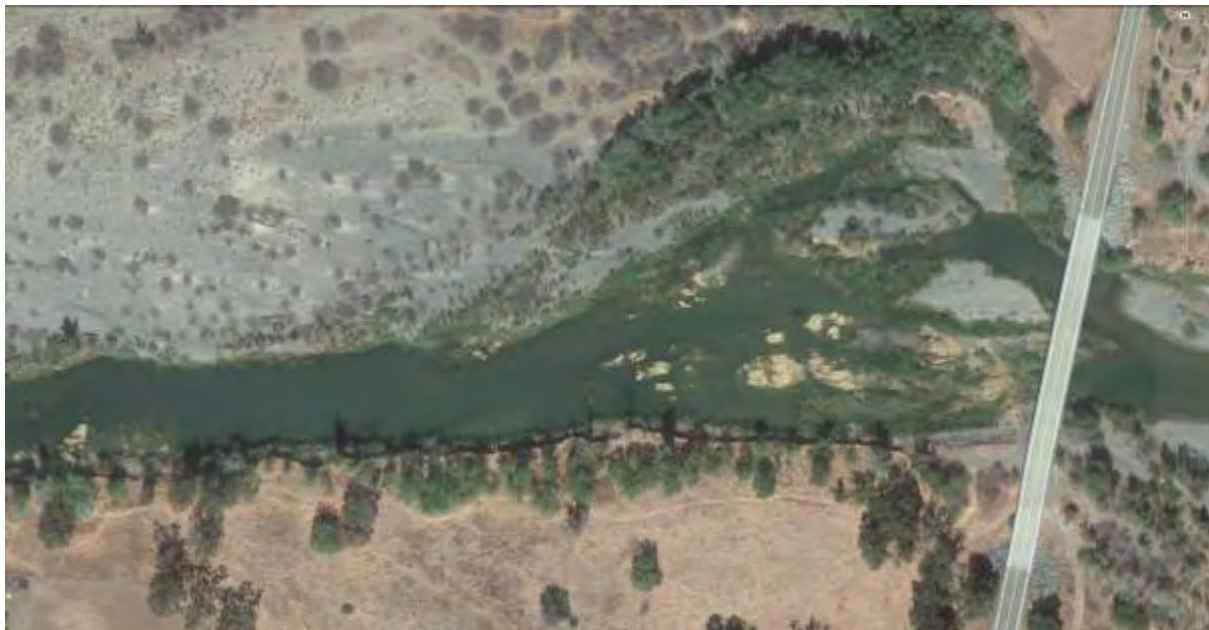
Figure 55 Capay Bridge (County Road 85) River Mile 26.35

The river width here is constricted by a factor of 0.5 as it flows under the current Capay Bridge, which was built in 1997. Heavy boulders have been imported to reinforce the outermost bridge abutments, with apparent success. The local land owners have expressed concern about erosion on the south bank upstream from the bridge, where there are steep banks with exposed soils. This concern was documented in detail above in this report.

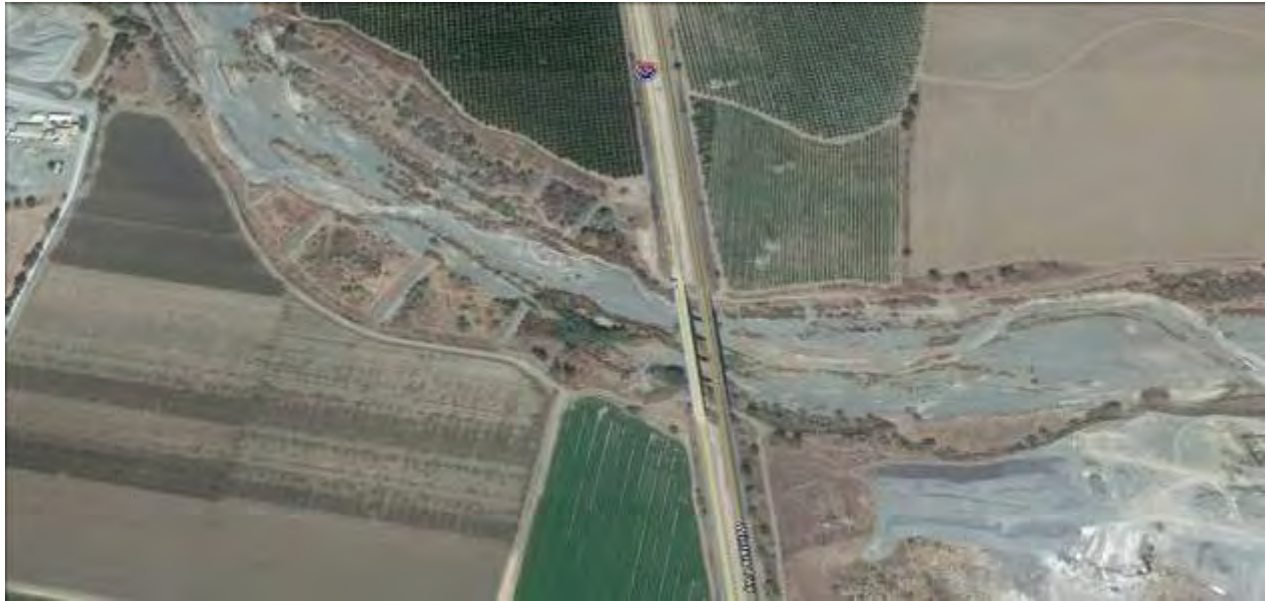
Figure 64 Interstate 505 Bridge (River Mile 21.0)

The channel is constricted by a factor of 0.5 to 0.7 times the normal width as it passes under the Highway I-505 Bridge. This bridge has an unusual longitudinal vane (pier) construction on the abutments that interferes with flow that is not perpendicular to the bridge. As a result, scour pools have formed around each abutment. Although the area appears to have scoured, it is not clear how much scour has occurred. The uncertainty emphasizes how important it is to have a history of pictures and bed profiles at a site; a practice which is a requirement of the program and has been resumed.

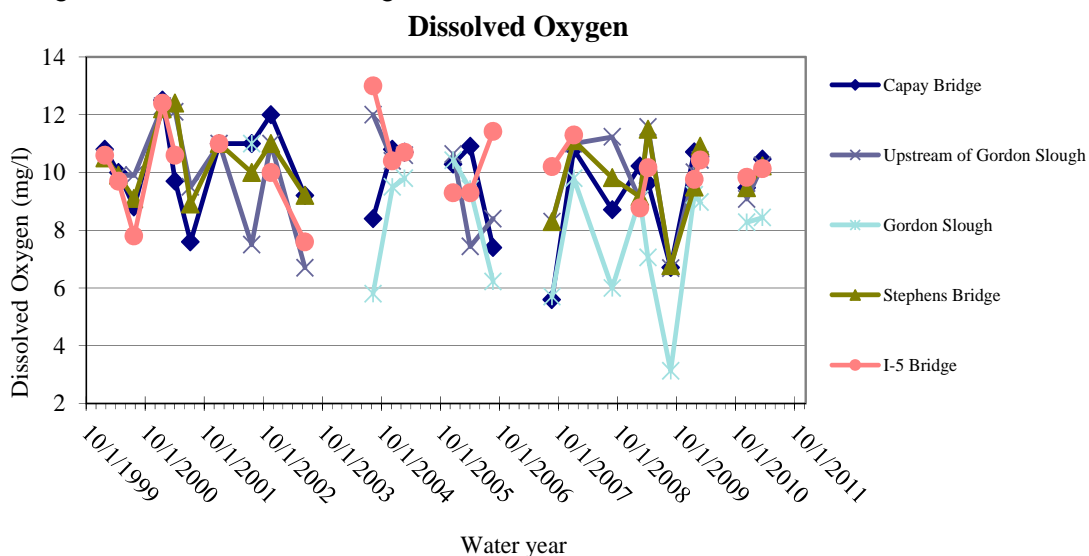
Gordon Slough has lower D.O. values, and this is consistent with the muddy, slower moving water that passes through the slough. Warm, slow-moving water maximizes the production of algae, and decomposition of the algae consumes oxygen. This becomes a concern because low oxygen conditions are also a factor in the production of methylmercury.

Figure 3.1.d: Dissolved oxygen levels at monitoring sites in the CCRMP area.

Dissolved Oxygen recommendation: Future analyses should assess oxygen levels as percent saturation. No action is recommended for the low dissolved oxygen values, except to continue monitoring work near Gordon Slough.
