# CACHE CREEK ANNUAL STATUS REPORT 2011

Cache Creek Technical Advisory Committee:

**February 28, 2012**

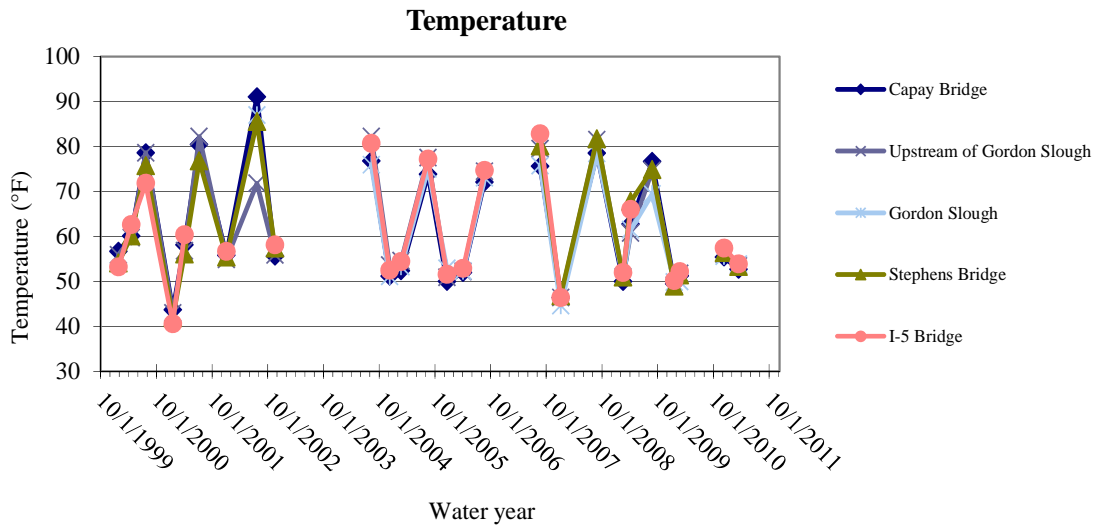
Surface water samples show seasonal temperature variations in Cache Creek (Figure 3.1.f). Summer water temperatures are usually above 70° F, and often above 80° F. All summer temperature samples exceed the Regional Water Quality Control Board (RWQCB) surface water objective of 68° F. Winter temperatures range from 40° to 50°, and are within the recommended range for resident native and anadromous fish. High summer temperatures on Cache Creek are related to low flow. Cache Creek becomes disconnected during the summer months. Flow is limited or absent in the upper 10 miles of the creek within the CCRMP study area, and water collects in shallow pools. This leads to high temperatures that promote bacteria and algal growth, and support the expansion of non-native fish populations.

Elevated summer water temperature is one of the largest water quality issues on Cache Creek, and is partially responsible for the limited aquatic diversity.

Figure 3.1.f: Temperature levels at monitoring sites in the CCRMP area.

Temperature recommendation: High summer water temperatures could be partly addressed by actively restoring native shrubs and trees on the banks for shade, and promoting the deposition of large woody debris in the channel. Large woody debris has several positive effects. Scour holes form near logs and root wads, and cooler groundwater may exchange with stream water in deep scour holes and pools. More riparian vegetation would lead to more dead logs in the channel. None of these steps will completely address the extreme temperature problem or lack of flow, but mature riparian vegetation and the resulting increase of in-stream woody debris would promote lower temperatures on Cache Creek. Cache Creek is a naturally ephemeral creek, which means that the creek goes dry in some reaches during the summer. The natural summer channel would have had a series of disconnected scour holes and pools for aquatic habitat, which could be mimicked on restoration projects. Water temperature control is an important part of channel restoration. Opportunities should be explored in areas that border the active channel to provide this type of dead woody material, and enhance the interaction between surface water and groundwater in the channel.

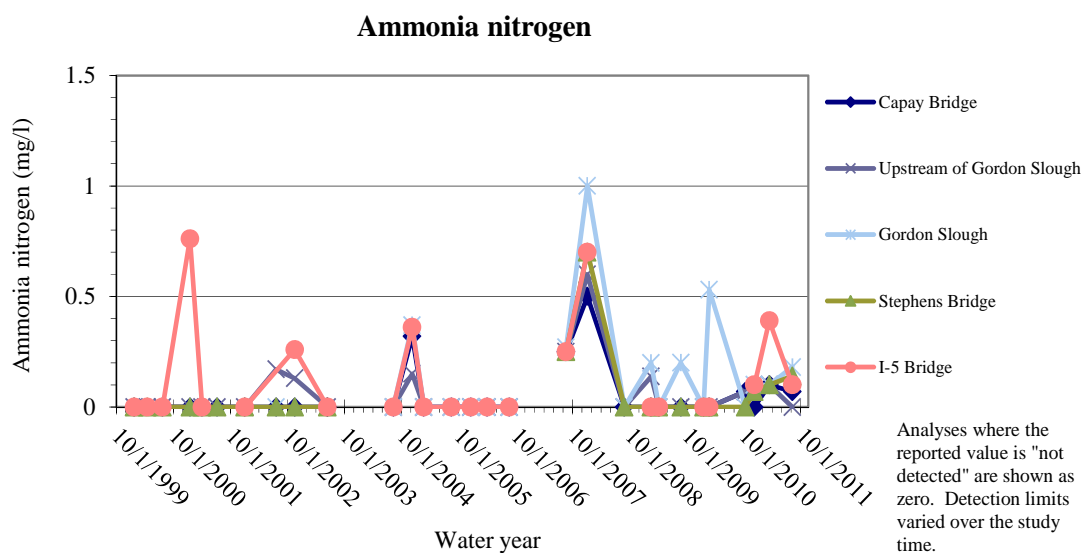
Ammonia is highly variable in the CCRMP area and many peaks in ammonia correlate with the first flush that occurs in winter (Figure 3.1.k). High levels of available nitrogen in the form of ammonia promote algal growth in Cache Creek during the hot summer months, so there are collateral effects to high ammonia concentrations in surface water. High surface water temperatures promote algal growth, and the ammonia provides necessary nutrients. Large mats of green algae are common in Cache Creek during the summer. Early ammonia measurements (1999 - 2004) often had maximum values at the downstream I-5 sample site. Based on detailed sampling that began at Gordon Slough in 2004, there was probably an ammonia source near or upstream from the Gordon Slough drainage. Ammonia is often related to agricultural sources, with ammonia applied to farm fields as a bioavailable source of nitrogen. Ammonia nitrogen is not regulated by the RWQCB, although the US EPA guidelines for aquatic life have a sliding scale for ammonia maxima that ranges from 0.3 - 0.5 mg/l. Ammonia levels discharged from Gordon Slough have at times exceeded this recommended maximum, although ammonia levels were generally low during the 2011 water year.

**Figure 3.1.k: Ammonia concentrations at monitoring sites in the CCRMP area.**

**Ammonia Nitrogen recommendation:** Continue to monitor ammonia levels, and if ammonia nitrogen levels increase again an appropriate course of action will be determined. This could include working with local partners to identify and reduce the source of ammonia.

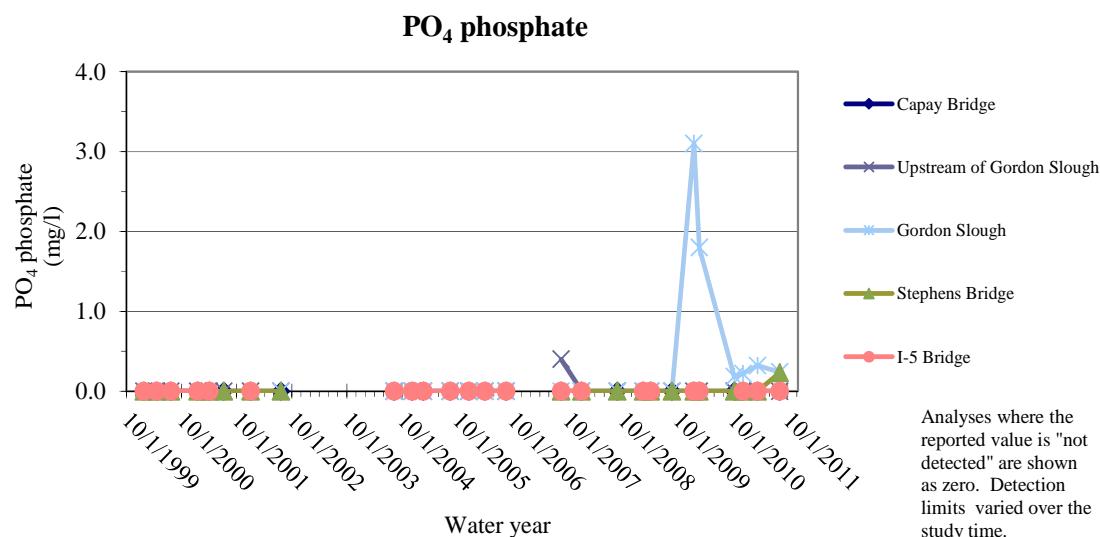
Orthophosphate phosphorus occurs naturally in streams, and is contributed by the underlying bedrock and recycled plant material. Orthophosphate is also a fertilizer, and excess orthophosphate in the CCRMP area is probably from agricultural sources. Orthophosphate may enhance algal blooms in streams, especially during the hot summer months. US EPA water quality standards for aquatic life have a maximum contaminant level of 0.1 mg/l for orthophosphate, although other regulatory agencies do not list this compound. This level was exceeded in the 2011 samples from Gordon Slough (Figure 3.1.q).

Figure 3.1.q: Orthophosphate (PO<sub>4</sub>) concentrations at monitoring sites in the CCRMP area.

Orthophosphate phosphorus recommendation: This is a new water quality problem, and levels of orthophosphate are high enough that orthophosphate should be monitored closely. If orthophosphate levels remain high, Yolo County should work with local partners to identify the source of orthophosphate and reduce the problem.

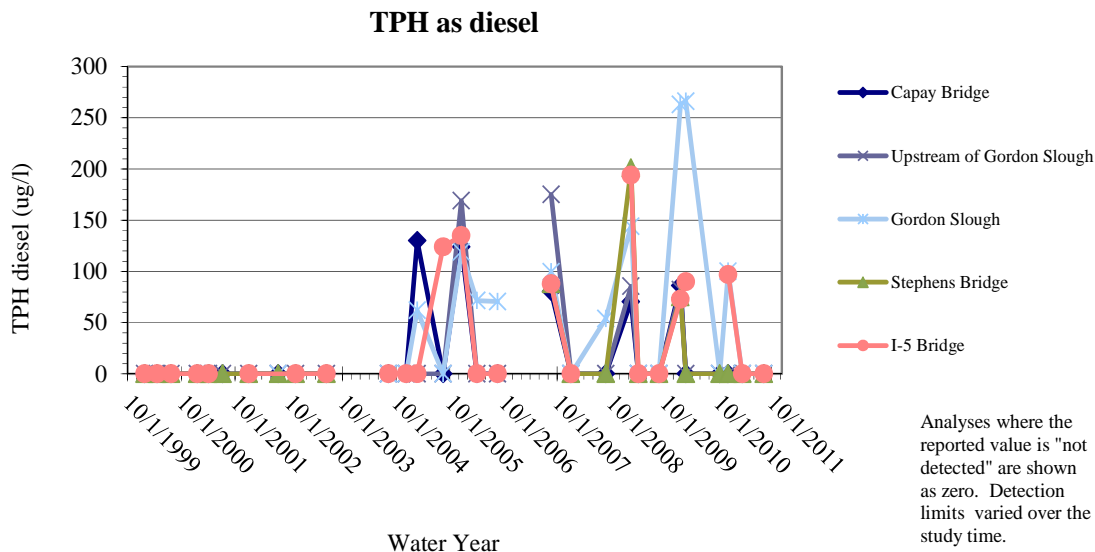
TPH (Total Petroleum Hydrocarbon) as diesel is not regulated by most agencies, although the RWQCB Basin Plan has a taste and odor threshold for diesel oil of 100 µg/l, with oil and grease not to affect "beneficial use". This 100 µg/l level was exceeded every winter from 2004 to 2010. There were seasonal variations, but in general there was concern that diesel fuel was leaking into the creek. Gordon Slough and downstream sites seemed especially affected by the problem. This all seems to have stopped for the 2011 water year. Gordon Slough and the I-5 bridge sites had elevated diesel levels on the Dec. 10 sampling event, but the two following samples have been below detection limits for diesel fuel. This could mean that the source has been stopped. It could also be a temporary low, so we will continue to monitor diesel fuel levels very closely.

Figure 3.1.r: Total petroleum hydrocarbon (TPH) concentrations as diesel, measured at monitoring sites in the CCRMP area.

TPH as diesel recommendation: Examine TPH as diesel levels after every sampling event, and work with local partners to identify the source if the problem returns.

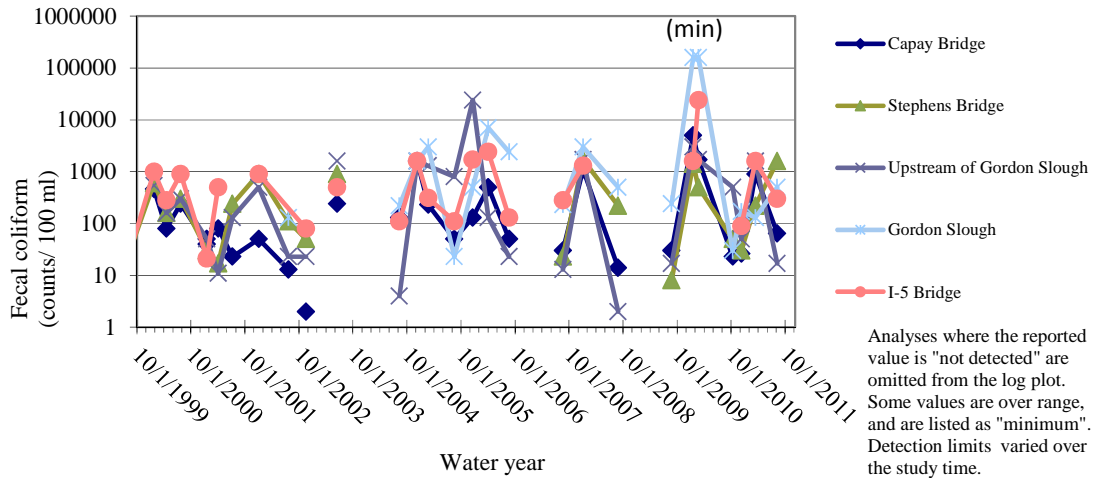
Results from several years of sampling in the CCRMP area show high variability, although fecal coliform bacteria are almost always present in very high levels (Figure 3.1.v). The lowest values are generally on the upstream end of the CCRMP area, and fecal coliform counts tend to increase downstream. Gordon Slough has had the highest bacteria counts in most recent sampling events, with a peak in February 2010 that exceeded 160,000 counts/100 ml. This is a high value for winter conditions, and suggests direct upstream input from a septic system, cattle yard, or similar source.

Figure 3.1.v: Fecal coliform bacteria counts at monitoring sites in the CCRMP area.

**Fecal coliform recommendation:** Seek to identify the source of the problem. Cache Creek will be significantly cleaner if the source of fecal coliform bacteria is identified and eliminated. Standing water allows the bacteria to breed, so one possible solution is to increase flow.

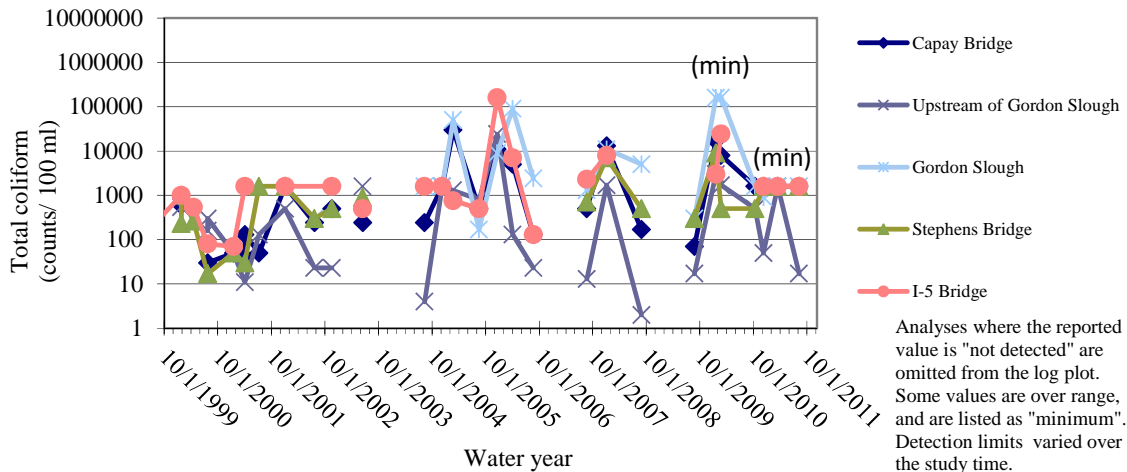
Total coliform bacteria are not regulated in natural waterways, but many of the health issues with fecal coliform are also present with total coliform bacteria. Total coliform counts include fecal coliform and other related bacteria, and have a variety of sources. They can cause infections in swimmers and recreational water users, and gastrointestinal problems when present in drinking water. Total coliform bacteria tend to increase during the warm summer months and in low flow areas. Total coliform bacteria are abundant in Cache Creek water samples (Figure 3.1.w), and closely follow trends observed in fecal coliform bacteria.

Figure 3.1.w: Total coliform bacteria counts at monitoring sites in the CCRMP area.

Total coliform bacteria recommendations: Reduce bacteria counts by increasing flow where possible. Consider other actions as appropriate to minimize human contact with bacteria, which tends to occur in the hot summer months.

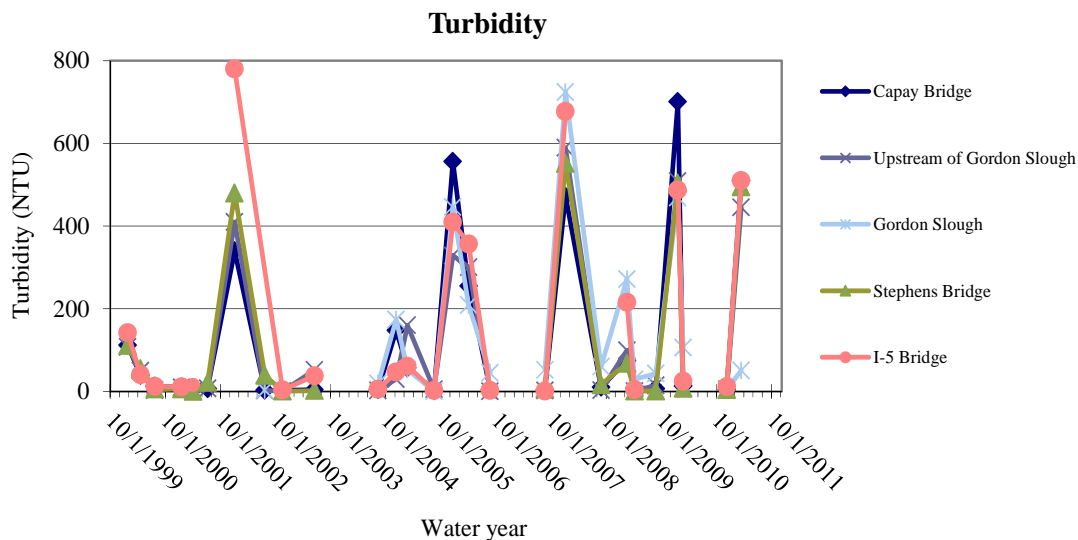
Turbidity is also monitored on construction projects to make sure that the project doesn't release a plume of muddy water into the creek. This site-specific turbidity monitoring may be mandated by the RWQCB as part of the permitting requirements for an in-stream project. The goal is to protect water quality, because high turbidity is harmful to aquatic life. Turbidity maxima are based on a sliding scale, with a baseline of 5 NTU (Nephelometric Turbidity Units) for drinking water. Site-specific goals are set for construction projects, and the turbidity is allowed to increase 10- 20% above background levels during construction. Turbidity levels on Cache Creek often exceed 5 NTU, especially during winter storms events (Figure 3.1.j). Turbidity maxima are two orders of magnitude higher than recommended levels during larger storm events.

Figure 3.1.j: Turbidity measurements at monitoring sites in the CCRMP area.

Turbidity monitoring recommendation: Turbidity monitoring methods should be upgraded to include continuous turbidity monitoring. This newer technology will allow better tracking of sediment and contaminant loads. Yolo County should continue to work with partners to obtain a continuous turbidity record at the upstream and downstream ends of the CCRMP area. This will provide a baseline for future regulatory actions. This is part of the changing regulatory world, and wasn't envisioned in the original CCRMP or CCIP documents. Turbidity monitoring is more important now than it was in 1996 because of the link between mercury transport and sediment transport.

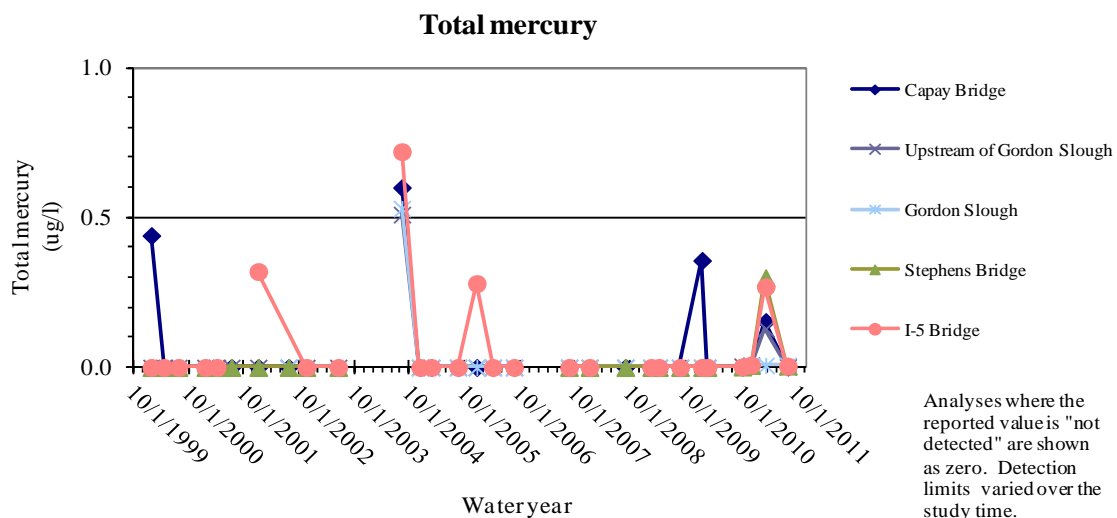
Total mercury is similar to dissolved mercury, but samples are not filtered before they are analyzed. This leaves clay particles and organic matter in suspension and mercury can bind to these compounds. Total mercury values are usually higher than dissolved mercury values. Total mercury tends to increase during high flow events that mobilize fine sediment and organic matter. A total mercury spike in 2011 is related to a high winter flow.

Figure 3.1.u: Total mercury concentrations at monitoring sites in the CCRMP area.

Total Mercury recommendation: Continue to monitor total mercury. At the present time regulatory agencies do not have a total mercury standard. There was a slight increase in total mercury levels from Cache Creek in 2011 (Figure 3.1.u), but no additional action is recommended.
