2013 CACHE CREEK ANNUAL STATUS REPORT

For the period of
October 1, 2012 to September 30, 2013

CACHE CREEK TECHNICAL ADVISORY COMMITTEE:

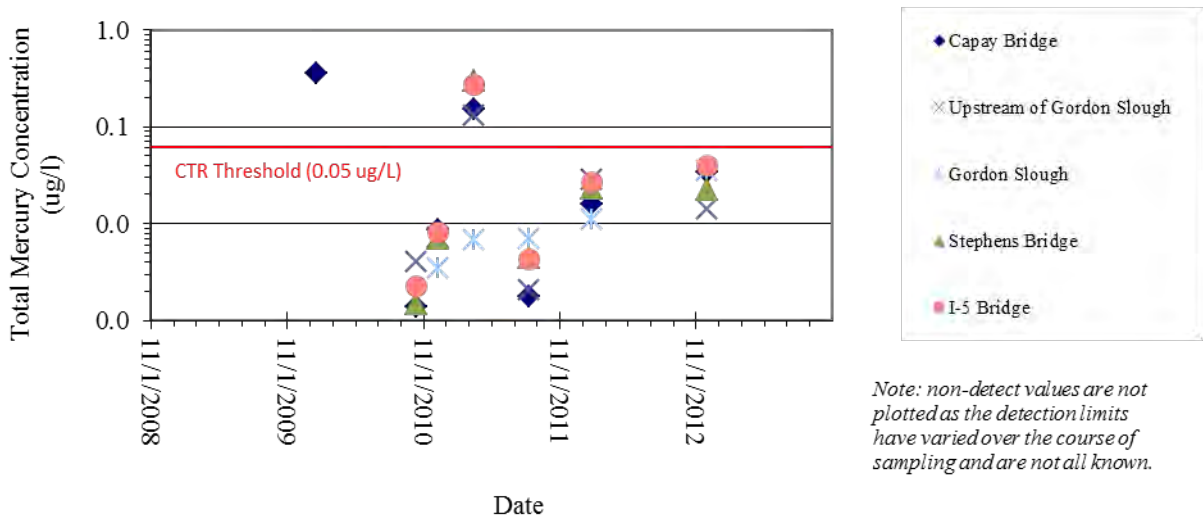
Figure 3: Total mercury concentrations in the CCIP area from water year 2008 through water year 2013.

Of note in 2013 were total and dissolved mercury concentrations that approximately doubled from 2012 concentrations at the Capay Bridge, Gordon Slough, and I-5 Bridge sites (Figure 2 and Figure 3). It is important to note that there are no threshold criteria for dissolved mercury and therefore this summary of results focuses on total mercury. In addition, mercury transport is strongly linked to sediment transport. Total mercury concentrations are still below the CTR threshold of 0.05 micrograms per liter.

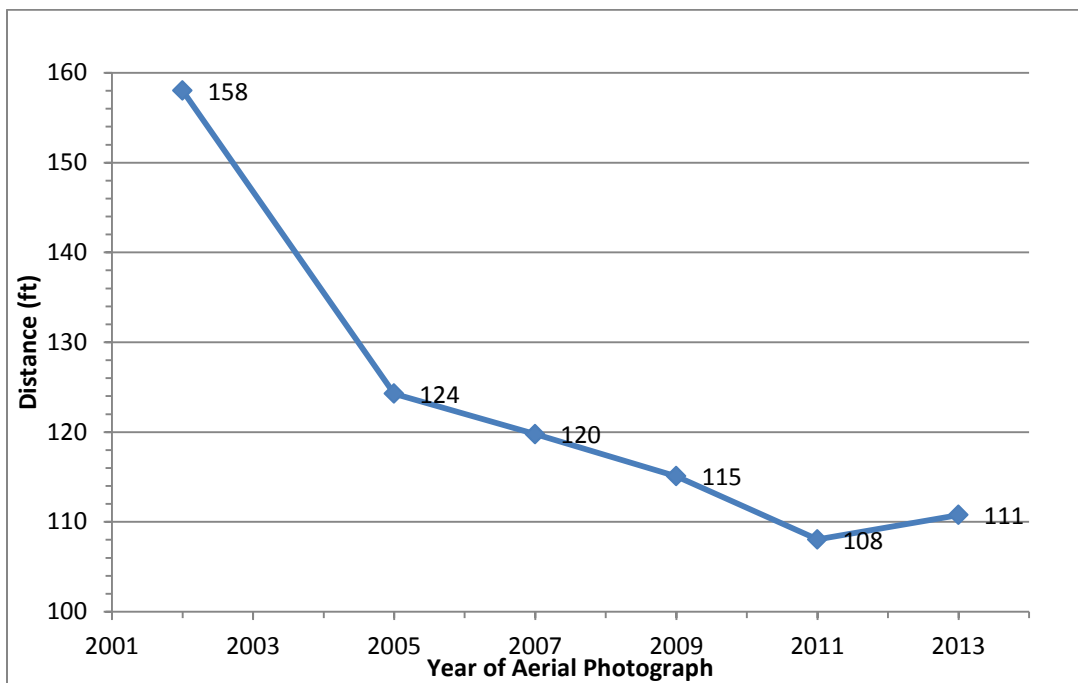
Figure 4: Distance between the edge of the vehicle boneyard and the right bank of Cache Creek from 2002 through 2013.

In 2013 the TAC quantified Cache Creek channel bank migration at the vehicle boneyard site by digitizing the edge of the vehicle boneyard closest to Cache Creek and the edge of the bank of Cache Creek and the distance between them using a series of historical aerial photographs from 2002 to 2013. The channel bank has migrated towards the vehicle boneyard approximately 50 feet from the 2002 to 2013 at this location (Figure 4 and Figure 5), with nearly all of the migration occurring between 2002 and 2005. The 2013 measurement of 111 feet provides a baseline for future monitoring of potential water quality degradation associated with the vehicle boneyard, and action should be taken to prevent water quality degradation if the distance between the vehicle boneyard and the creek decreases to below fifty (50) feet. At this distance, it is possible that contaminants from the abandoned vehicles (e.g. gasoline, oil, etc.) could be carried by surface runoff into Cache Creek and contaminate downstream reaches.

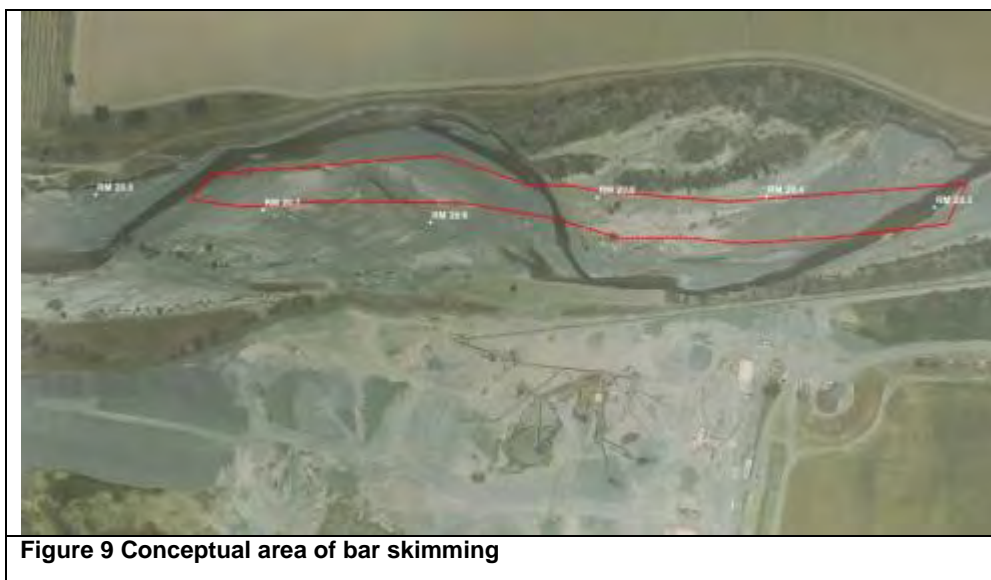
Bar skimming is recommended at the CEMEX site located between roughly RM 20.8 and RM 20.3 (Figure 9) on Cache Creek. The work would provide multiple benefits, but is not urgent for the safety of the CEMEX plant or the integrity of the banks at this location. The recommended bar-skimming would provide the benefit of reduced pressure on the south bank which has experienced severe erosion in the past and required corrective work by CEMEX to protect the conveyor system located near the top of the bank. Reducing pressure on the south bank could help to avoid further bank instability and severe erosion on the south bank in the future.

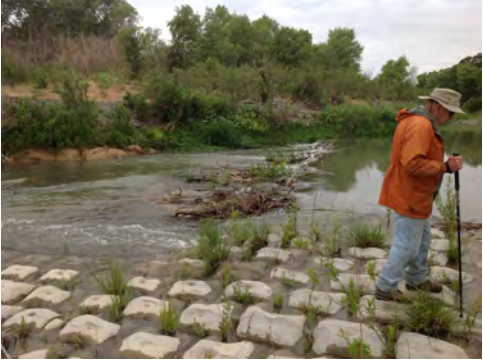
Observer	Comments	Verbose Comments	River Reach	River Miles	Image
Larsen	Bank erosion from flow diversion of PGE crossing.	AUDIO notes included here discussing methods that PGE proposes.	Capay Reach	RM 26.9

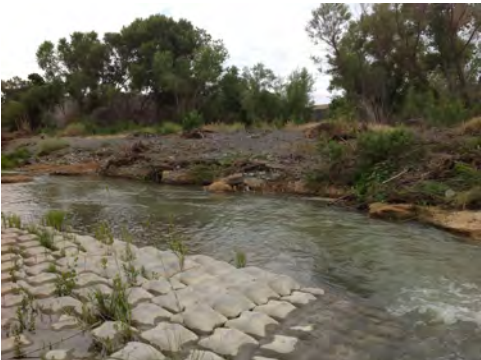
Larsen	Bank erosion from flow diversion of PGE crossing.	AUDIO notes included here discussing methods that PGE proposes.	Capay Reach	RM 26.9	
Martin	Platings at north bank near PGE pallisades in generally good condition. Scattered arundo clumps observed along treated stands on north bank.		Capay Reach	RM 26.9

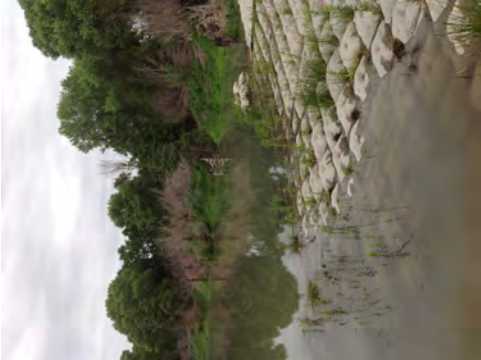
Martin	Bank erosion from flow diversion of PGE crossing with channel migrating to the south.		Capay Reach	RM 26.9

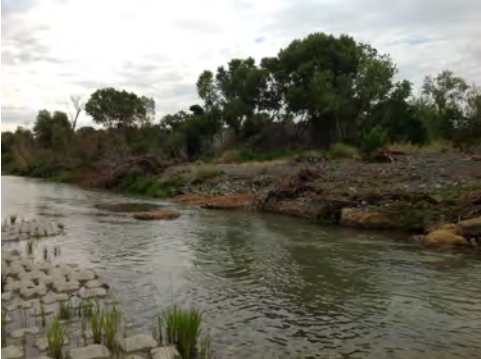
Tompkins	Possible fill on RB but no significant new erosion.	Looking at the right bank from the concrete sack revetment at the Palisades. Right bank vegetation has been removed since 2012 and fill material has been placed on the bank or deposited by a high flow. Conditions in 2013 appear mostly stable, but if the new bare sediment does not revegetate before the next high flows this area could be susceptible to bank erosion and migration.	Capay Reach	RM 26.9

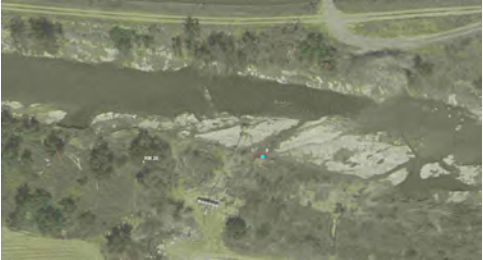
Observer	Comments	Verbose Comments	River Reach	River Miles	Image
Larsen	South bank runoff	There appears to be runoff from the south bank that appears to have cut into the bedrock of the channel.	Capay Reach	RM 28

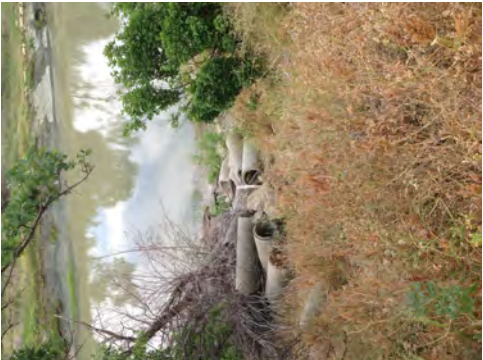
Martin	Concrete rubble in creek channel. Possible future removal project as part of CCRMP.		Capay Reach	RM 28.3

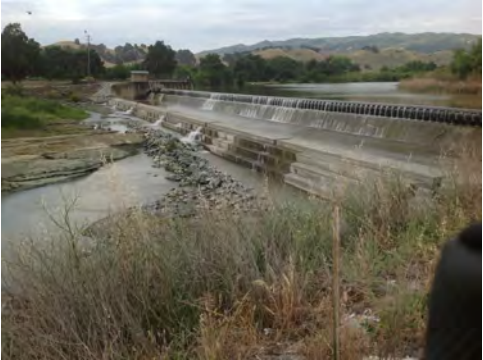
Larsen	Capay Dam	Note that the rock has moved downstream from the apron.	Capay Reach	RM 28.4

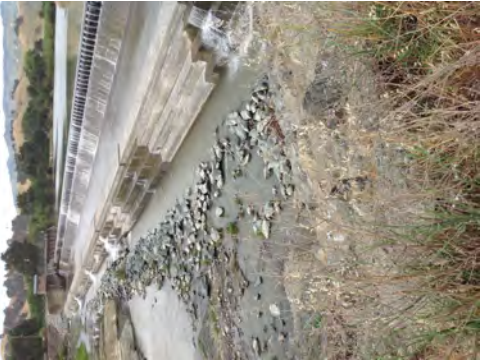
Observer	Comments	Verbose Comments	River Reach	River Miles	Image
Tompkins	Riprap migrating downstream of dam.	We observed riprap that had migrated a short distance downstream of dam face where it was originally placed. The riprap does not appear to have moved significantly since the 2012 Creek Walk.	Capay Reach	RM 28.4

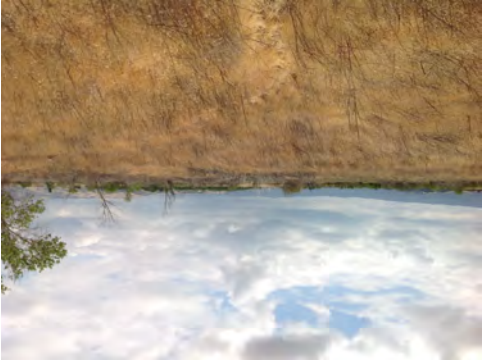
Observer	Comments	Verbose Comments	River Reach	River Miles	Image
Tompkins	View up and downstream of treated tamarisk stand with natural regeneration.	Looking upstream and downstream at a treated tamarisk stand where natural regeneration appears to be occurring and may require additional eradication treatment.	Hungry Hollow Reach	RM 23.6

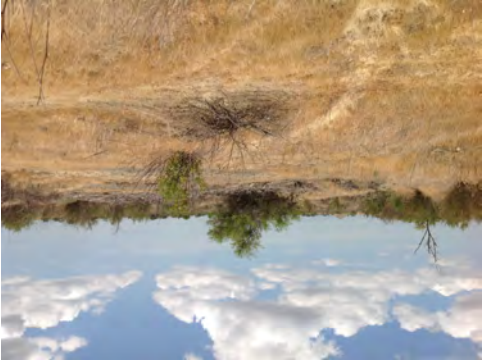
Tompkins	View up and downstream of treated tamarisk stand with natural regeneration.	Looking upstream and downstream at a treated tamarisk stand where natural regeneration appears to be occurring and may require additional eradication treatment.	Hungry Hollow Reach	RM 23.6

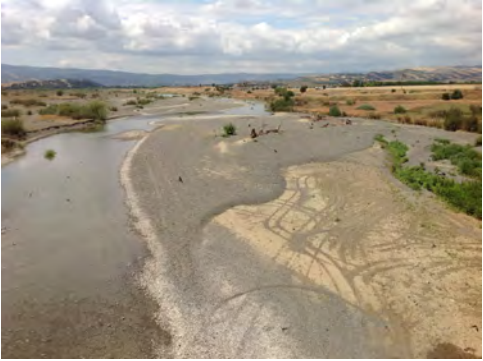
Observer	Comments	Verbose Comments	River Reach	River Miles	Image
Larsen	View from bridge	On bridge looking US	Hungry Hollow Reach Hungry Hollow Reach	RM 24.3

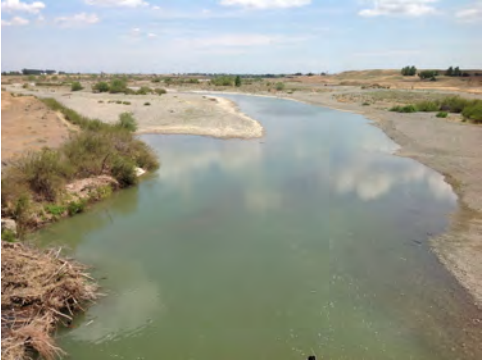
Larsen	View from bridge	On bridge looking DS	Hungry Hollow Reach	RM 24.3

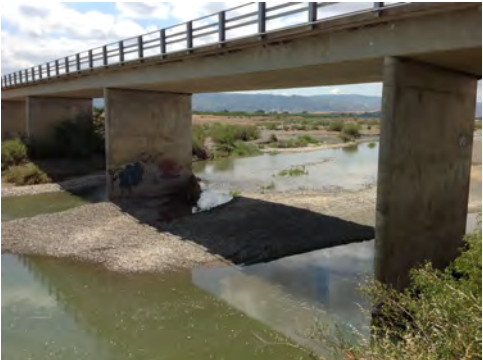
Larsen	Bridge piers	Bridge piers with possible aggradation.	Hungry Hollow Reach	RM 24.3

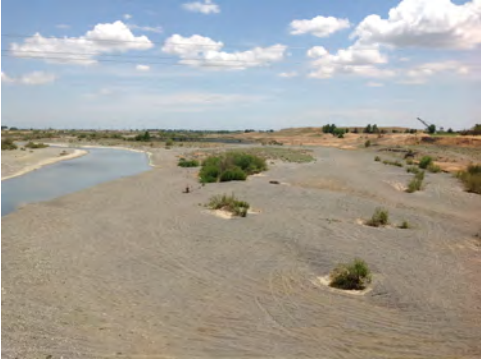
Observer	Comments	Verbose Comments	River Reach	River Miles	Image
Martin	View upstream and downstream of bridge. No major changes in vegetation establishment discernable. Major swallow colony under bridge primarily over water.		Hungry Hollow Reach Hungry Hollow Reach	RM 24.3

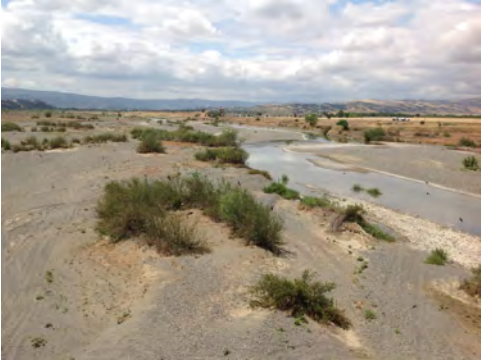
Martin	View upstream and downstream of bridge. No major changes in vegetation establishment discernable. Major swallow colony under bridge primarily over water.		Hungry Hollow Reach	RM 24.3

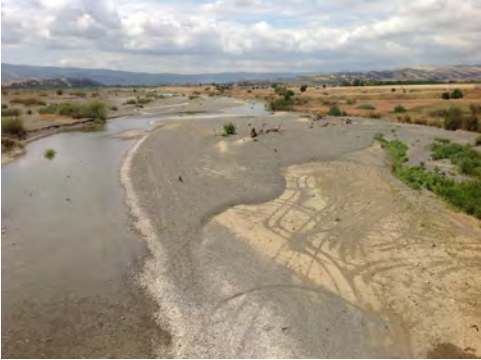
Tompkins	On bridge looking US	Looking upstream from County Road 87 bridge. No major channel change since 2012. However, definite gravel (estimate 45-64mm median diameter) that was mobilized during the high flows of winter 2012/2013 and forms a lobe prograding downstream towards the bridge. Also slightly more riparian vegetation in 2013.	Hungry Hollow Reach	RM 24.3

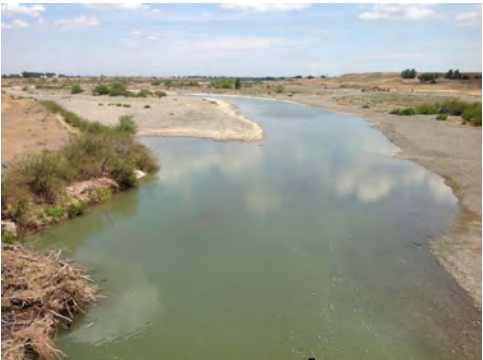
Observer	Comments	Verbose Comments	River Reach	River Miles	Image
Tompkins	On bridge looking DS	Looking downstream from County Road 87 bridge. No major channel change since 2012. Slightly more riparian vegetation in 2013.	Hungry Hollow Reach	RM 24.3

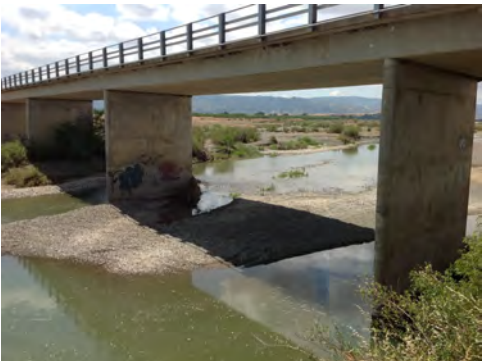
Tompkins	Bridge piers with possible aggradation.	Looking upstream and across to right bank at highway 87 bridge. Possible gravel aggradation at the bridge. Does not appear to be significant scour at bridge piers since 2012.	Hungry Hollow Reach	RM 24.3

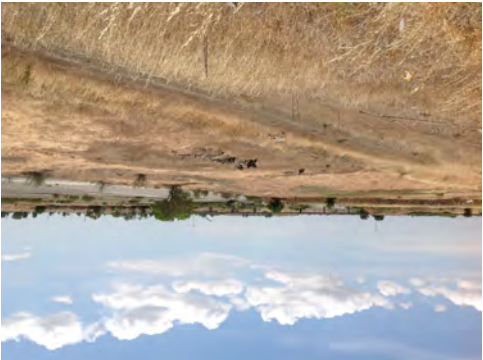
Martin	Spur dike with some early successional shrubs.		Hungry Hollow Reach	RM 24.6

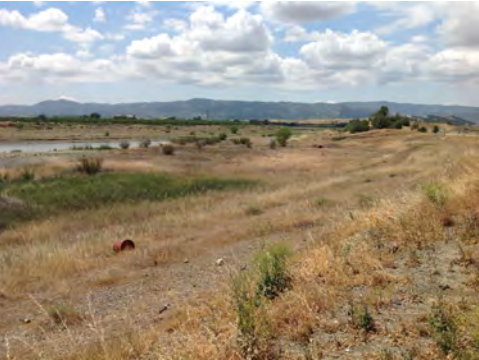
Observer	Comments	Verbose Comments	River Reach	River Miles	Image
Tompkins	US	Looking upstream showing no significant channel changes since 2012. Minor riparian vegetation increase since 2012.	Hungry Hollow Reach	RM 24.6

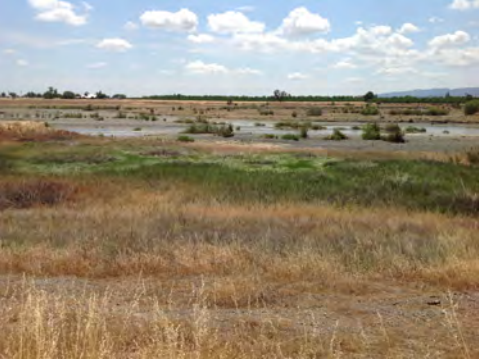
Tompkins	Across	Looking across showing no significant channel changes since 2012. Minor riparian vegetation increase since 2012.	Hungry Hollow Reach	RM 24.6

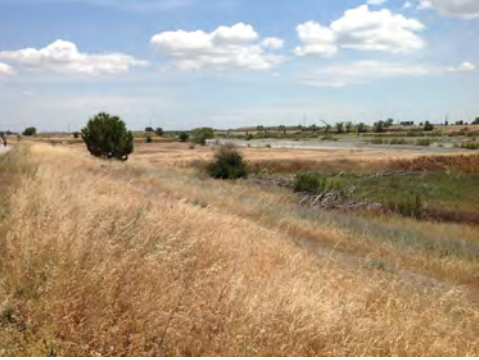
Tompkins	DS - LB training berms	Looking downstream showing no significant channel changes since 2012. Minor riparian vegetation increase since 2012. This photo also shows the training berms that do not appear to have changed significantly since 2012.	Hungry Hollow Reach	RM 24.6

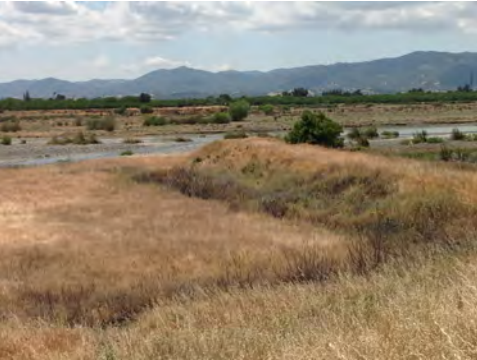
Observer	Comments	Verbose Comments	River Reach	River Miles	Image
Tompkins	US LB training berm.	Looking across at left bank training berm showing no significant channel changes since 2012. Minor riparian vegetation increase since 2012.	Hungry Hollow Reach Hungry Hollow Reach	RM 24.6

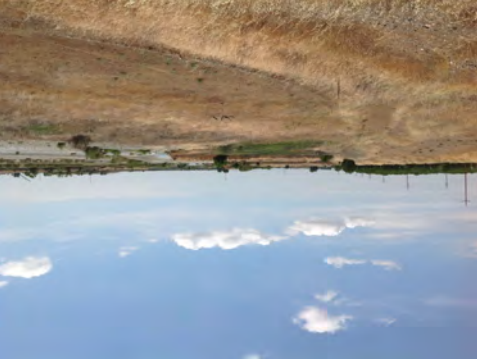
Martin	View of spur dikes at Granite Esparto site.		Hungry Hollow Reach	RM 24.7

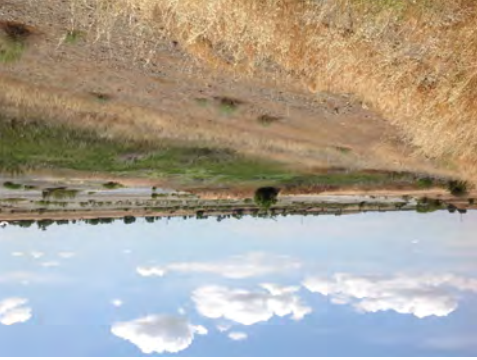
Martin	View of spur file on north bank witherrennoal pepper weed.		Hungry Hollow Reach	RM 24.7

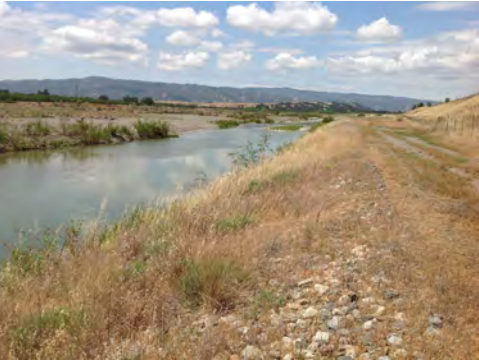
Observer	Comments	Verbose Comments	River Reach	River Miles	Image
Tompkins	US	Looking upstream showing no significant channel changes since 2012. Minor riparian vegetation increase since 2012.	Hungry Hollow Reach	RM 24.8

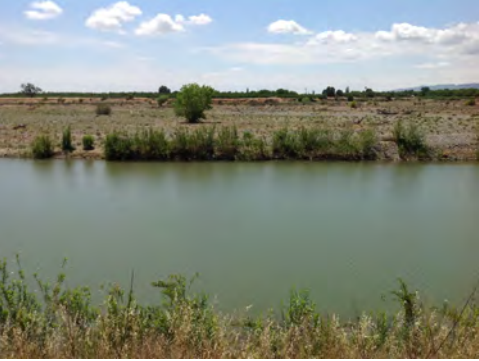
Tompkins	Across	Looking across showing no significant channel changes since 2012. Minor riparian vegetation increase since 2012.	Hungry Hollow Reach	RM 24.8

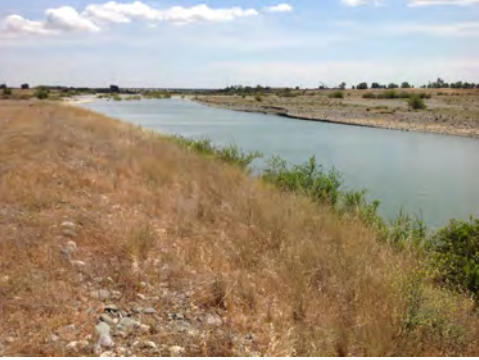
Tompkins	DS	Looking downstream showing no significant channel changes since 2012. Minor riparian vegetation increase since 2012.	Hungry Hollow Reach	RM 24.8

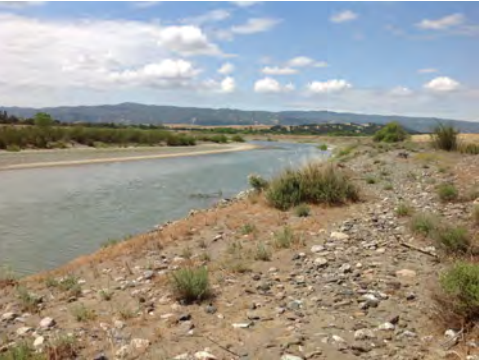
Observer	Comments	Verbose Comments	River Reach	River Miles	Image
Tompkins	US	Looking upstream from just south of the Teichert plant. No significant channel changes since 2012. Minor riparian vegetation increase since 2012.	Hungry Hollow Reach	RM 25.1

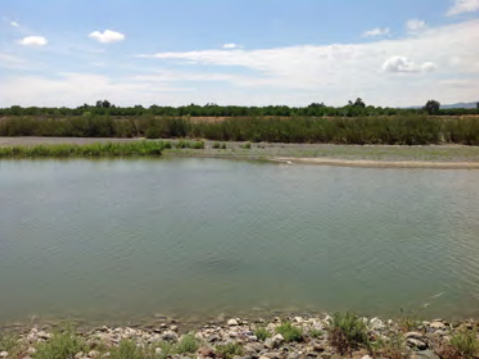
Tompkins	Across	Looking across the channel from just south of the Teichert plant. No significant channel changes since 2012. Minor riparian vegetation increase since 2012.	Hungry Hollow Reach	RM 25.1

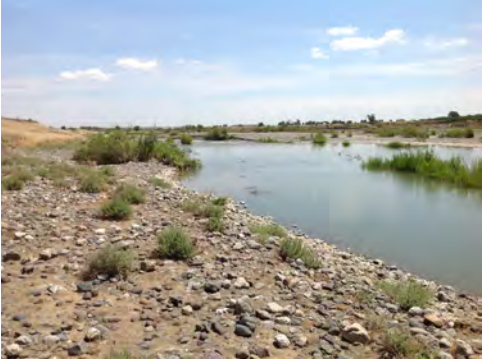
Observer	Comments	Verbose Comments	River Reach	River Miles	Image
Tompkins	DS - Ben noticed possible RB channel and vegetation change and we confirmed with photos from last year	Looking downstream from just south of the Teichert plant. No significant channel changes since 2012. Minor riparian vegetation increase since 2012. Ben Adamo identified right bank channel and vegetation change between 2012 and 2013 that were confirmed by the Creek Walk photo database. No major channel or vegetation changes.	Hungry Hollow Reach	RM 25.1

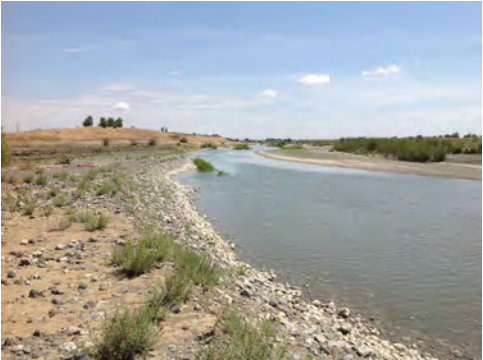
Larsen	Bank stabilizatoin LB	View downstream of channel at north bank which has been stabilized in the past.	Hungry Hollow Reach	RM 25.2

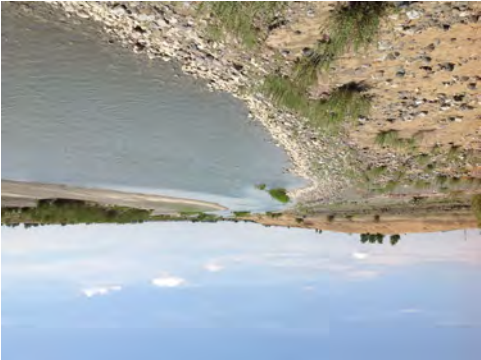
Observer	Comments	Verbose Comments	River Reach	River Miles	Image
Martin	View downstream of channel at eroded north bank at Granite Esparto site which has been stabilized in the past.		Hungry Hollow Reach Hungry Hollow Reach	RM 25.2

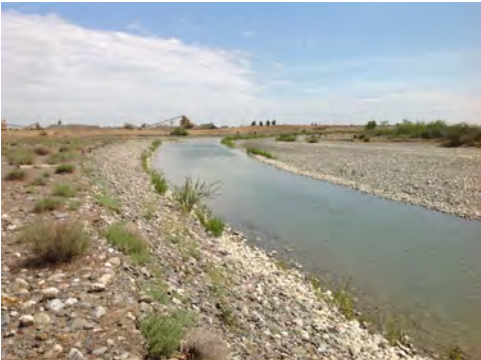
Larsen	Looking DS at Granite plant. Potential selective bar skimming on RB.	AUDIO - Ben Adamo is involved with a long discussion of the practical aspects related to bar skimming policy. There is also discussion of the Granite construction bank protection area, and the large spur dike on the right bank. Also includes a discussion of major bar-skimming locations and approach.	Hungry Hollow Reach	RM 25.3

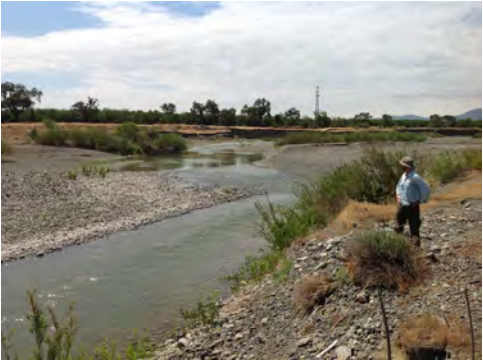
Observer	Comments	Verbose Comments	River Reach	River Miles	Image
Tompkins	Looking US. Eroding RB. US end of long straight reach pointed at Granite. Land ownership issues for skimming.	Looking upstream at eroding right bank. This bank was already eroding in 2012. The eroding right bank is at the upstream end of the long, straight reach of the main channel that flows directly at the Granite plant. The TAC discussed bar skimming in this location and land ownership issues that would complicate bar skimming were raised.	Hungry Hollow Reach Hungry Hollow Reach	RM 25.3

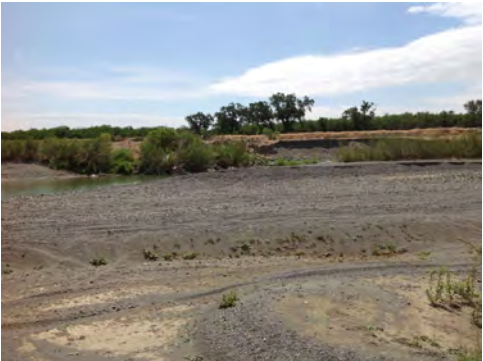
Larsen	Exposed concrete rubble from dike on south bank.	AUDIO - there is a long discussion with Ben and Cindy about the CCIP regulations and policies on bar skimming	Hungry Hollow Reach	RM 25.4

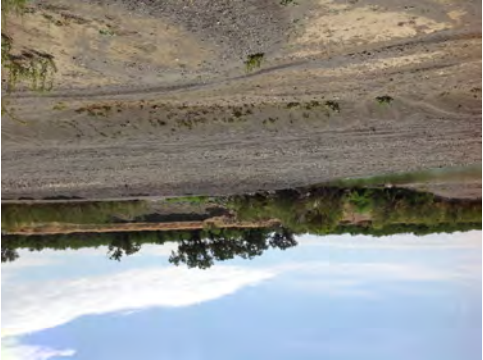
Martin	Exposed concrete rubble from spur dike on south bank.		Hungry Hollow Reach	RM 25.4

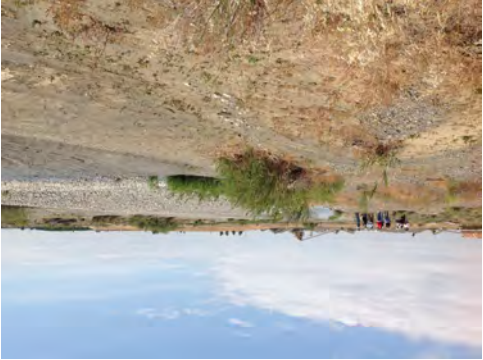
Martin	View downstream showing sparse vegetation cover.		Hungry Hollow Reach	RM 25.4

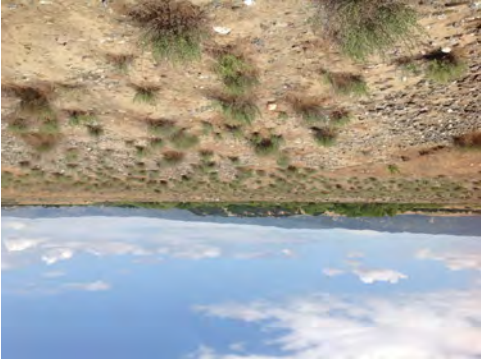
Observer	Comments	Verbose Comments	River Reach	River Miles	Image
Martin	Possible gravel skimming alignment to relieve flood pressure on south bank and downstream pressure on north bank.		Hungry Hollow Reach Hungry Hollow Reach	RM 25.4

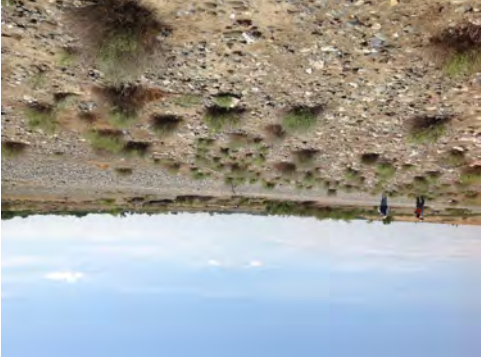
Martin	Possible gravel skimming alignment to relieve flood pressure on south bank and downstream pressure on north bank.		Hungry Hollow Reach	RM 25.4

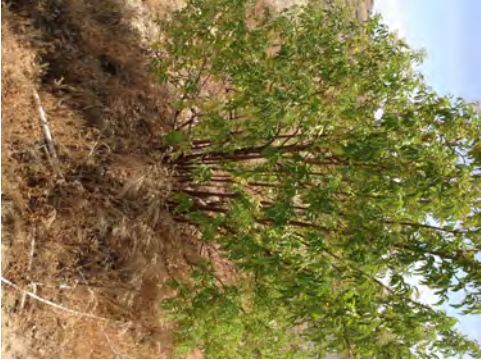
Martin	Elderberry location near alignment of possible gravel skimming location. Total of 14 stems over 1 inch.		Hungry Hollow Reach	RM 25.4

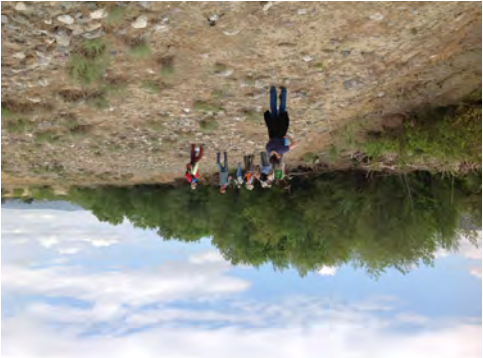
Observer	Comments	Verbose Comments	River Reach	River Miles	Image
Martin	Vigorous growth of willow scrub approaching tree height.		Hungry Hollow Reach Hungry Hollow Reach	RM 25.7

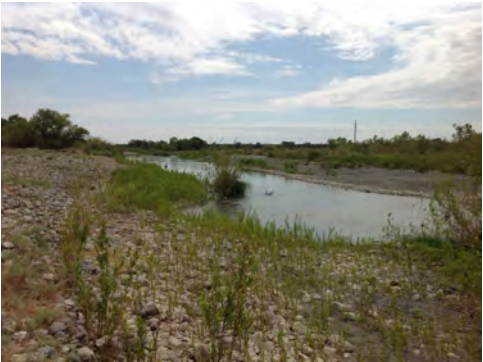
Tompkins	Looking DS	Looking downstream showing no major channel changed between 2012 and 2013.	Hungry Hollow Reach	RM 25.9

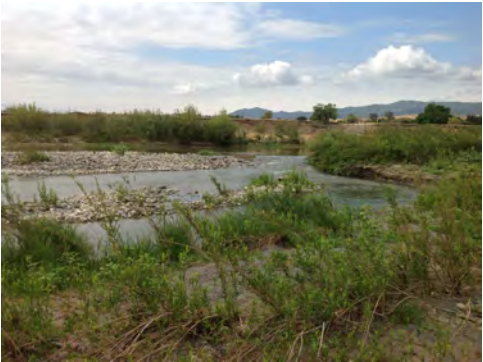
Tompkins	Looking US	Looking upstream showing no major channel changed between 2012 and 2013.	Hungry Hollow Reach	RM 25.9

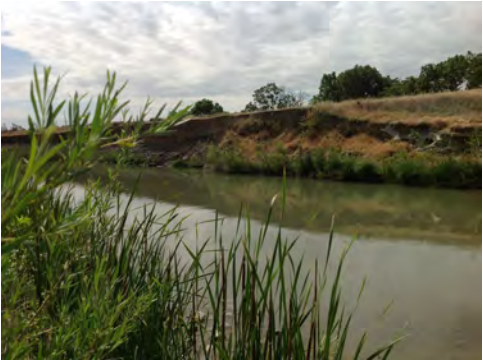
Observer	Comments	Verbose Comments	River Reach	River Miles	Image
Larsen	Erosion RB	Exposed geotextile on RB.	Hungry Hollow Reach	RM 26

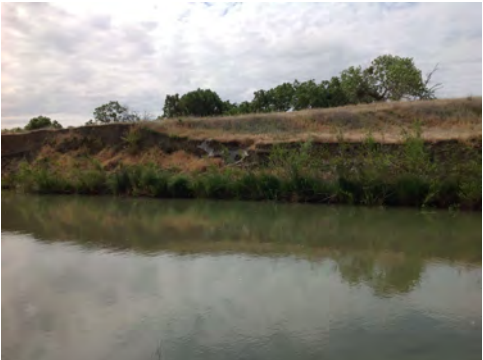
Larsen	Erosion RB	Exposed geotextile on RB.	Hungry Hollow Reach	RM 26

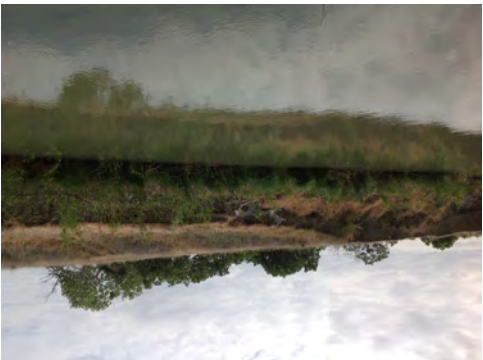
Martin	Bank erosion exposing geofabric on slope of previous stabilization area.		Hungry Hollow Reach	RM 26

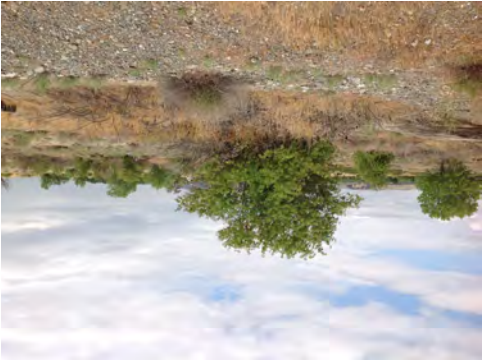
Observer	Comments	Verbose Comments	River Reach	River Miles	Image
Martin	Elderberry establishing on channel bottom where tamarisk stumps have allowed for silt accumulation.		Hungry Hollow Reach Hungry Hollow Reach	RM 26

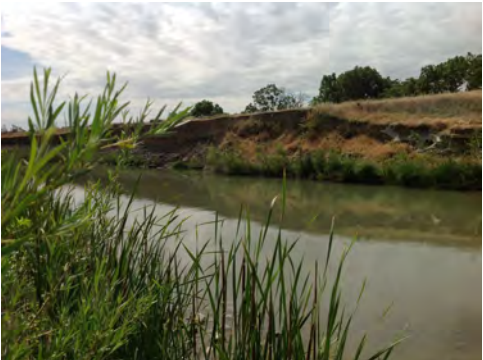
Tompkins	Exposed geotextile on RB.	Looking at the right bank where geotextile fabric has been exposed, possibly by high flows between 2012 and 2013. The geotextile indicates this is a constructed bank that is eroding.	Hungry Hollow Reach	RM 26

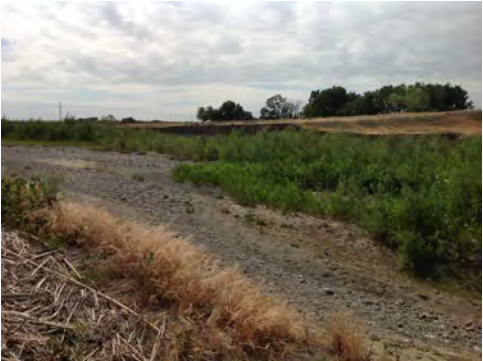
Larsen	Looking downstream.	Possible erosion along RB and potential area for LB bar skimming.	Hungry Hollow Reach	RM 26.1

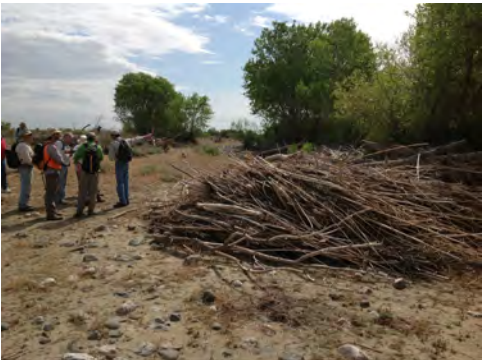
Observer	Comments	Verbose Comments	River Reach	River Miles	Image
Martin	View of debris accumulation in channel bottom. Confirm need for channel maintenance at this location - bar skimming? Does not appear necessary given width of channel bottom.		Hungry Hollow Reach Hungry Hollow Reach	RM 26.1

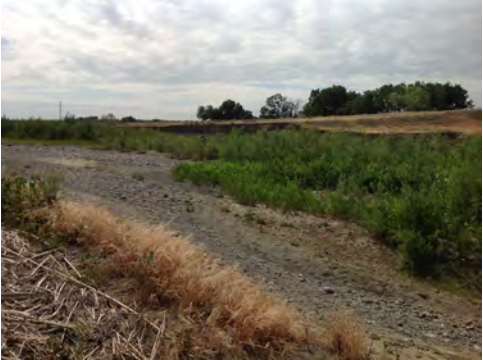
Tompkins	LB to RB DS possible erosion along RB and need for LB bar skimming.	Looking from the left bank to the right bank and downstream where the right bank is eroding (some may have occurred between 2012 and 2013) and gravel accumulation on the left bank may be directing flow at the right bank. There was discussion of possible left bank bar skimming at this location.	Hungry Hollow Reach	RM 26.1

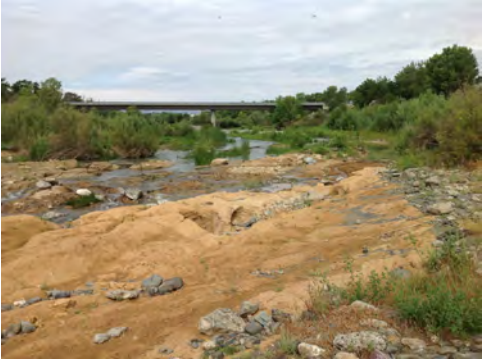
Tompkins	US	Looking upstream along exposed clay hardpan downstream of CR 85 bridge. No significant channel change in this reach between 2012 and 2013.	Hungry Hollow Reach	RM 26.2

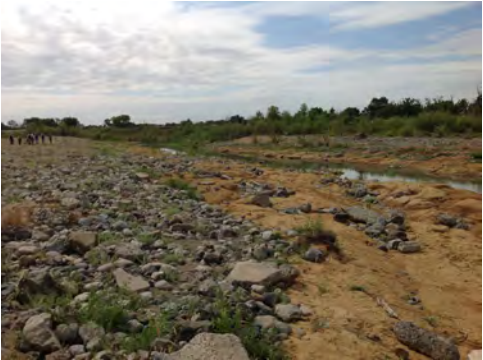
Observer	Comments	Verbose Comments	River Reach	River Miles	Image
Tompkins	DS	Looking downstream along exposed clay hardpan downstream of CR 85 bridge. No significant channel change in this reach between 2012 and 2013.	Hungry Hollow Reach	RM 26.2

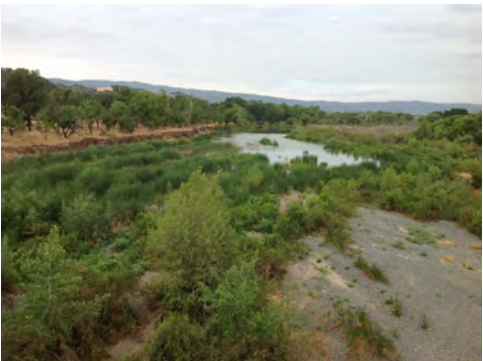
Larsen	Erosion on south bank upstream from bridge.	Audio includes notes on erosion upstream from bridge. The right bank appears to be higher than it was last year. Ben explained that it might not be higher (i.e. lower water surface elevation) but that the lateral erosion in the south direction gives this appearance to the bank height..	Hungry Hollow Reach	RM 26.3

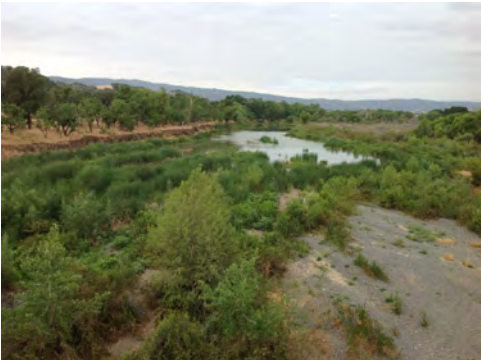
Tompkins	Looking US from bridge. Eric thinks RB cut bank higher.	Looking upstream from CR 85 bridge. The right bank of the channel appears to be downcut five to ten feet below the top of bank. We did not have a photo from this location in 2012 so it is unclear whether this downcut occurred between 2012 and 2013. Future Creek Walks should assess whether this cut bank changes.	Hungry Hollow Reach	RM 26.3

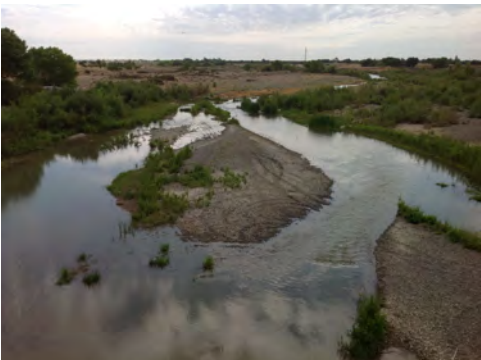
Tompkins	Looking DS. Large gravel bars DS bridge.	Looking downstream from CR 85 bridge. There continue to be large gravel bars downstream of the bridge but no significant channel change between 2012 and 2013.	Hungry Hollow Reach	RM 26.3

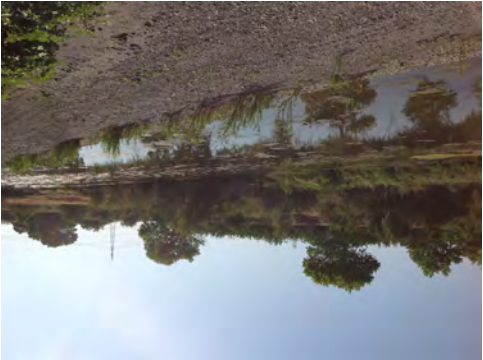
Observer	Comments	Verbose Comments	River Reach	River Miles	Image
Martin	Spur dikes on north bank are capped with soil where revegetation has been possible. Capping the spur dikes on south bank should be considered to allow for revegetation and improve habitat values.		Madison Reach	RM 21.2

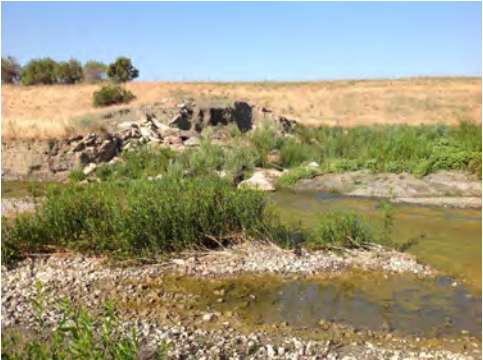
Observer	Comments	Verbose Comments	River Reach	River Miles	Image
Tompkins	RB training berm with eroding face.	Looking at right bank training berm with eroding face. While this should be monitored in future years, it has not changed significantly since 2012.	Madison Reach	RM 21.3

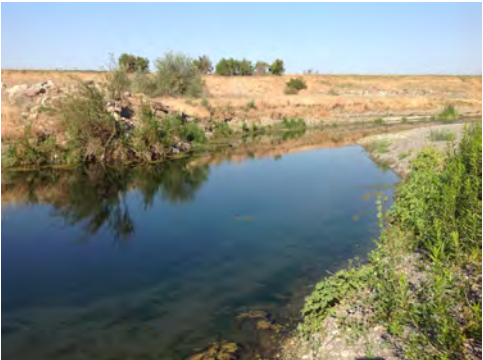
Tompkins	Looking US LB to RB large 10' deep pool and eroding RB between training berms.	Looking upstream from left bank to right bank at large, 10 foot deep pool and eroding right bank between training berms. Training berms appear to be creating hydraulics that maintain pool habitat in some locations.	Madison Reach	RM 21.3

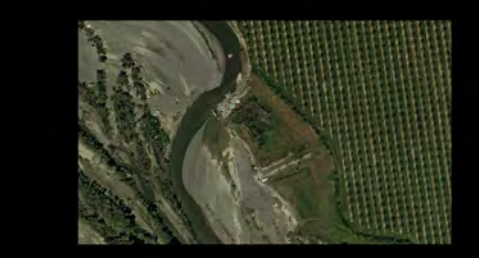
Larsen	View of berms	These berms have contributed to the bank retreat immediately upstream from them	Madison Reach	RM 21.5

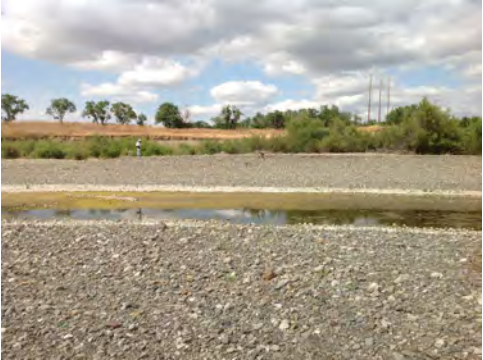
Larsen	Channel has removed material	Across RB to LB. The bar skimming that we previously considered has been done by the channel.	Madison Reach	RM 21.6

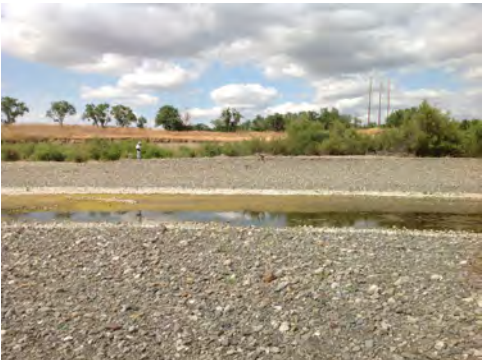
Observer	Comments	Verbose Comments	River Reach	River Miles	Image
Tompkins	Across RB to LB. Bar skimming Eric proposed has been done by channel.	Looking from right bank across to left bank. TAC discussed that previously proposed bar skimming for this area may have already been accomplished by natural channel sediment transport.	Madison Reach	RM 21.6

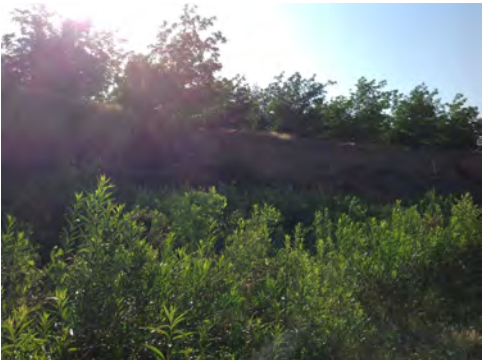
Observer	Comments	Verbose Comments	River Reach	River Miles	Image
Tompkins	At LB note possible active erosion at top of bank orchard and irrigation return flow seep.	Looking at left bank where there is possible active erosion at top of bank orchard and irrigation return flow seep.	Madison Reach	RM 21.6

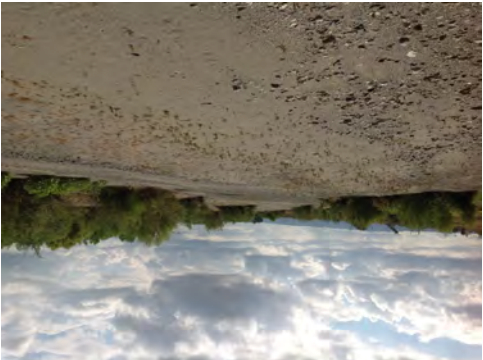
Martin	Ste vertical bank with historic bank swallow habitat. Willow becoming well established at base of slope.		Madison Reach	RM 21.7

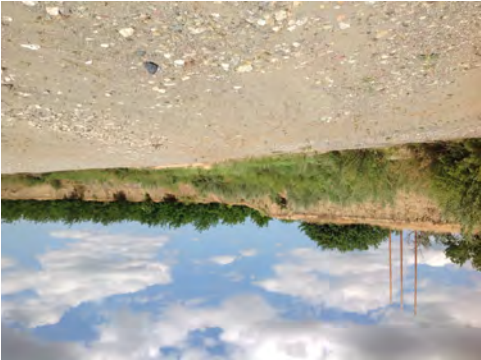
Observer	Comments	Verbose Comments	River Reach	River Miles	Image
Martin	Ste vertical bank with historic bank swallow habitat. Willow becoming well established at base of slope.		Madison Reach	RM 21.7

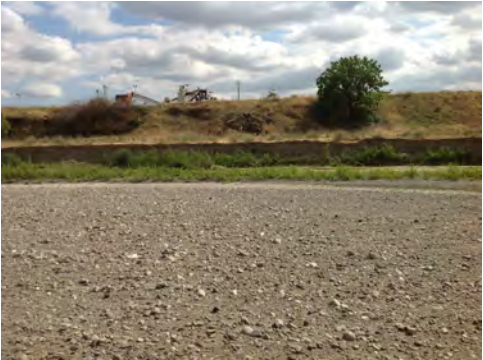
Observer	Comments	Verbose Comments	River Reach	River Miles	Image
Tompkins	Across LB to RB eroding low bank at Syar	Looking from left bank across to right bank where there is an eroding low bank along the Syar plant. This erosion has not changed substantially since 2012.	Madison Reach	RM 21.8

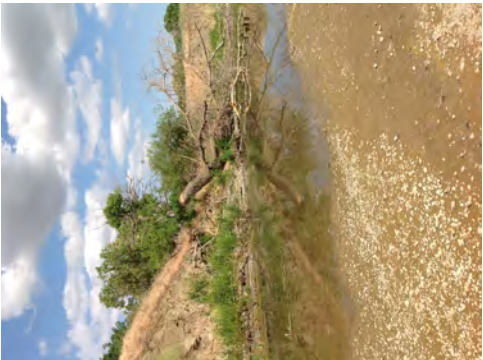
Observer	Comments	Verbose Comments	River Reach	River Miles	Image
Martin	Beaver felling of mature cottonwood. Raises question of whether some protection of essential large trees should be proved to secure woodland canopy as has been done on CC Preserve.		Madison Reach	RM 21.9

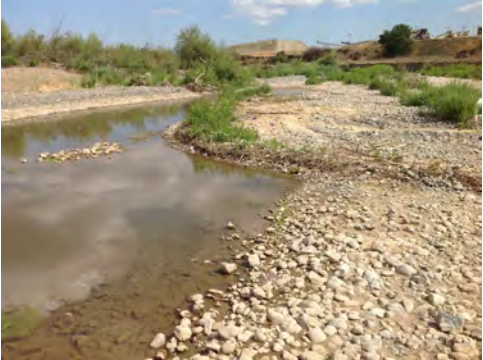
Tompkins	Small beaver dam	Small beaver dam that was not present in 2012.	Madison Reach	RM 21.9

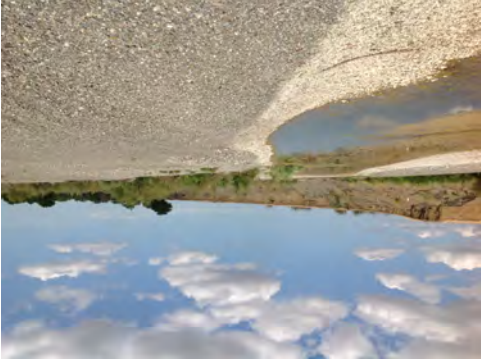
Martin	River Mile 22 with exposed north bank and low terrace with restoration opportunity.		Madison Reach	RM 22.1

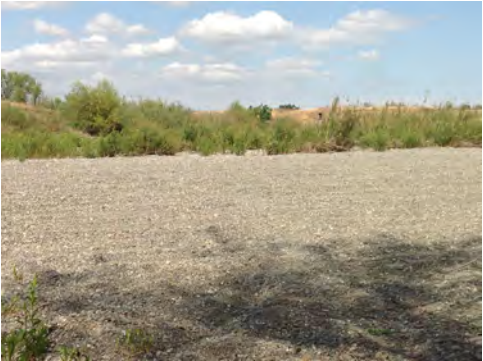
Tompkins	Across note perched pipe.	Looking across showing no significant channel changes since 2012. Perched pipe should be added to potential water quality contaminant source database. Minor riparian vegetation increase since 2012.	Madison Reach	RM 22.2

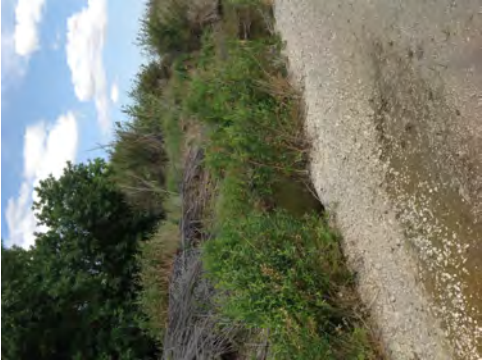
Martin	Arundo reestablishment in elevated terrace with scattered black walnut on north side of low flow channel.		Madison Reach	RM 22.4

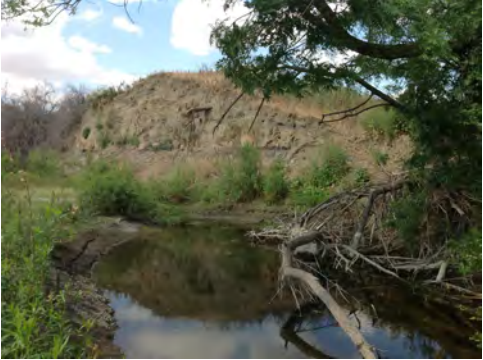
Tompkins	Tall eroded LB just US of pond turtle pond with large black walnut tree.	Tall eroded LB just US of pond turtle pond with large black walnut tree.	Madison Reach	RM 22.4

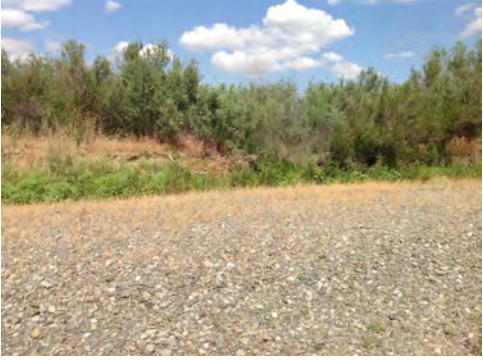
Tompkins	LB exposed pipe in bank	Small exposed irrigation type hose / pipe on left bank. Does not appear to have been active recently and does not appear to be influencing water quality. However, this should be added to the database of potential water quality contaminant sources.	Madison Reach	RM 22.5

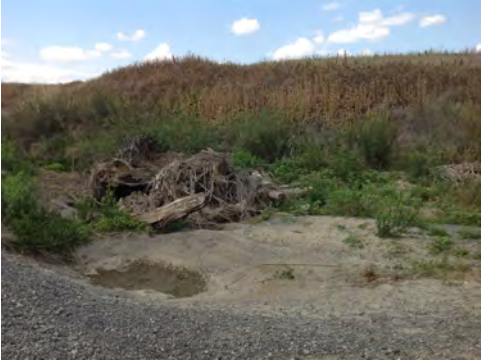
Larsen	Old exposed bank protection	Root wad bank stabilization along Teichert.	Madison Reach	RM 22.9

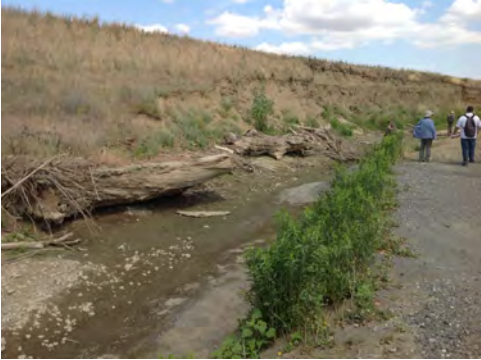
Larsen	Old exposed bank protection	Teichert root wads now exposed	Madison Reach	RM 22.9

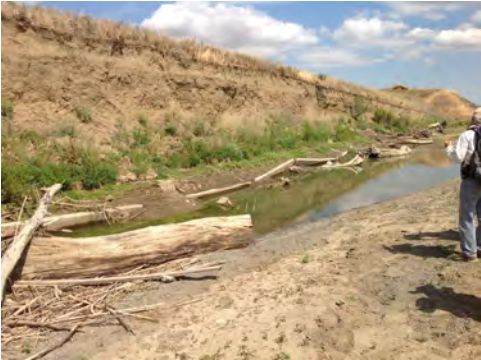
Observer	Comments	Verbose Comments	River Reach	River Miles	Image
Larsen	Old exposed bank protection	LB toe of slope along Teichert. Concrete k-rail exposed at toe. Scour holes.	Madison Reach	RM 22.9

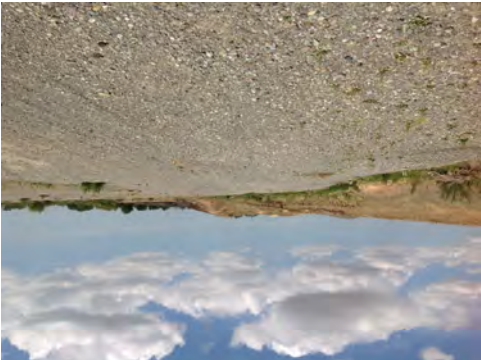
Martin	Bank erosion where large woody debris was used to stabilize base of slope. Questa did stabilization plan with large woody debris about six years ago. Needs continuing monitoring and future treatment.		Madison Reach	RM 22.9

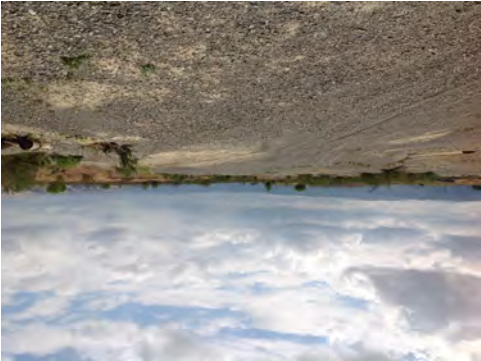
Martin	Bank erosion where large woody debris was used to stabilize base of slope. Questa did stabilization plan with large woody debris about six years ago. Needs continuing monitoring and future treatment.		Madison Reach	RM 22.9

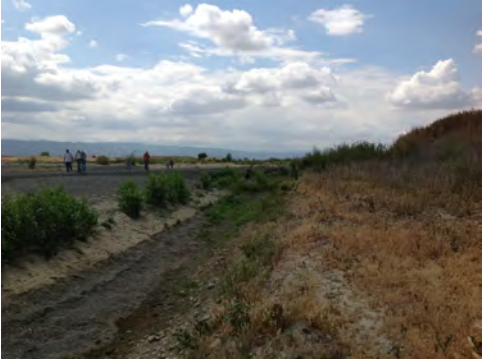
Observer	Comments	Verbose Comments	River Reach	River Miles	Image
Martin	anchored and cabled root wads now exposed at base of eroded bank.		Madison Reach	RM 22.9

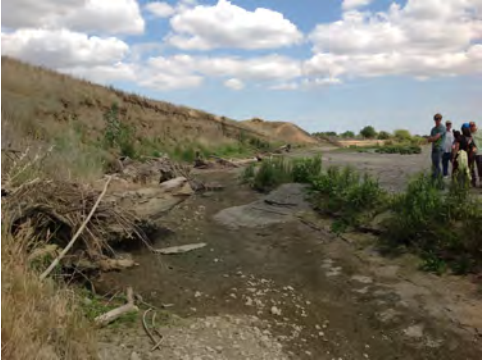
Martin	anchored and cabled root wads now exposed at base of eroded bank.		Madison Reach	RM 22.9

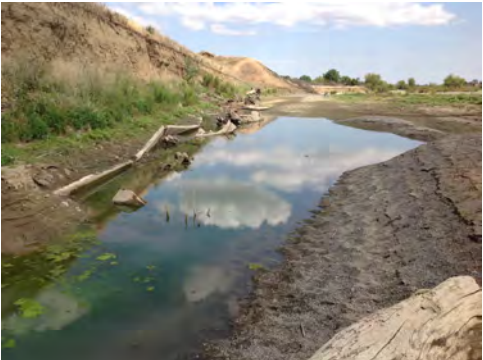
Martin	Exposed k-rail in mid-reach of eroded bank. K-rails were completely buried as part of original bank reconstruction.		Madison Reach	RM 22.9

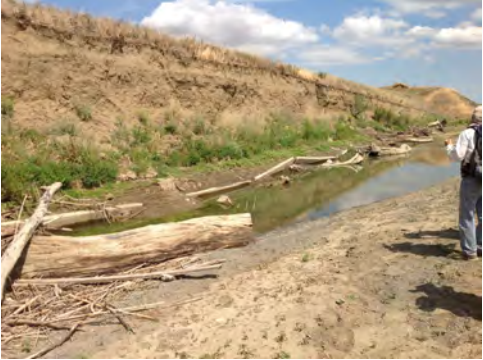
Tompkins	LB toe of slope along Teichert. Concrete k-rail exposed at toe. Scour holes.	Concrete k-rail exposed at toe of slope along left bank of Teichert plant. Scour holes in adjacent channel. This revetment hasn't changed significantly since 2012 but should be monitored on all Creek Walks.	Madison Reach	RM 22.9

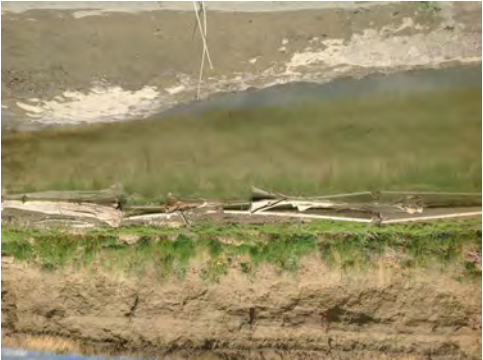
Observer	Comments	Verbose Comments	River Reach	River Miles	Image
Tompkins	Audio	Additional images of k-rail / log revetment that is being undermined.	Madison Reach	RM 22.9

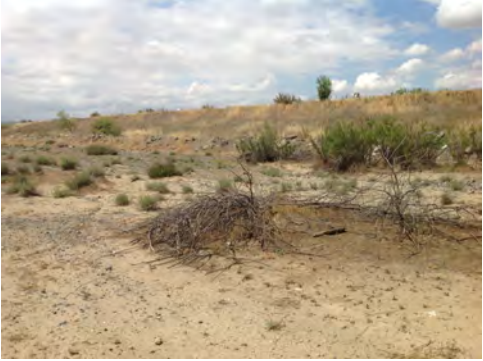
Larsen	Concrete rubble in channel	LB secondary crap rap berm along Teichert. Looking US.	Madison Reach	RM 23.3

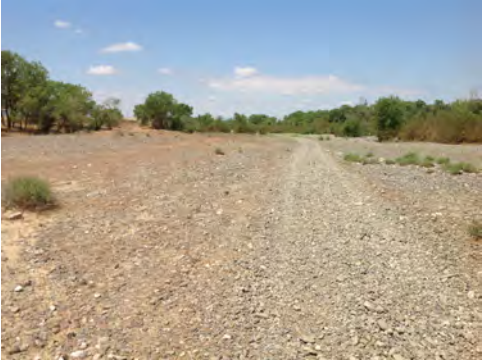
Observer	Comments	Verbose Comments	River Reach	River Miles	Image
Tompkins	Looking upstream brought reach into narrower reach with mature riparian vegetation on both banks	Looking upstream into narrower reach with mature riparian vegetation on both banks. No major channel changes since 2012.	Guesisosi Reach	RM 19
