2013 CACHE CREEK ANNUAL STATUS REPORT

For the period of
October 1, 2012 to September 30, 2013

CACHE CREEK TECHNICAL ADVISORY COMMITTEE:

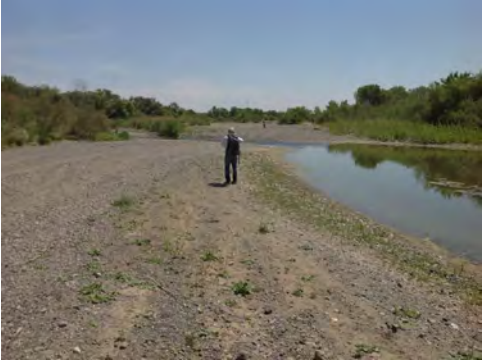
Larsen	Narrow area	We are coming down the reach that has been relatively narrow it's the area near CEMEX.	Guesisosi Reach	RM 19.2

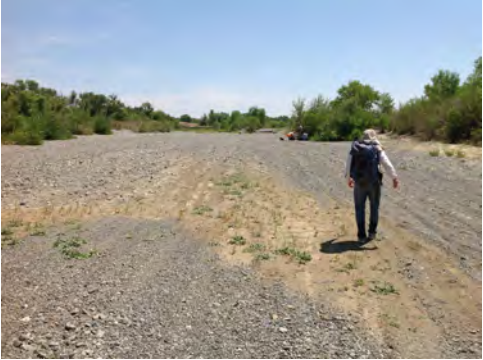
Larsen	Wider area	The area is and has been naturally wider than immediately upstream. The gravel mining operations have taken advantage of this fact and used to extract from bank to bank.	Guesisosi Reach	RM 19.2

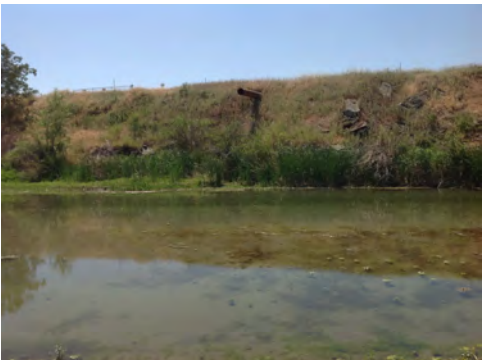
Tompkins	Hanging corrugated metal pipe on the right bank	Hanging corrugated metal pipe on the right bank. This should be added to the potential water quality contaminant database.	Guesisosi Reach	RM 19.2

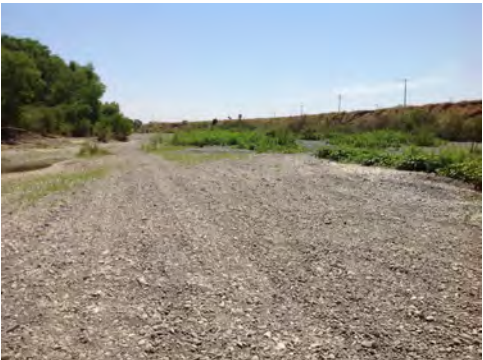
Observer	Comments	Verbose Comments	River Reach	River Miles	Image
Tompkins	Looking downstream right bank some erosion near the top of bank	Looking downstream at right bank with some erosion near the top of bank.	Guesisosi Reach	RM 19.5

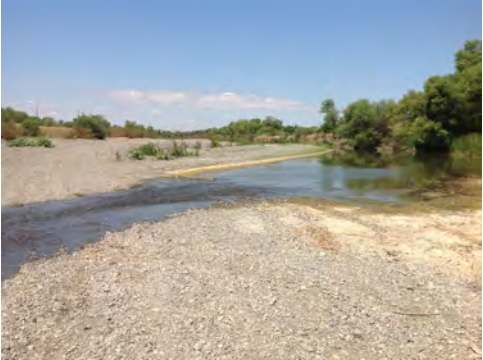
Tompkins	Looking upstream some left bank erosion	Looking upstream at some left bank erosion.	Guesisosi Reach	RM 19.5

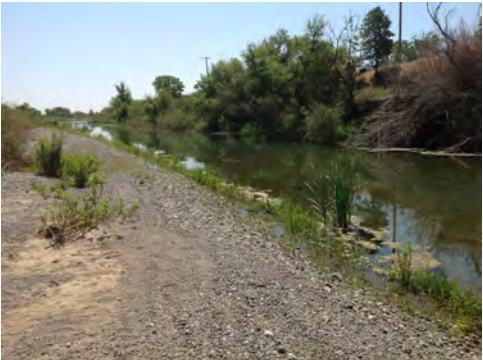
Larsen	Bank erosion at toe of bank	This is an area where there is erosion at the toe of the berm and not much distance from the road to the top where there's a conveyor belt and power poles. This is an area of concern.	Guesisosi Reach	RM 19.8

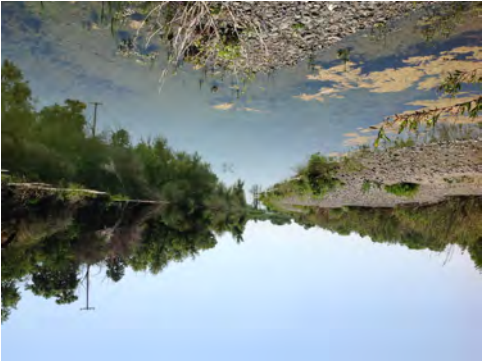
Martin	View of south bank with exposed vertical bank of immature woody vegetation.		Guesisosi Reach	RM 19.8

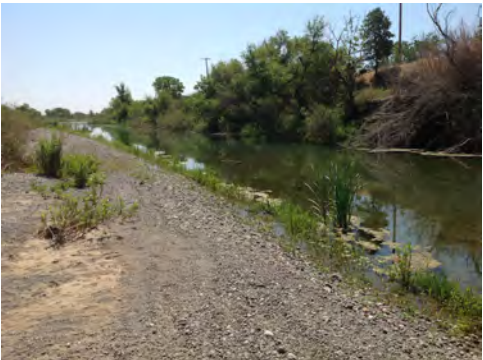
Observer	Comments	Verbose Comments	River Reach	River Miles	Image
Tompkins	Looking down stream large right bank pool. Possible bank treatment location right bank	Looking down stream large right bank pool. Possible bank treatment location on right bank.	Guesisosi Reach	RM 19.8

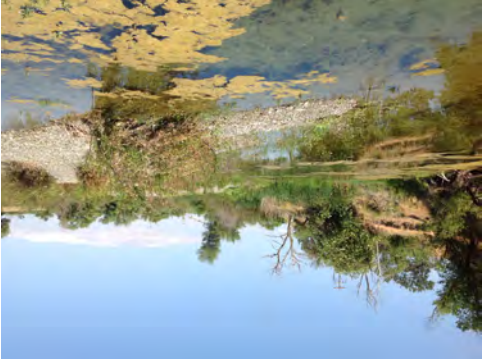
Martin	View of vertical banks with mature woody vegetation on south side of active channel at downstream end of Cemex property.		Guesisosi Reach	RM 19.9

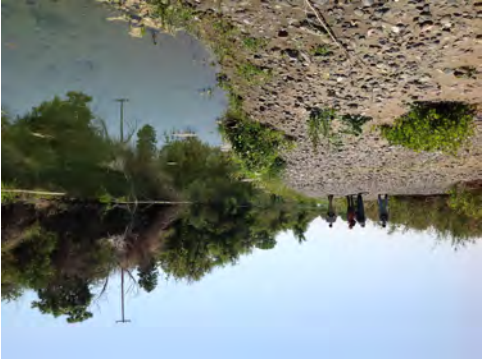
Observer	Comments	Verbose Comments	River Reach	River Miles	Image
Martin	View of vertical banks with mature woody vegetation on south side of active channel at downstream end of Cemex property.		Guesisosi Reach	RM 19.9

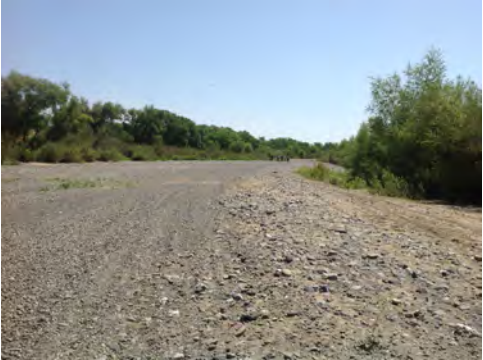
Larsen	Bar skimming discussion area	Looking downstream vegetation on both sides. Ben comments that this is an ideal spot for instream mining or bar skimming where the vegetation is on the margins; in the channel it open it and works for the industry and then the landowners wer	Guesisosi Reach	RM 20

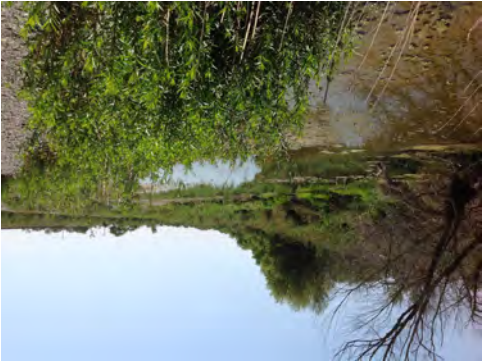
Martin	Exposed vertical bank with regeneration at base of slope and exposed dead willow tree.		Guesisosi Reach	RM 20.2

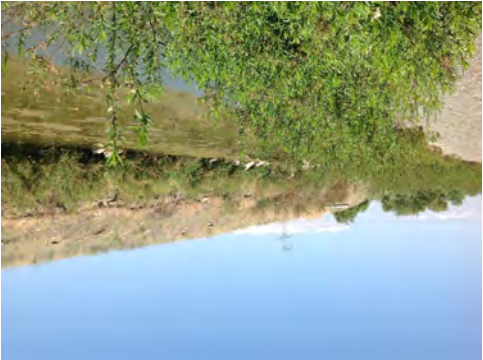
Observer	Comments	Verbose Comments	River Reach	River Miles	Image
Martin	Exposed vertical bank with regeneration at base of slope and exposed dead willow tree.		Guesisosi Reach	RM 20.2

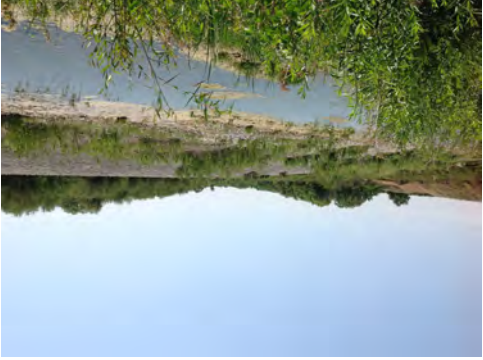
Martin	Downstream end of proposed bar skimming at Cemex site.		Guesisosi Reach	RM 20.3

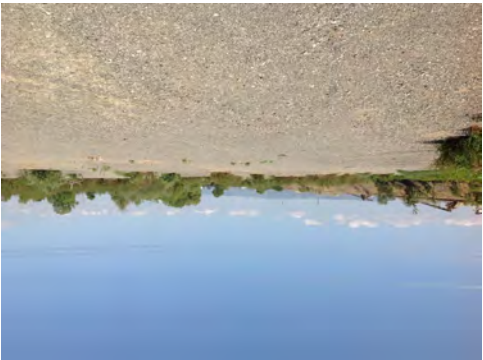
Observer	Comments	Verbose Comments	River Reach	River Miles	Image
Martin	Downstream end of proposed bar skimming at Cemex site.		Guesisosi Reach	RM 20.3

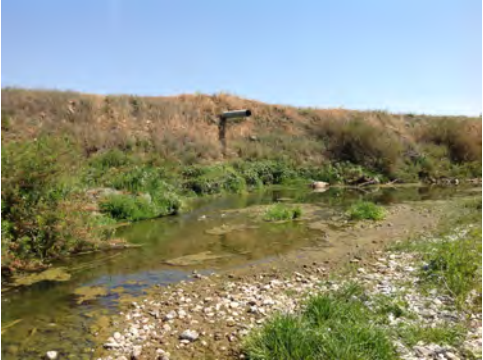
Larsen	Near bar skimming area	This shows a tree in the channel where the bar skimming is proposed.	Guesisosi Reach	RM 20.4

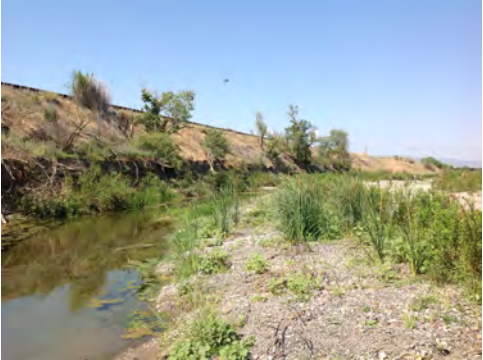
Larsen	More area that will benefit	Vulnerable bank at CEMIX site where bar skimming in center of creek is proposed.	Guesisosi Reach	RM 20.4

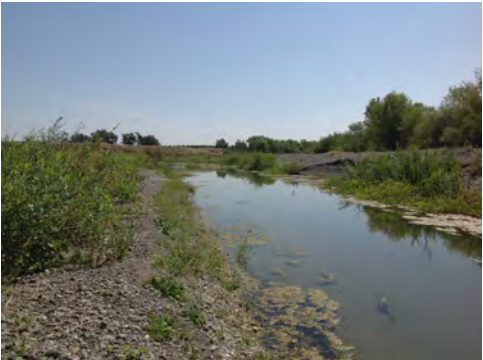
Observer	Comments	Verbose Comments	River Reach	River Miles	Image
Martin	Vulnerable bank at Cemex site where bar skimming in center of creek is considered as management technique to reduce potential bank erosion.		Guesisosi Reach	RM 20.4

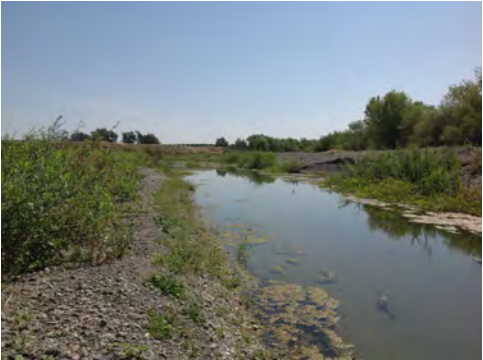
Martin	Vulnerable bank at Cemex site where bar skimming in center of creek is considered as management technique to reduce potential bank erosion.		Guesisosi Reach	RM 20.4

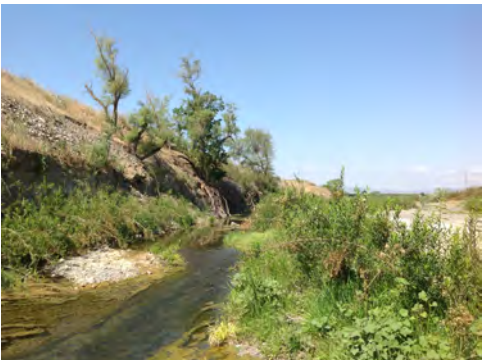
Observer	Comments	Verbose Comments	River Reach	River Miles	Image
Martin	Vertical creek bank where mature trees are about to be lost downstream of possible bar skimming location near Cemex site.		Guesisosi Reach	RM 20.4	 
Martin	Sapling elderberry in thicket north of the proposed bar skimming at Cemex site with no stems greater than 1 inch.		Guesisosi Reach	RM 20.4

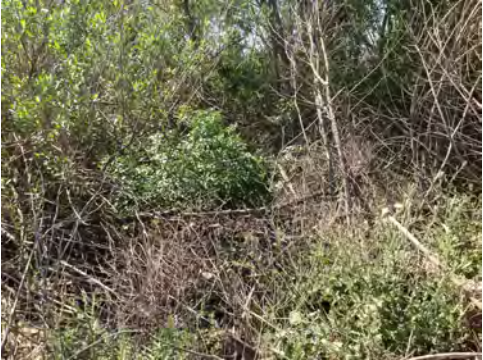
Tompkins	Looking at RB along cemex eroded Bank. Note significant new Willow growth since 2012 potential for toe of slope protection in 10 to 20 foot strips between new willows and vertical Bank	Looking at right bank along Cemex eroded bank. Note significant new willow growth since 2012 and potential for toe of slope protection in 10 to 20 foot strips between new willows and vertical bank.	Guesisosi Reach	RM 20.4

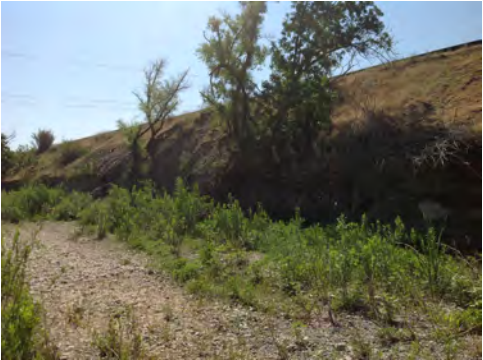
Martin	Continuation of proposed bar skimming channel near Cemex site on current low-flow meander of the creek.		Guesisosi Reach	RM 20.5

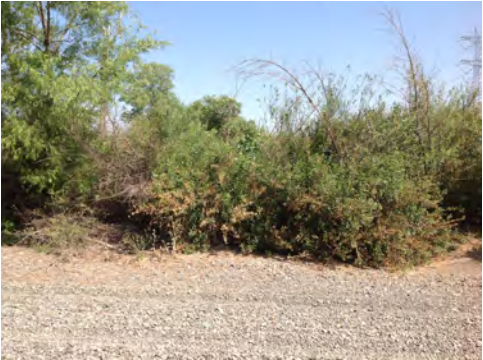
Martin	<p>Downstream extension of proposed bar skimming at center of creek near Cemex site. Proposal is for bar skimming to occur on either side of cottonwood tree and extend southward to low flow channel.</p>		Guesisosi Reach	RM 20.5

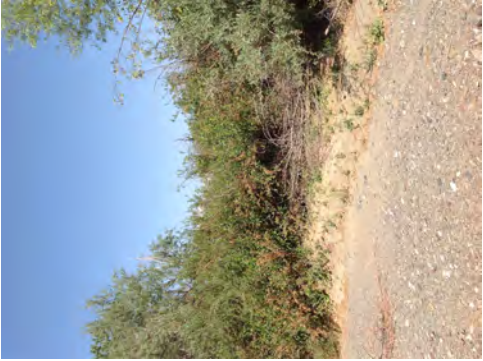
Tompkins	Right bank looking downstream adjacent to cemex Steepbank with significant erosion	Right bank looking downstream adjacent to Cemex steep bank with significant erosion.	Guesisosi Reach	RM 20.5

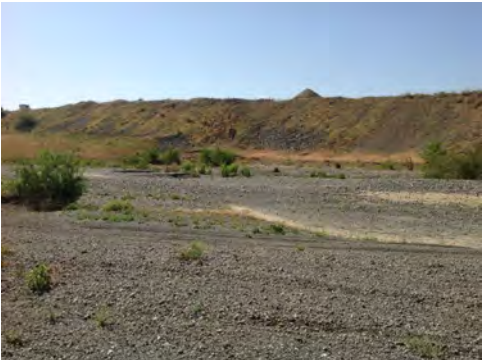
Larsen	Potential bar skimming area	This is an area where there is potential for bar skimming in order to protect the left bank.	Guesisosi Reach	RM 20.6

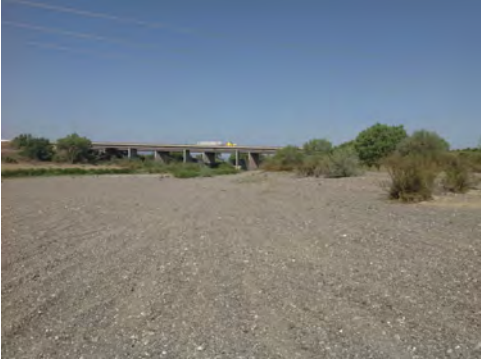
Larsen	Bar of pea gravel	1995 RB bank protection project. Riprap at base of slope. 1997 flows silted floodplain and seeded with grasses. Pile of pea gravel is 200,000 tons about a 2 year supply. Row of cottonwoods shows rock toe.	Guesisosi Reach	RM 20.8

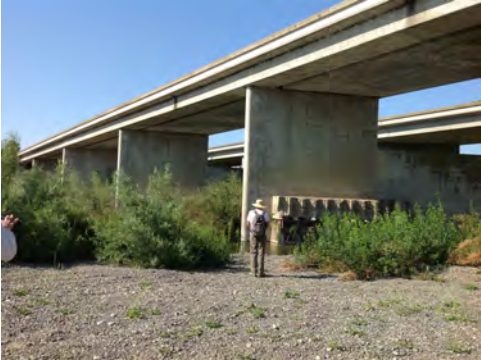
Larsen	Vegetation near bridge	Upstream from the highway 505 bridge we notice on the south side that the vegetation has gotten taller. Last year we considered the way the vegetation impeded the flow. Last year we thought it was not impeding flow; this year we think that it might.	Guesisosi Reach	RM 21

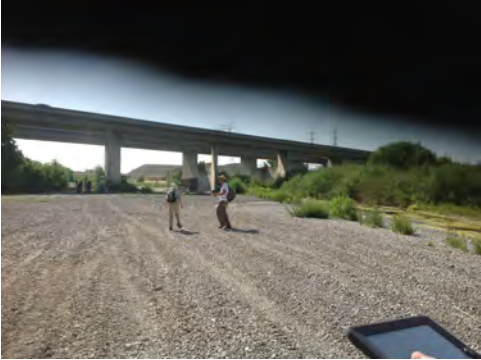
Observer	Comments	Verbose Comments	River Reach	River Miles	Image
Larsen	505 bridge	It appears that the bridge abutments were built in two phases and are oriented in two significantly different directions probably somewhere between 10 and 30° difference.	Guesisosi Reach	RM 21

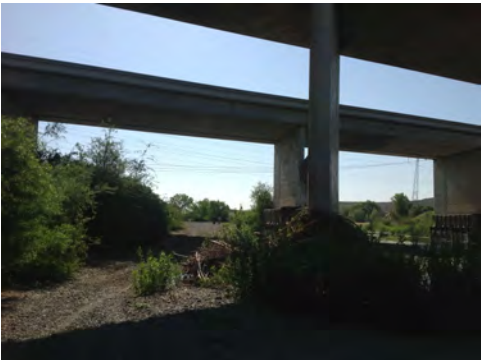
Larsen	Undercut bridge piers Highway 505.	Apperar to be no change since last year.	Guesisosi Reach	RM 21

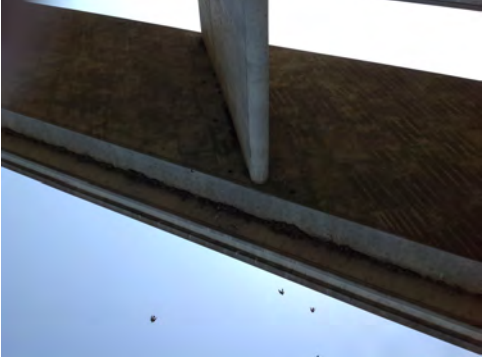
Martin	Cliff swallows nesting on west side of I-505 bridge.		Guesisosi Reach	RM 21

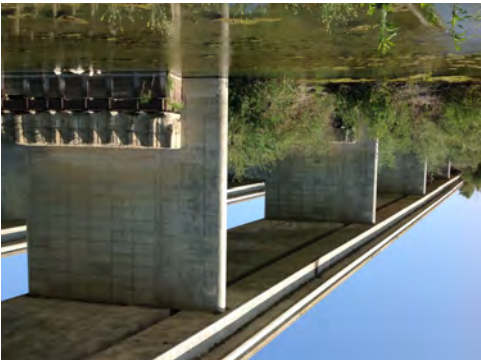
Observer	Comments	Verbose Comments	River Reach	River Miles	Image
Martin	View to south of I-505 bridge with expose retrofitted piers.		Guesisosi Reach	RM 21

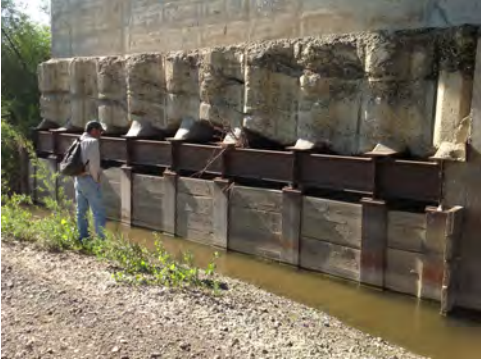
Tompkins	Left Bank downstream exposed bridge piers with Ben Adamo for scale still no significant change since last year	Left bank downstream of exposed I505 bridge piers with Ben Adamo for scale. No significant change since 2012.	Guesisosi Reach	RM 21

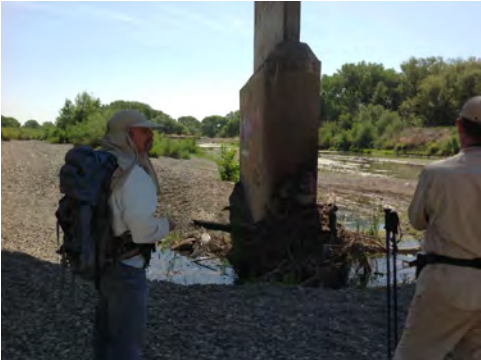
Observer	Comments	Verbose Comments	River Reach	River Miles	Image
Larsen	#75b Vegetation caught on bridge piling	The vegetation file filling the left-hand here looking downstream is dense and would impede the flow and reduce flow capacity. It is not clear whether this has changed since last year. If so only a li	Hoppin Reach	RM 15.9

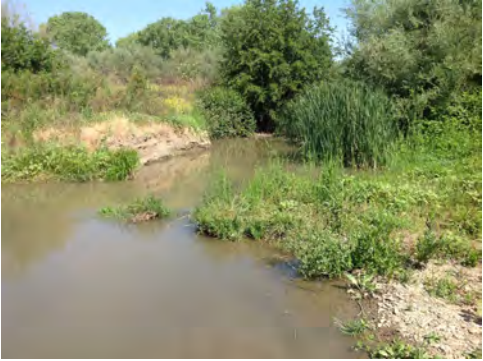
Observer	Comments	Verbose Comments	River Reach	River Miles	Image
Tompkins	Looking up stream into Gordon Slough. Note somewhat turbid Gordon slough outflow.	Looking upstream into Gordon Slough. Note somewhat turbid Gordon Slough outflow as observed in previous years.	Dunnigan Hills Reach	RM 15.9

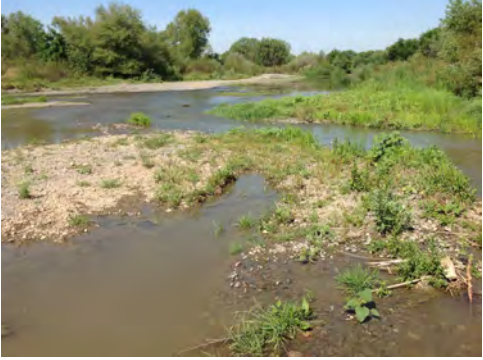
Tompkins	Looking upstream from Gordon slough confluence.	Looking upstream from Gordon Slough confluence. No significant channel change.	Dunnigan Hills Reach	RM 15.9

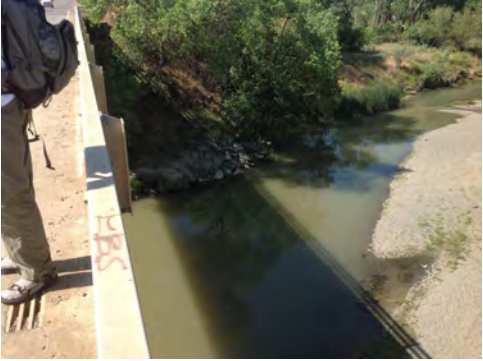
Observer	Comments	Verbose Comments	River Reach	River Miles	Image
Tompkins	Looking Upstream. Road 94b. LB riprap on the left bank near bridge abutment. Scour around midstream bridge piers	Looking Upstream at Road 94b. Riprap on the left bank near bridge abutment. Scour around midstream bridge piers does not appear to have worsened since 2012 but should be monitored in future years.	Dunnigan Hills Reach Hoppin Reach	RM 15.9

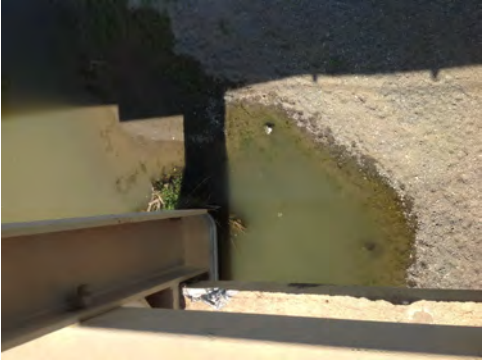
Tompkins	Looking Upstream. Road 94b. LB riprap on the left bank near bridge abutment. Scour around midstream bridge piers	Looking Upstream at Road 94b. Riprap on the left bank near bridge abutment. Scour around midstream bridge piers does not appear to have worsened since 2012 but should be monitored in future years.	Hoppin Reach	RM 15.9

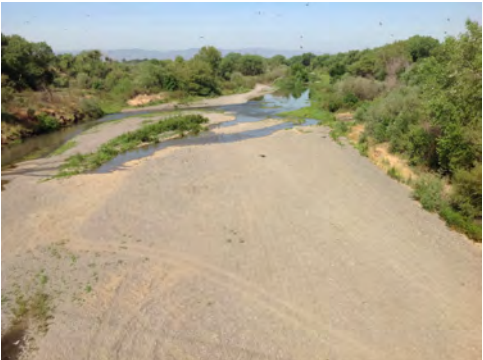
Tompkins	Looking Upstream. Road 94b. LB riprap on the left bank near bridge abutment. Scour around midstream bridge piers	Looking Upstream at Road 94b. Riprap on the left bank near bridge abutment. Scour around midstream bridge piers does not appear to have worsened since 2012 but should be monitored in future years.	Hoppin Reach	RM 15.9

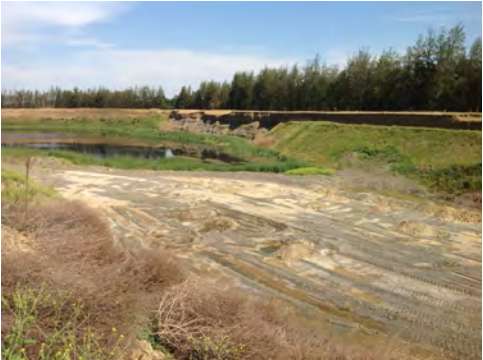
Observer	Comments	Verbose Comments	River Reach	River Miles	Image
Tompkins	Shallow 25' pit at clay bottom.	Shallow 25' pit at clay bottom.	Dunnigan Hills Reach	RM 16.6

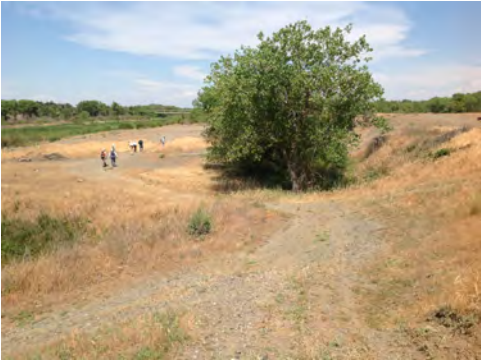
Martin	Potential upper terrace restoration project at Patterson property east of former pit. Need further exploration of opportunity and feasibility.		Dunnigan Hills Reach	RM 17.3

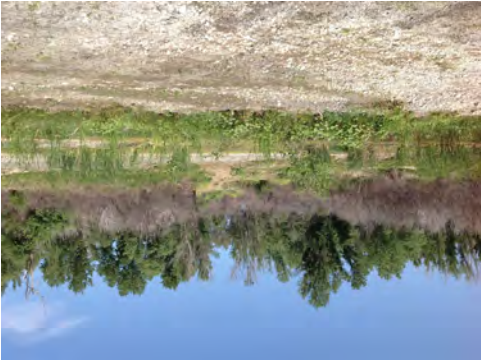
Observer	Comments	Verbose Comments	River Reach	River Miles	Image
Martin	Abundant surface water with excellent regeneration at mid to upper terraces with heavy tamarisk infestation largely eliminated on north bank.		Dunnigan Hills Reach Dunnigan Hills Reach	RM 17.3

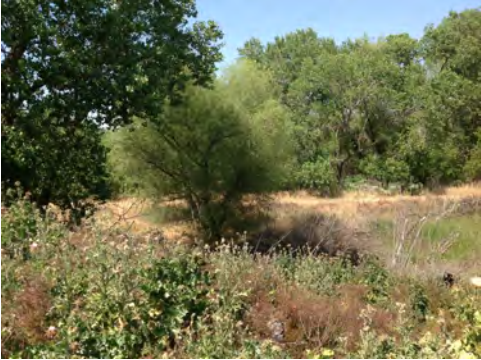
Martin	Assumed natural revegetation in former extraction pit on south bank of Patterson property.		Dunnigan Hills Reach	RM 17.3

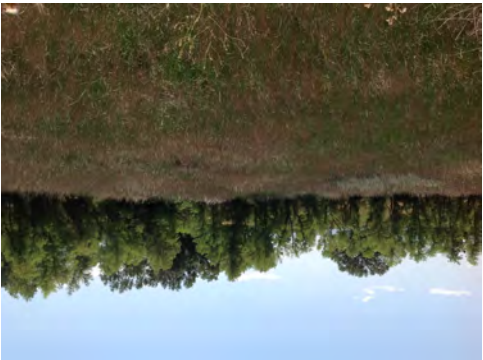
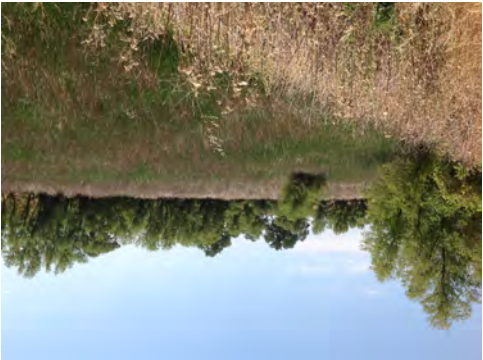
Observer	Comments	Verbose Comments	River Reach	River Miles	Image
Martin	Views of former Patterson pit with dense freshwater marsh vegetation.		Dunnigan Hills Reach Dunnigan Hills Reach	RM 17.5

Martin	Views of former Patterson pit with dense freshwater marsh vegetation.		Dunnigan Hills Reach	RM 17.5

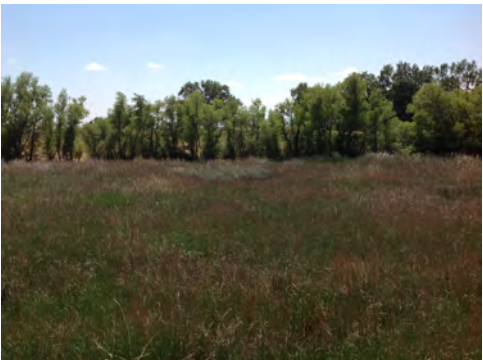
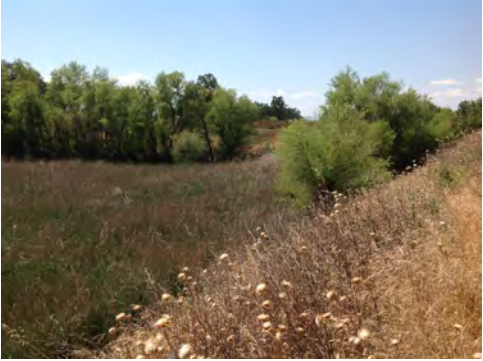
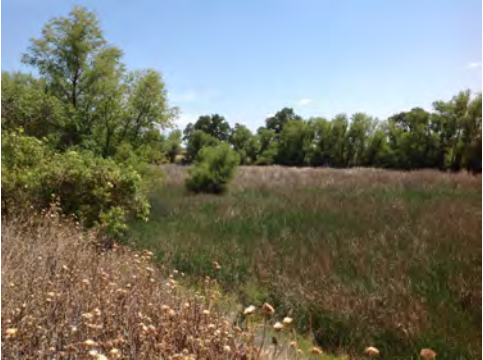
Martin	Natural revegetation to freshwater marsh and willow scrub at Patterson pit.		Dunnigan Hills Reach	RM 17.5

Observer	Comments	Verbose Comments	River Reach	River Miles	Image
Martin	Natural revegetation to freshwater marsh and willow scrub at Patterson pit.		Dunnigan Hills Reach Dunnigan Hills Reach	RM 17.5

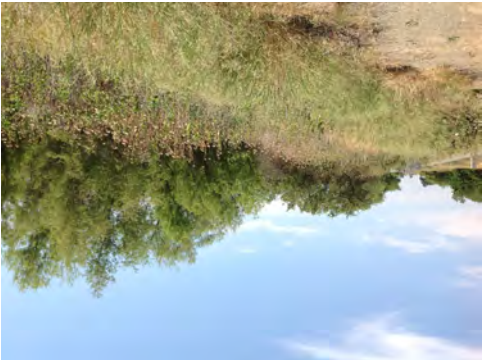
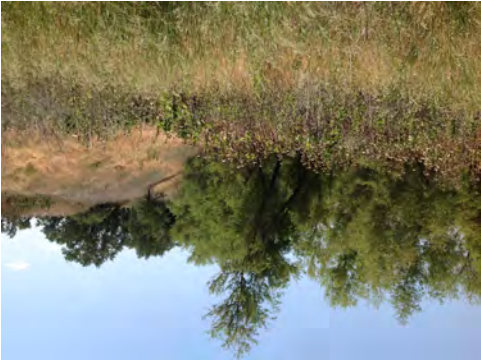
Martin	Former Patterson pit with natural revegetation. Mined in 1980s with south slope revegetated.		Dunnigan Hills Reach	RM 17.6

Observer	Comments	Verbose Comments	River Reach	River Miles	Image
Martin	Former Patterson pit with natural revegetation. Mined in 1980s with south slope revegetated.		Dunnigan Hills Reach Dunnigan Hills Reach	RM 17.6

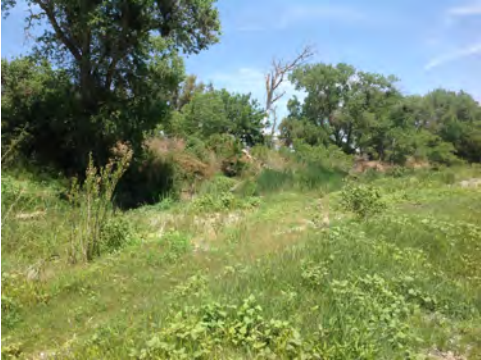
Larsen	Benefits of erosion	This is an example of a rather steep bank that has been allowed to naturally vegetate. This is what is not possible on area where cement and Kabul predominates.	Dunnigan Hills Reach	RM 17.8

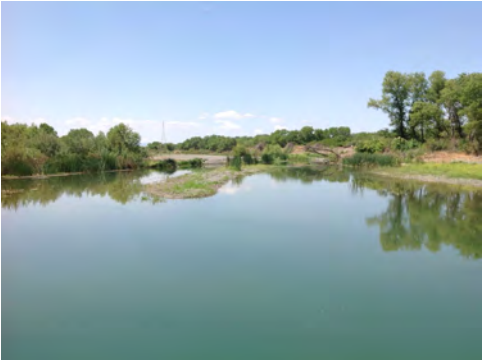
Observer	Comments	Verbose Comments	River Reach	River Miles	Image
Larsen	#74b Audio notes on Moores siphon.	Moore siphon	Dunnigan Hills Reach	RM 18

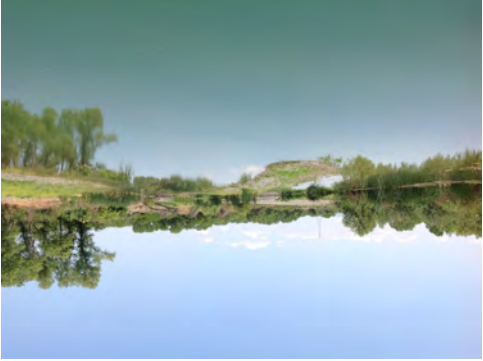
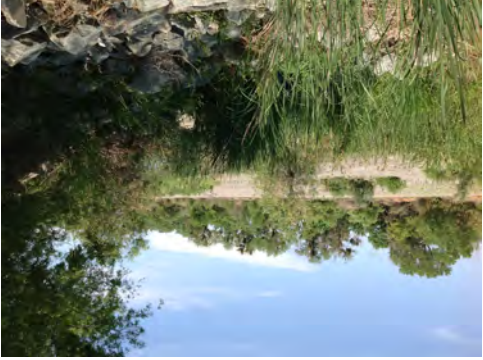
Martin	Moore Siphon crossing with beaver dam at crossing location.		Dunnigan Hills Reach	RM 18

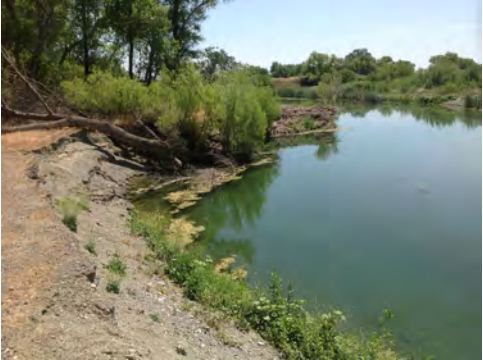
Larsen	More of the habitat created by erosion	In this area we saw the largest school of fish we have seen in the creek including a big largemouth bass. This underscores the value of this small area for habitat including the wood in the stream.	Dunnigan Hills Reach	RM 18.1

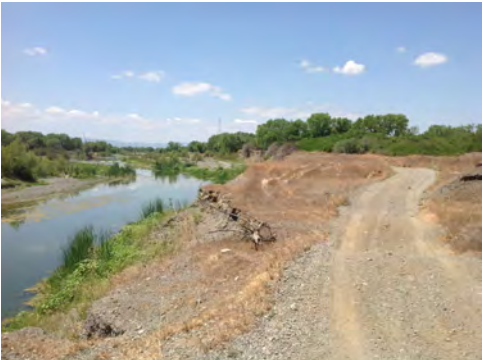
Larsen	Swallow habitat created by erosion.	Looking upstream we see a vertically cut Bank on the northside a natural process of stream dynamics which we should acknowledge and encourage wherever it occurs. It provides habitat for swallows.	Dunnigan Hills Reach	RM 18.1

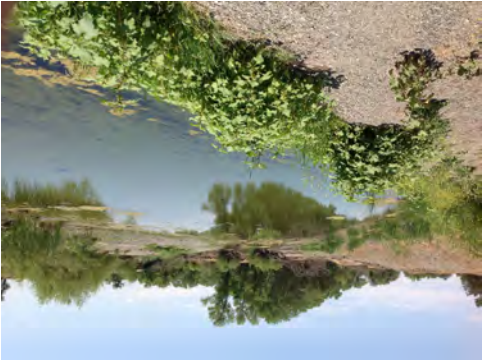
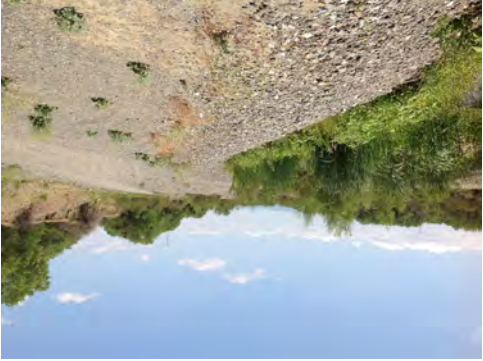
Observer	Comments	Verbose Comments	River Reach	River Miles	Image
Martin	Actively eroding banks taking out mature cottonwoods and other vegetation just upstream of Moore Siphon.		Dunnigan Hills Reach Dunnigan Hills Reach	RM 18.1

Martin	Actively eroding banks taking out mature cottonwoods and other vegetation just upstream of Moore Siphon.		Dunnigan Hills Reach	RM 18.1

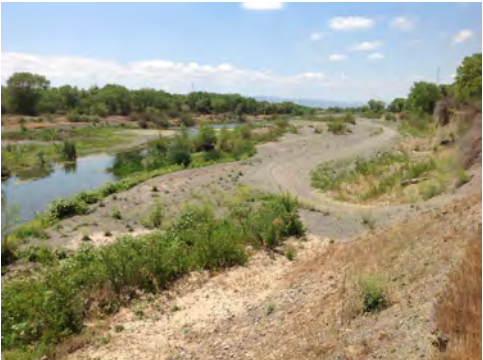
Tompkins	Looking upstream mature riparian vegetation on both banks	Looking upstream at mature riparian vegetation on both banks.	Dunnigan Hills Reach	RM 18.1

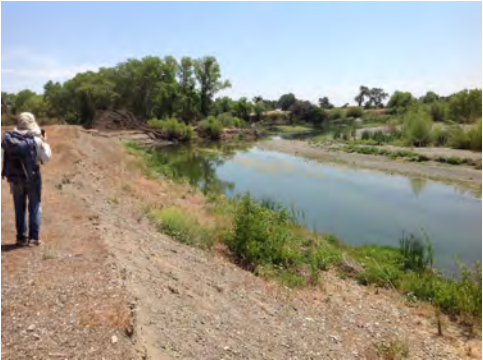
Observer	Comments	Verbose Comments	River Reach	River Miles	Image
Tompkins	Looking downstream towards Moores siphon. Some erosion of left Bank	Looking downstream towards Moore's siphon. Some erosion of left bank.	Dunnigan Hills Reach	RM 18.1

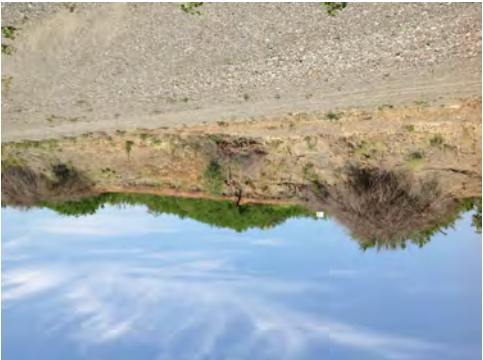
Martin	Dense stand of tamarisk and arundo on north bank above vertical the space. Consider cooperative agreement to allow County to treat tamarisk and arundo at this location.		Dunnigan Hills Reach	RM 18.2

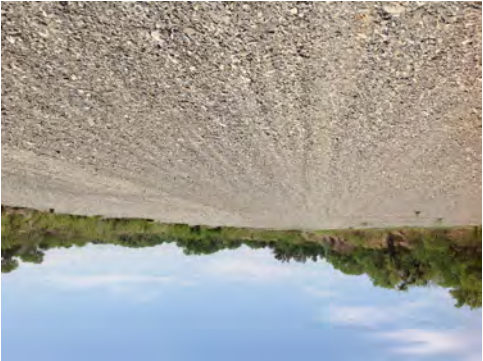
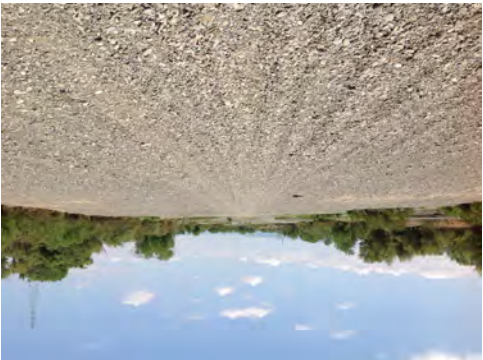
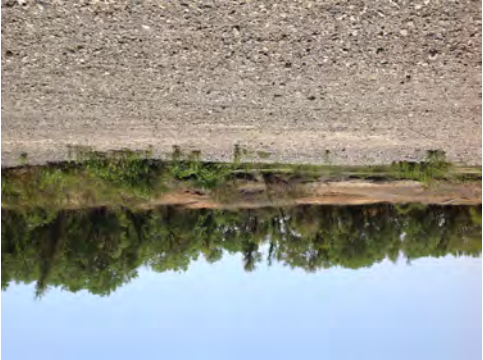
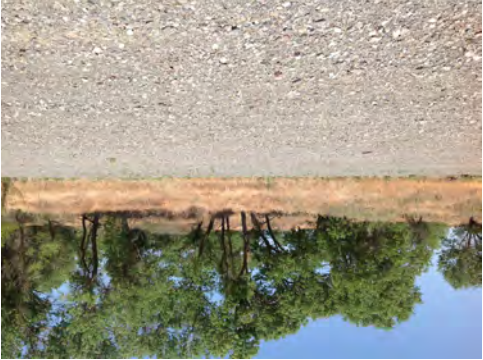
Martin	Broad unvegetated channel bottom bordered by well-developed woody vegetation on both north and south banks with mid-level terrace.		Dunnigan Hills Reach	RM 18.3

Observer	Comments	Verbose Comments	River Reach	River Miles	Image
Martin	Broad unvegetated channel bottom bordered by well-developed woody vegetation on both north and south banks with mid-level terrace.		Dunnigan Hills Reach Dunnigan Hills Reach	RM 18.3

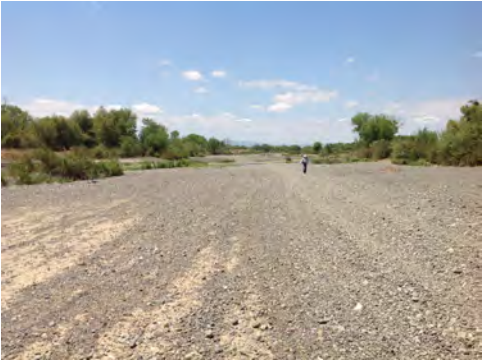
Observer	Comments	Verbose Comments	River Reach	River Miles	Image
Tompkins	Looking upstream note large mature cottonwood willow black walnut right bank and left Bank	Looking upstream. Note large mature cottonwood, willow, and black walnut on right bank and left bank.	Dunnigan Hills Reach	RM 18.3

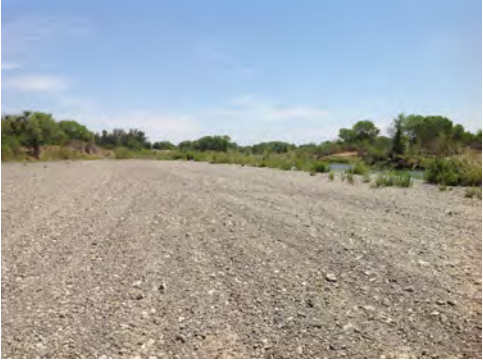
Tompkins	Looking downstream primary channel on the right bank adjacent to flat Terrace approximately 50 to 100 feet wide flanked by mature cottonwoods and Willow	Looking downstream at primary channel on the right bank adjacent to flat terrace approximately 50 to 100 feet wide flanked by mature cottonwoods and willow.	Dunnigan Hills Reach	RM 18.3

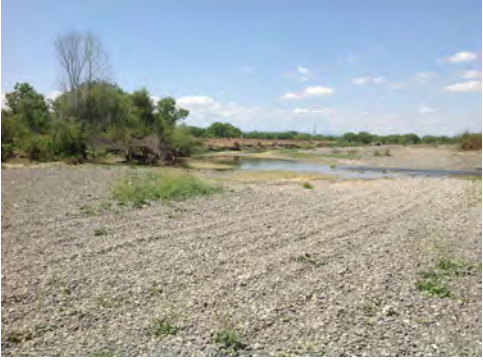
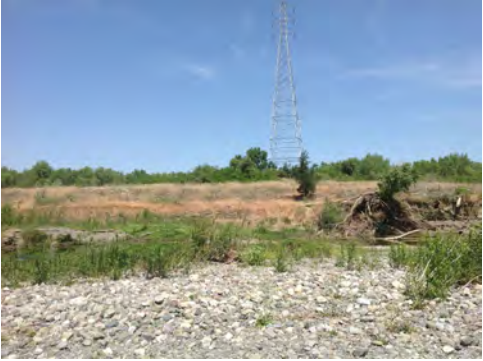
Larsen	Spur dikes	The upstream photo of Southbank spur dikes. They influenced the channel so that it swings to the north bank downstream from the spur dilkes	Dunnigan Hills Reach	RM 18.5

Observer	Comments	Verbose Comments	River Reach	River Miles	Image
Larsen	Spur dikes	The upstream photo of Southbank spur dikes. They influenced the channel so that it swings to the north bank downstream from the spur dikes	Dunnigan Hills Reach Dunnigan Hills Reach	RM 18.5

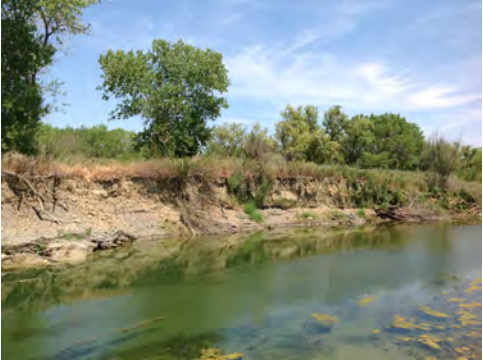
Martin	At least two pair of rough winged swallows nesting on vertical cliff of north bank.		Dunnigan Hills Reach	RM 18.5

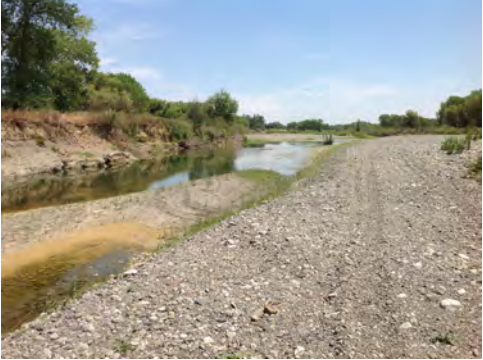
Tompkins	Looking downstream left bank erosion at bedrock toe	Looking downstream left bank erosion at bedrock toe.	Dunnigan Hills Reach	RM 18.5

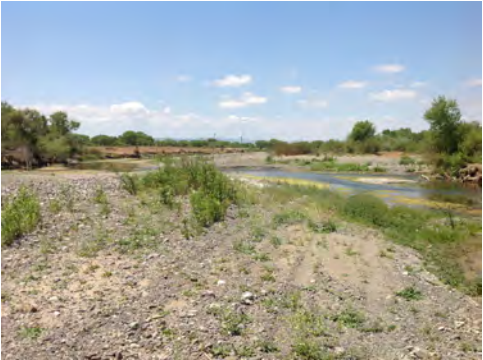
Observer	Comments	Verbose Comments	River Reach	River Miles	Image
Tompkins	Looking upstream at right bank erosion of spur Dykes	Looking upstream at right bank erosion of spur dykes.	Dunnigan Hills Reach	RM 18.5

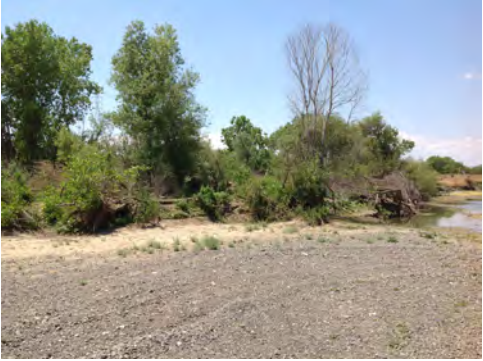
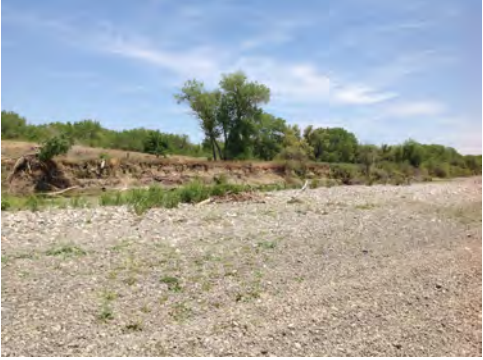
Martin	Heavy beaver loss of cottonwood trees at outside edge of low flow channel in view upstream just downstream of Rincon spur dikes. View downstream of exposed bank with nesting swallows.		Dunnigan Hills Reach	RM 18.6

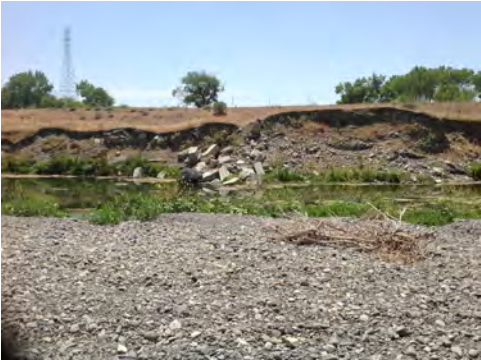
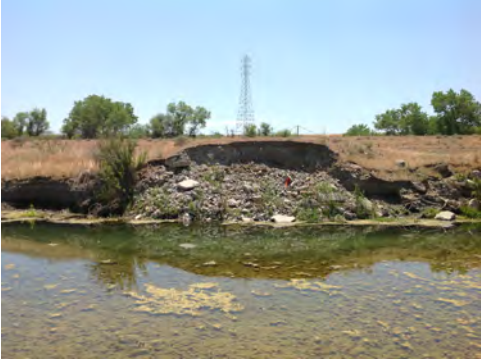
Observer	Comments	Verbose Comments	River Reach	River Miles	Image
Larsen	Dike nose erosion	Exposed concrete rubble where erosion has moved into a former spur dike. This area has degraded habitat value. This is a good example of the degraded habitat that occurs with cement rubble is used to make spur dikes.	Dunnigan Hills Reach	RM 18.7

Larsen	Dike nose erosion	Exposed concrete rubble where erosion has moved into a former spur dike. This area has degraded habitat value. This is a good example of the degraded habitat that occurs with cement rubble is used to make spur dikes.	Dunnigan Hills Reach	RM 18.7

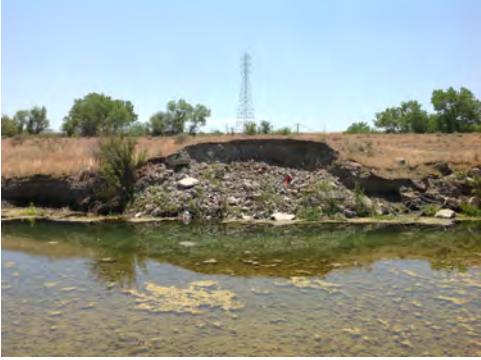
Tompkins	Right bank eroded spur dike note small relatively small concrete rubble eroding out of spur dike	Right bank eroded spur dike. Note relatively small concrete rubble eroding out of spur dike. This should be monitored after future high winter flows.	Dunnigan Hills Reach	RM 18.7

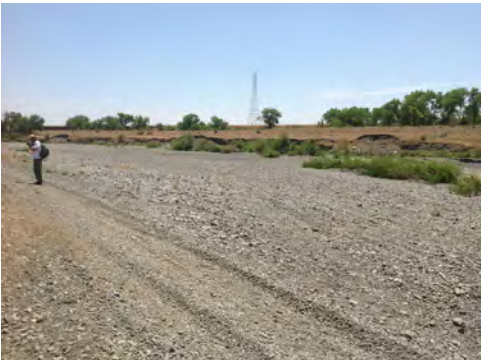
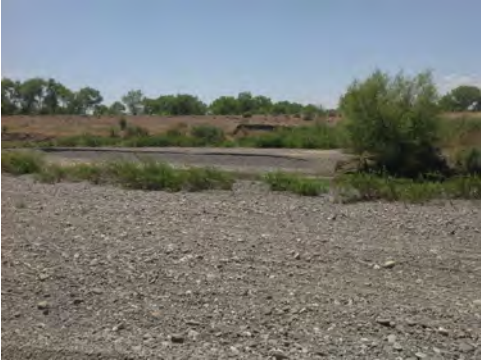
Observer	Comments	Verbose Comments	River Reach	River Miles	Image
Larsen	Dike toe erosion	Photos of possible toes of dikes from pre-ordnance construction here. It would be possible to lessen the erosion pressure here by bar skimming	Dunnigan Hills Reach	RM 18.8

Larsen	Dike toe erosion	Photos of possible toes of dikes from pre-ordnance construction here. It would be possible to lessen the erosion pressure here by bar skimming	Dunnigan Hills Reach	RM 18.8

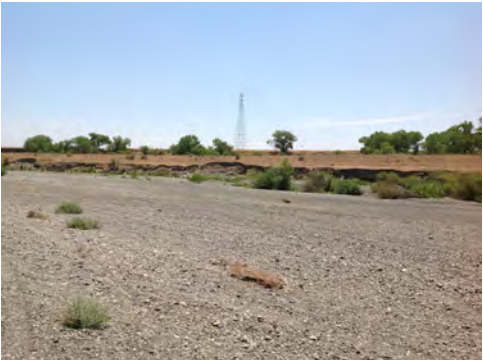
Martin	Severe erosion on south bank of active channel at spur dikes installed in 1998. Possible future treatment area for bar skimming to relieve pressure at south bank.		Dunnigan Hills Reach	RM 18.8

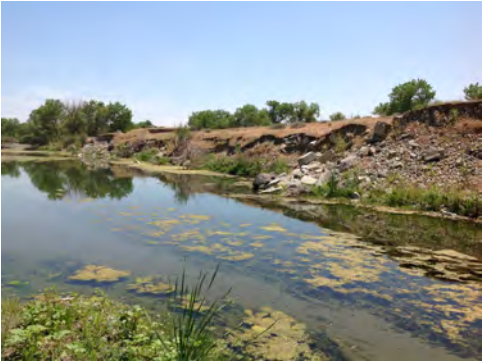
Martin	Concrete rubble at eroded spur dikes on Solano Concrete property at river mile 18.1. Concrete rubble limits habitat value and could be capped as part of future restoration.		Dunnigan Hills Reach	RM 18.8

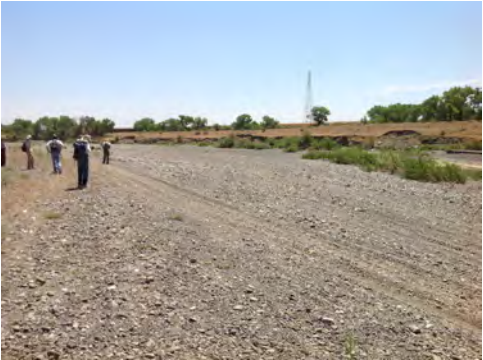
Observer	Comments	Verbose Comments	River Reach	River Miles	Image
Tompkins	Looking downstream towards the right bank where erosion scallops are present erosion was also present in 2012	Looking downstream towards the right bank where erosion scallops are present erosion was also present in 2012.	Dunnigan Hills Reach	RM 18.8

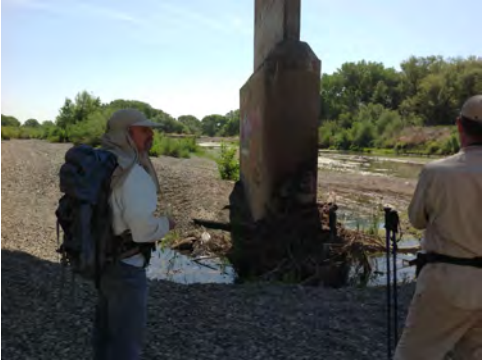
Observer	Comments	Verbose Comments	River Reach	River Miles	Image
Larsen	#75b Vegetation caught on bridge piling	The vegetation pile filling the left-hand here looking downstream is dense and would impede the flow and reduce flow capacity. It is not clear whether this has changed since last year. If so only a li	Hoppin Reach	RM 15.9

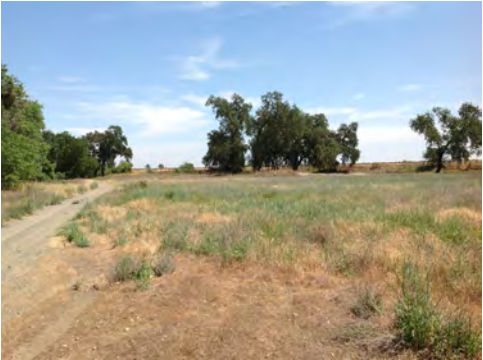
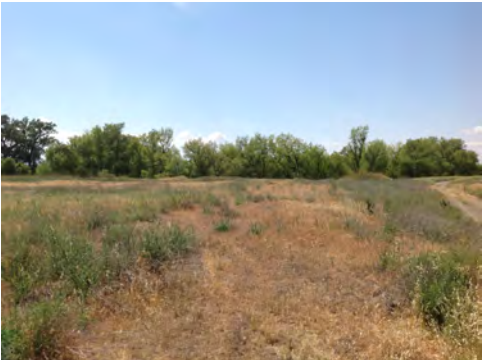
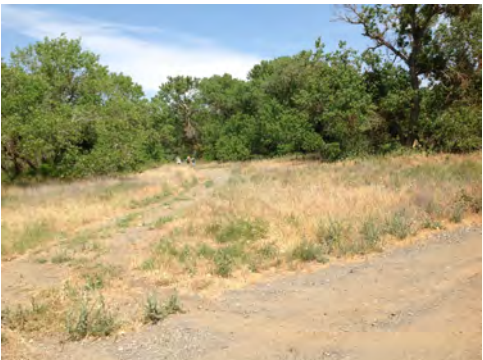
Observer	Comments	Verbose Comments	River Reach	River Miles	Image
Martin	Potential upper terrace restoration project at Patterson property east of former pit. Need further exploration of opportunity and feasibility.		Dunnigan Hills Reach	RM 17.3

Martin	Potential upper terrace restoration project at Patterson property east of former pit. Need further exploration of opportunity and feasibility.		Dunnigan Hills Reach	RM 17.3

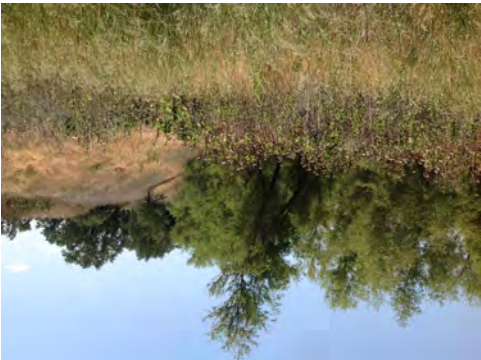
Larsen	Benefits of erosion	This is an example of a rather steep bank that has been allowed to naturally vegetate. This is what is not possible on area where cement and Kabul predominates.	Dunnigan Hills Reach	RM 17.8

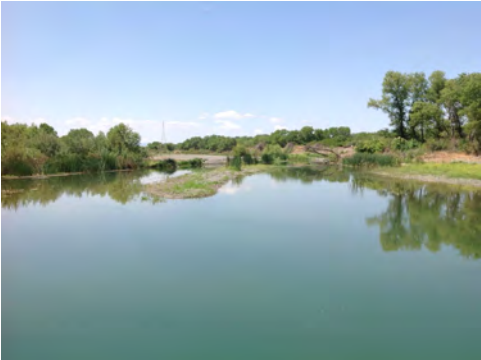
Observer	Comments	Verbose Comments	River Reach	River Miles	Image
Larsen	#74b Audio notes on Moores siphon.	Moore siphon	Dunnigan Hills Reach	RM 18

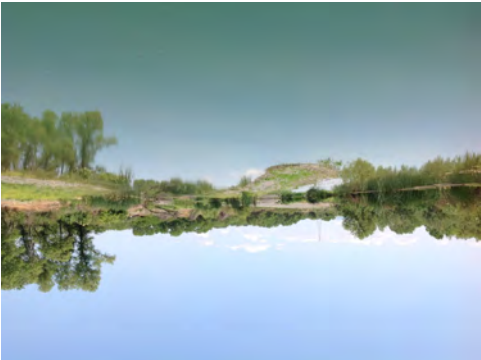
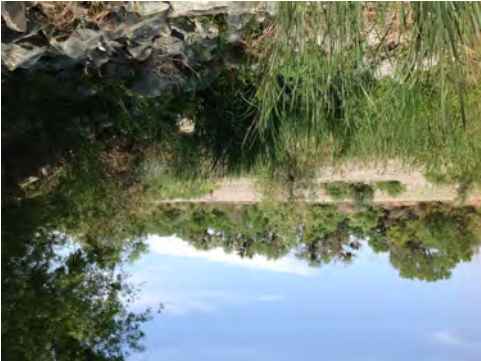
Martin	Moore Siphon crossing with beaver dam at crossing location.		Dunnigan Hills Reach	RM 18

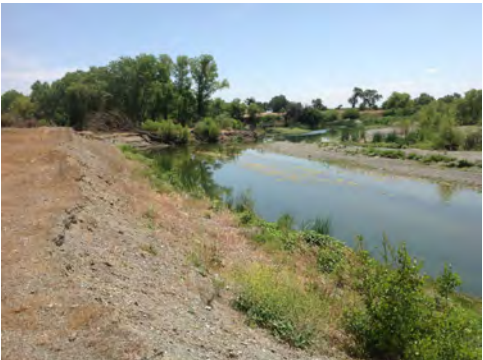
Observer	Comments	Verbose Comments	River Reach	River Miles	Image
Larsen	Instream habitat	Valuable instream habitat created by natural process of bank erosion. This is an area that would loose if you treat upstream from Morris siphon. We have agreed that this is an area that provides habitat Value in stream and off stream	Dunnigan Hills Reach	RM 18.1

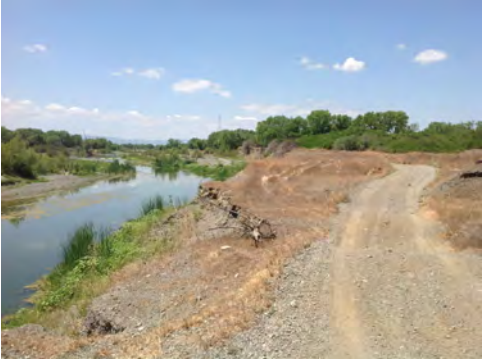
Larsen	Swallow habitat created by erosion.	Looking upstream we see a vertically cut Bank on the northside a natural process of stream dynamics which we should acknowledge and encourage wherever it occurs. It provides habitat for swallows.	Dunnigan Hills Reach	RM 18.1

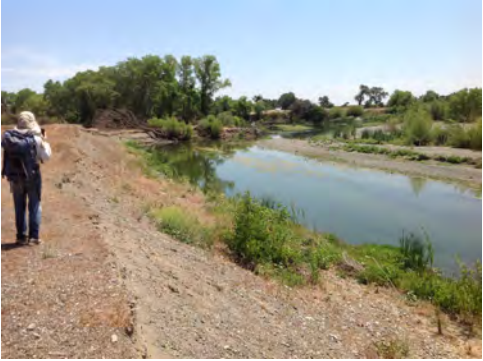
Observer	Comments	Verbose Comments	River Reach	River Miles	Image
Tompkins	Looking downstream towards Moores siphon. Some erosion of left Bank	Looking downstream towards Moore's siphon. Some erosion of left bank.	Dunnigan Hills Reach	RM 18.1

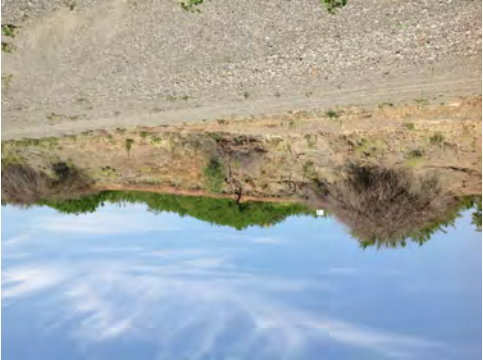
Martin	Dense stand of tamarisk and arundo on north bank above vertical the space. Consider cooperative agreement to allow County to treat tamarisk and arundo at this location.		Dunnigan Hills Reach	RM 18.2

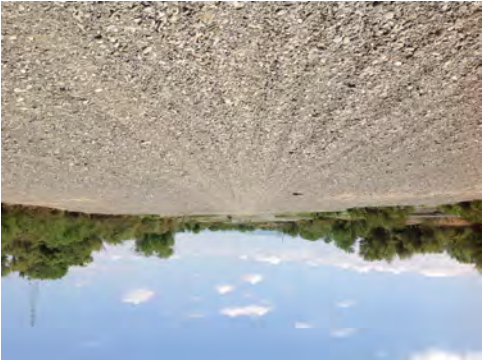
Observer	Comments	Verbose Comments	River Reach	River Miles	Image
Martin	Broad unvegetated channel bottom bordered by well-developed woody vegetation on both north and south banks with mid-level terrace.		Dunnigan Hills Reach	RM 18.3

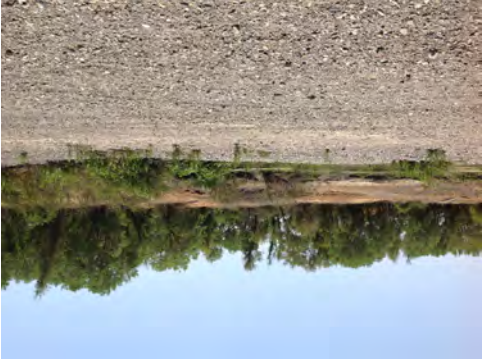
Martin	Broad unvegetated channel bottom bordered by well-developed woody vegetation on both north and south banks with mid-level terrace.		Dunnigan Hills Reach	RM 18.3

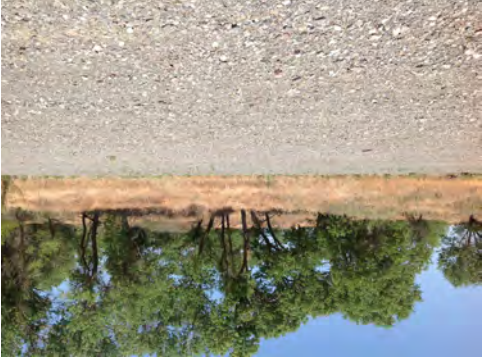
Martin	Broad unvegetated channel bottom bordered by well-developed woody vegetation on both north and south banks with mid-level terrace.		Dunnigan Hills Reach	RM 18.3

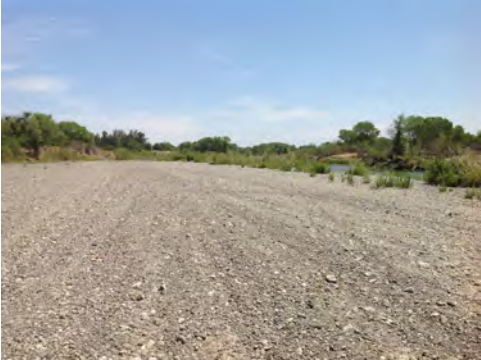
Observer	Comments	Verbose Comments	River Reach	River Miles	Image
Tompkins	Looking upstream note large mature cottonwood willow black walnut right thank and left Bank	Looking upstream. Note large mature cottonwood, willow, and black walnut on right bank and left bank.	Dunnigan Hills Reach	RM 18.3	 
Tompkins	Looking downstream primary channel on the right bank adjacent to flat Terrace approximately 50 to 100 feet wide flanked by mature cottonwoods and Willow	Looking downstream at primary channel on the right bank adjacent to flat terrace approximately 50 to 100 feet wide flanked by mature cottonwoods and willow.	Dunnigan Hills Reach	RM 18.3

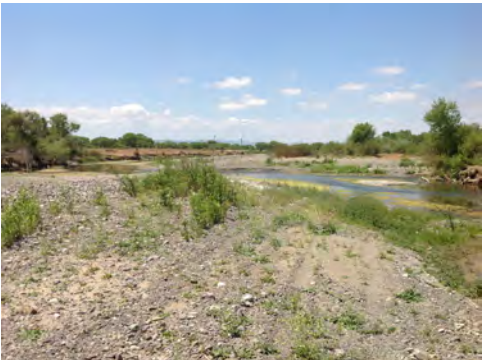
Observer	Comments	Verbose Comments	River Reach	River Miles	Image
Tompkins	Looking upstream at right bank erosion of spur Dykes	Looking upstream at right bank erosion of spur dykes.	Dunnigan Hills Reach	RM 18.5
