2013 CACHE CREEK ANNUAL STATUS REPORT

For the period of
October 1, 2012 to September 30, 2013

CACHE CREEK TECHNICAL ADVISORY COMMITTEE:

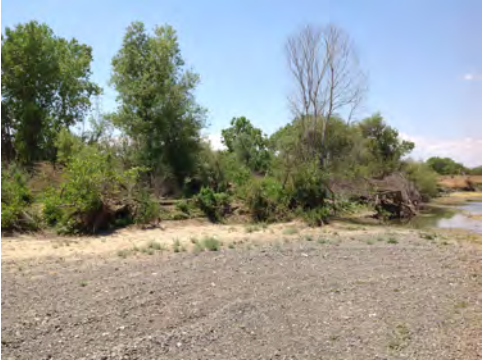
Martin	Heavy beaver loss of cottonwood trees at outside edge of low flow channel in view upstream just downstream of Rincon spur dikes. View downstream of exposed bank with nesting swallows.		Dunnigan Hills Reach	RM 18.6

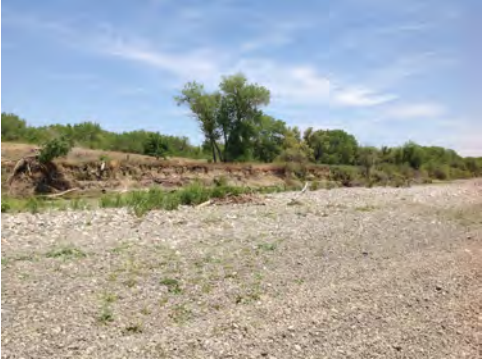
Martin	Heavy beaver loss of cottonwood trees at outside edge of low flow channel in view upstream just downstream of Rincon spur dikes. View downstream of exposed bank with nesting swallows.		Dunnigan Hills Reach	RM 18.6

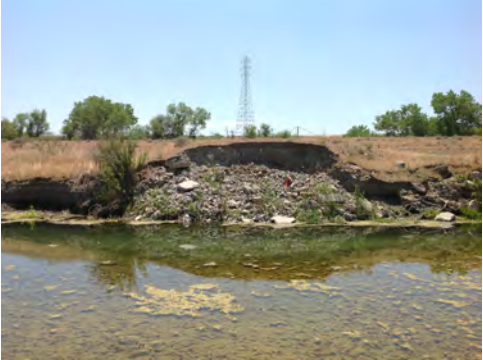
Larsen	Dike nose erosion	Exposed concrete rubble where erosion has moved into a former spur dike. This area has degraded habitat value. This is a good example of the degraded habitat that occurs with cement rubble is used to make spur dikes.	Dunnigan Hills Reach	RM 18.7

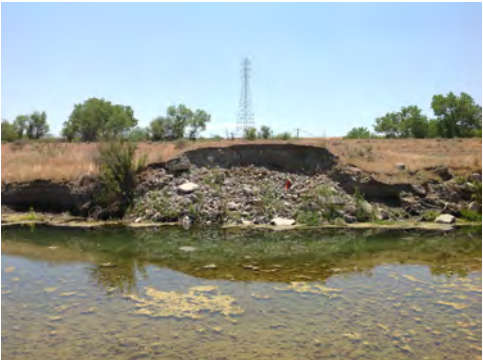
Tompkins	Right bank eroded spur dike note small relatively small concrete rubble eroding out of spur dike	Right bank eroded spur dike. Note relatively small concrete rubble eroding out of spur dike. This should be monitored after future high winter flows.	Dunnigan Hills Reach	RM 18.7

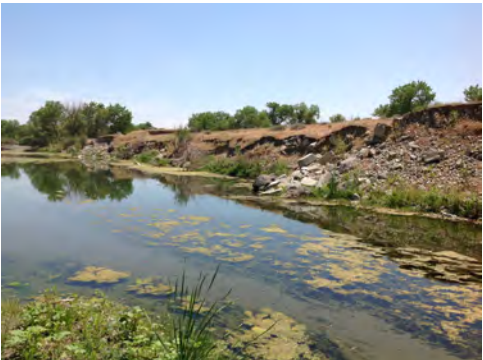
Observer	Comments	Verbose Comments	River Reach	River Miles	Image
Larsen	Dike nose erosion dumping rubble into the creek	There is exposed concrete rubble in the tophus burdocks upstream from more siphon. Each of the Forsberg likes is a rodent. It is unsightly and his discharging cement Creek. Jlm remarked that this concrete limits the habitat vvalue.	Dunnigan Hills Reach	RM 18.8

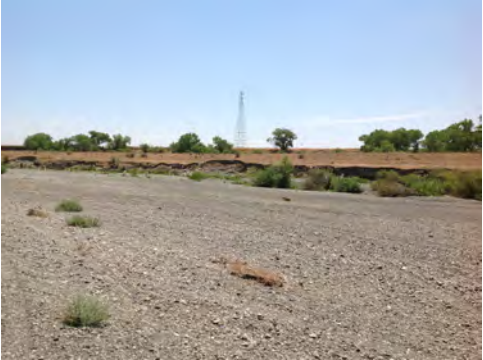
Martin	Severe erosion on south bank of active channel at spur dikes installed in 1998. Possible future treatment area for bar skimming to relieve pressure at south bank.		Dunnigan Hills Reach	RM 18.8

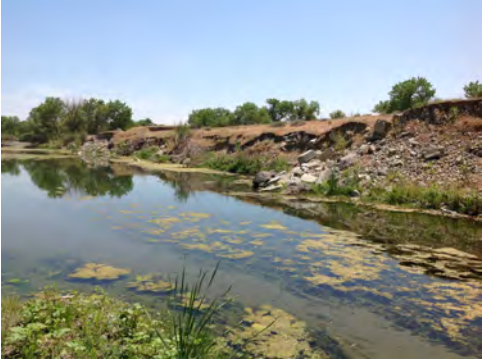
Martin	Concrete rubble at eroded spur dikes on Solano Concrete property at river mile 18.1. Concrete rubble limits habitat value and could be capped as part of future restoration.		Dunnigan Hills Reach	RM 18.8

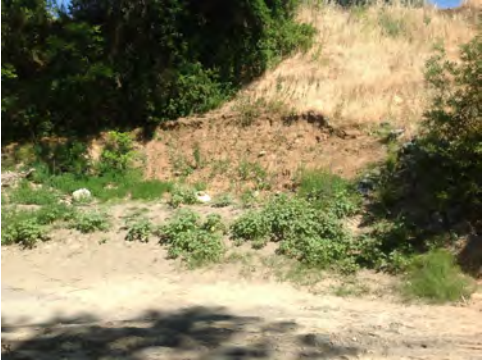
Observer	Comments	Verbose Comments	River Reach	River Miles	Image
Larsen	Deposition occurring at former erosion spot	Fine deposition in an area downstream from the rock. This is an area of former erosion. It's possible that this deposition will continue to occur and protect the slump bank above it.	Rio Jesus Maria Reach	RM 11.6

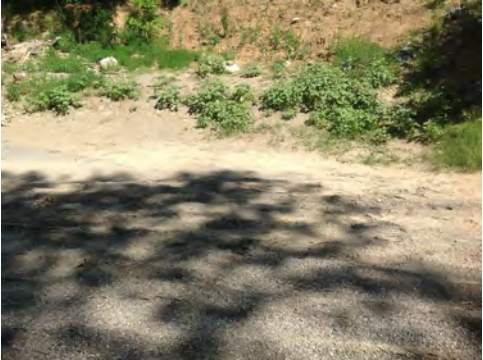
Larsen	Deposition occurring at former erosion spot	Fine deposition in an area downstream from the rock. This is an area of former erosion. It's possible that this deposition will continue to occur and protect the slump bank above it.	Rio Jesus Maria Reach	RM 11.6

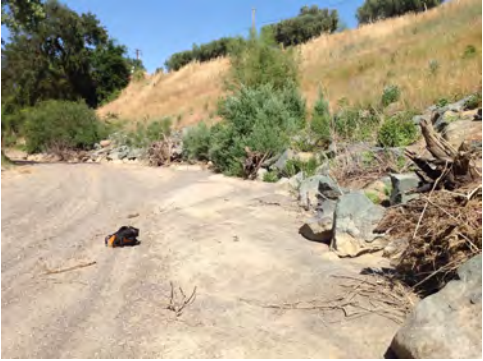
Observer	Comments	Verbose Comments	River Reach	River Miles	Image
Tompkins	Looking downstream at huffs corner. Right thanks large riprap go. Possibly some fine sediment infill since 2012.	Looking downstream at Huffs Corner. Right bank large may have some fine sediment infill since 2012.	Rio Jesus Maria Reach	RM 11.6

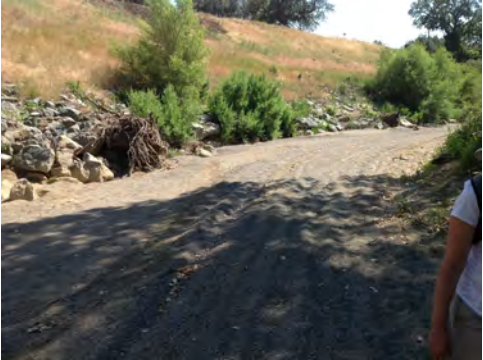
Tompkins	Looking upstream. House corner right bank. Fine sediment infill along large rock toe of slope.	Looking upstream. Huff's Corner right bank. Fine sediment infill along large rock toe of slope since 2012.	Rio Jesus Maria Reach	RM 11.6

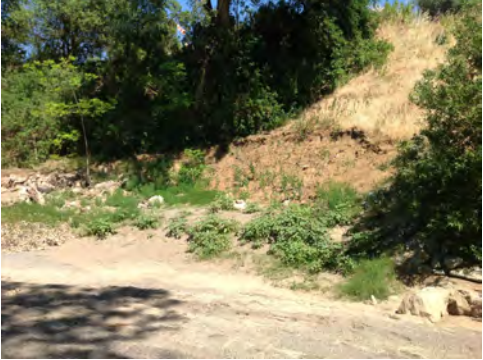
Tompkins	Right bank downstream end of huffs corner revetment. Looks like minor improvement with some new vegetation in scoured area downstream thanks protection.	Right bank downstream end of huffs corner revetment. Looks like minor improvement with some new vegetation in scoured area downstream thanks protection. Additional purposeful revegetation prior to next high flows could improve conditions in this location even further.	Rio Jesus Maria Reach	RM 11.6

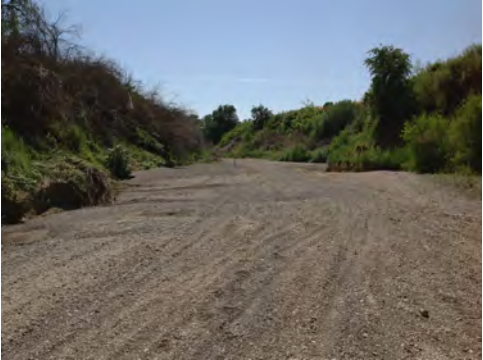
Martin	Deeply incised channel with heavy tamarisk removal evident. Very little replacement groundcover in the vicinity of removed tamarisk.		Rio Jesus Maria Reach	RM 11.8

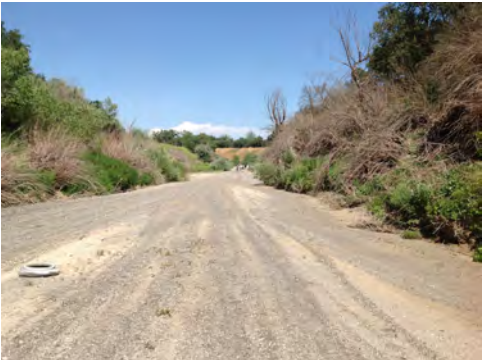
Martin	Deeply incised channel with heavy tamarisk removal evident. Very little replacement groundcover in the vicinity of removed tamarisk.		Rio Jesus Maria Reach	RM 11.8

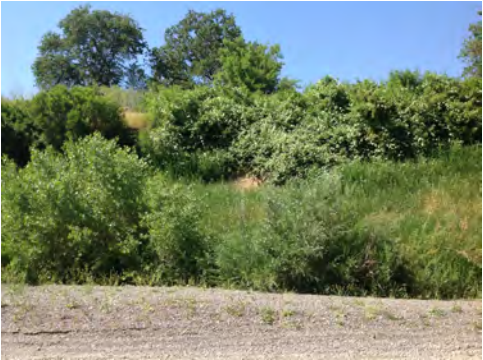
Observer	Comments	Verbose Comments	River Reach	River Miles	Image
Martin	Deeply incised channel with heavy tamarisk removal evident. Very little replacement groundcover in the vicinity of removed tamarisk.		Rio Jesus Maria Reach	RM 11.8

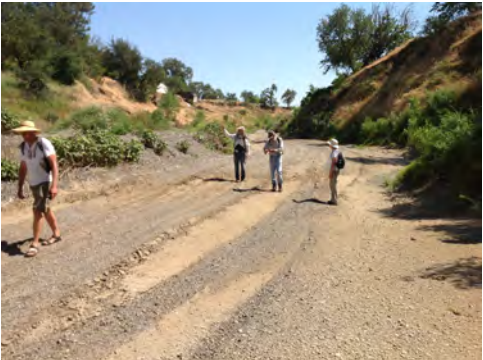
Tompkins	Looking upstream. Narrow confined reach. Right bank structure falling into Creek.	Looking upstream. Narrow confined reach. Right bank structure falling into creek.	Rio Jesus Maria Reach	RM 12.1

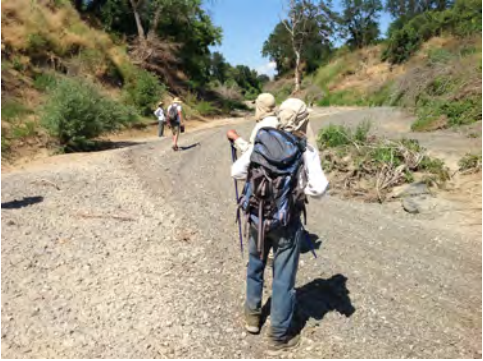
Observer	Comments	Verbose Comments	River Reach	River Miles	Image
Tompkins	Looking downstream. Narrow confined reach. Entering huffs corner.	Looking downstream. Narrow confined reach. Entering Huff's Corner.	Rio Jesus Maria Reach	RM 12.1

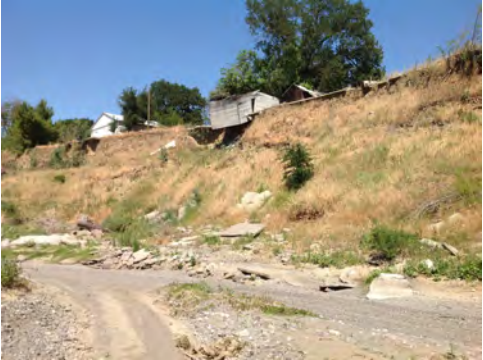
Tompkins	Looking at right bank. Significant debris at whole of right bank slope structure at top of slope still cantilevered over top of bank. Similar to last year.	Looking at right bank. Significant debris at whole of right bank slope structure at top of slope still cantilevered over top of bank. Similar to last year.	Rio Jesus Maria Reach	RM 12.2

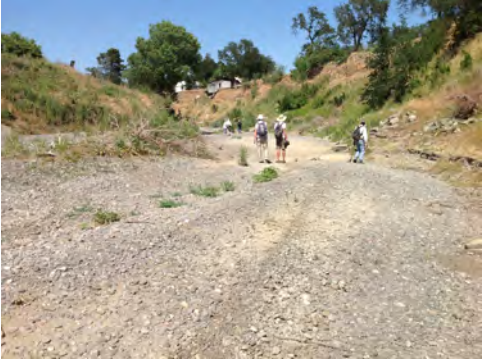
Tompkins	Downstream. White building at top of right bank near to falling into the channel	Downstream. White building at top of right bank near to falling into the channel. Does note appear to have changed substantially since 2012 but should be monitored closely in future years.	Rio Jesus Maria Reach	RM 12.3

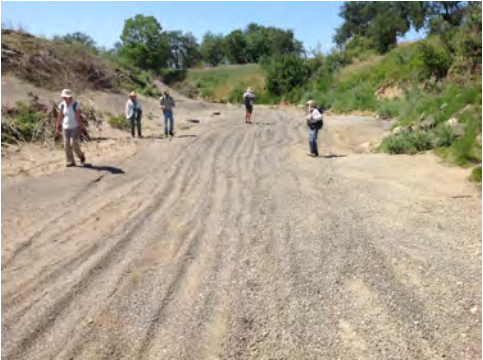
Observer	Comments	Verbose Comments	River Reach	River Miles	Image
Tompkins	Looking upstream. Large rock riprap At toe of left Bank. Erosion along west bank.	Looking upstream. Large rock riprap at toe of left Bank. Erosion along west bank.	Rio Jesus Maria Reach	RM 12.4

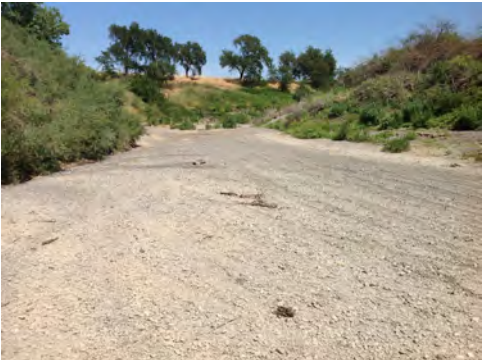
Tompkins	Looking downstream. Just upstream of tight ass band.	Looking downstream. Just upstream of tight meander bend.	Rio Jesus Maria Reach	RM 12.5

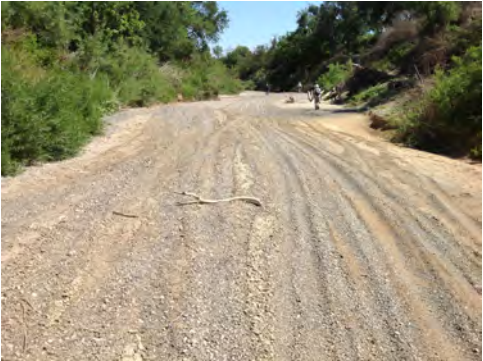
Tompkins	Looking downstream. Continued transition from gravel sand. Extensive eradicated Arendo.	Looking downstream. Continued transition from gravel sand. Extensive eradicated Arendo.	Rio Jesus Maria Reach	RM 12.5

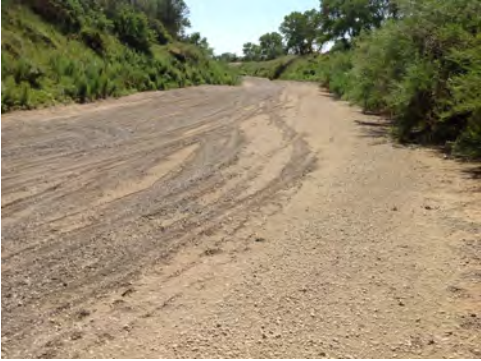
Observer	Comments	Verbose Comments	River Reach	River Miles	Image
Tompkins	Looking upstream. Narrow confined reach. Beginning transition from gravel to sand.	Looking upstream. Narrow confined reach. Beginning transition from gravel to sand.	Rio Jesus Maria Reach	RM 12.6

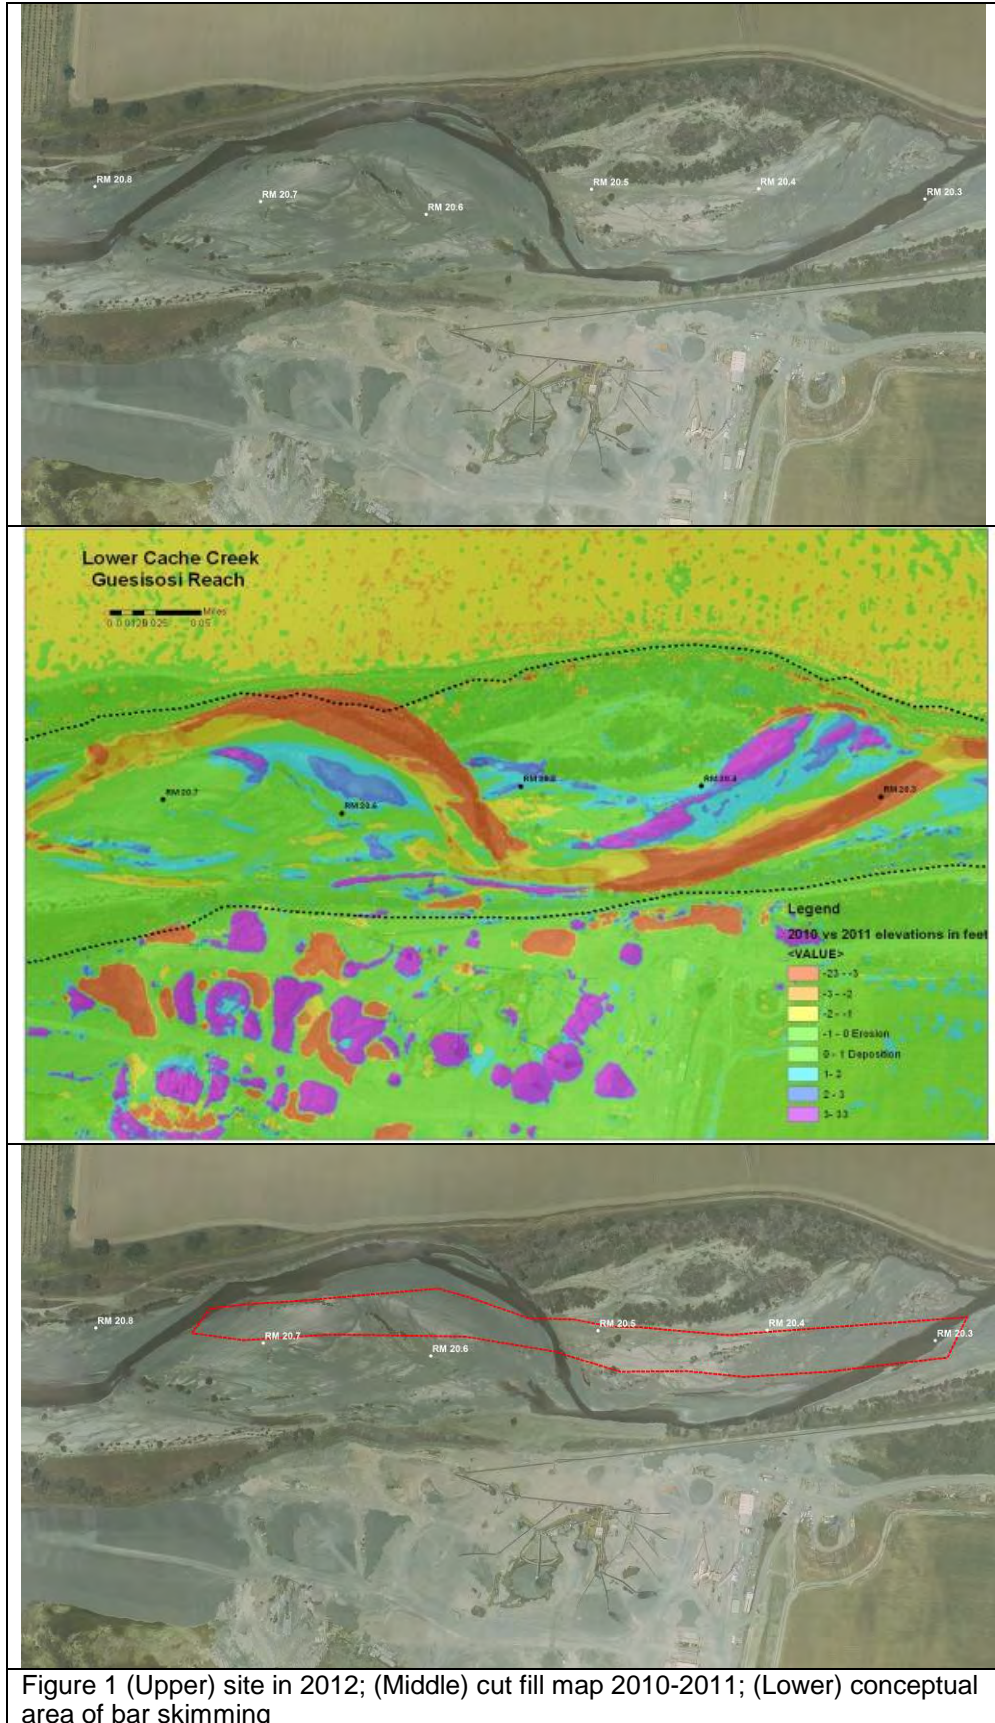
Gravel Bar Skimming - RM 20.3 - 20.8

Based on observations made during the 2013 Creek Walk, bar skimming is recommended at the CEMEX site located between RM 20.8 and RM 20.3 (Figure 1, upper figure) on Cache Creek. The work would provide multiple benefits, but is not urgent for the integrity of the banks at this location or for the safety of the CEMEX plant. The recommended bar-skimming would provide the benefit of reduced pressure on the south bank. The south bank has experienced severe erosion in the past and has required corrective work by CEMEX to protect the conveyor system located near the top of the bank. Reducing pressure on the south bank could help to avoid further bank instability and severe erosion on the south bank in the future.

Cut and fill maps between 2010 and 2011 (Figure 1, middle image) show that considerable deposition of sand and gravel has occurred in this area. Observations in both the 2012 and 2013 Creek Walks have suggested that there is continued deposition in this area. This deposition has occurred as the channel shifted in 2011 toward the south bank near RM 20.4, which resulted in bank repairs near this area performed by CEMEX in 2010.

The TAC recommends that bar skimming be performed in the vicinity of RM 20.5 to 20.3. To facilitate this, and to increase the probability that this extracted area not fill immediately following large peak flows, it is recommended that an area immediately upstream and in direct alignment with the depositional area of concern also be extracted (Figure 1, lower figure). The proposed area for extraction in the figure is a conceptual sketch and not meant to be used for design purposes. If bar skimming is determined to be feasible, the final design of the operation should include input from the TAC so that the skimming optimizes habitat enhancement and protection.

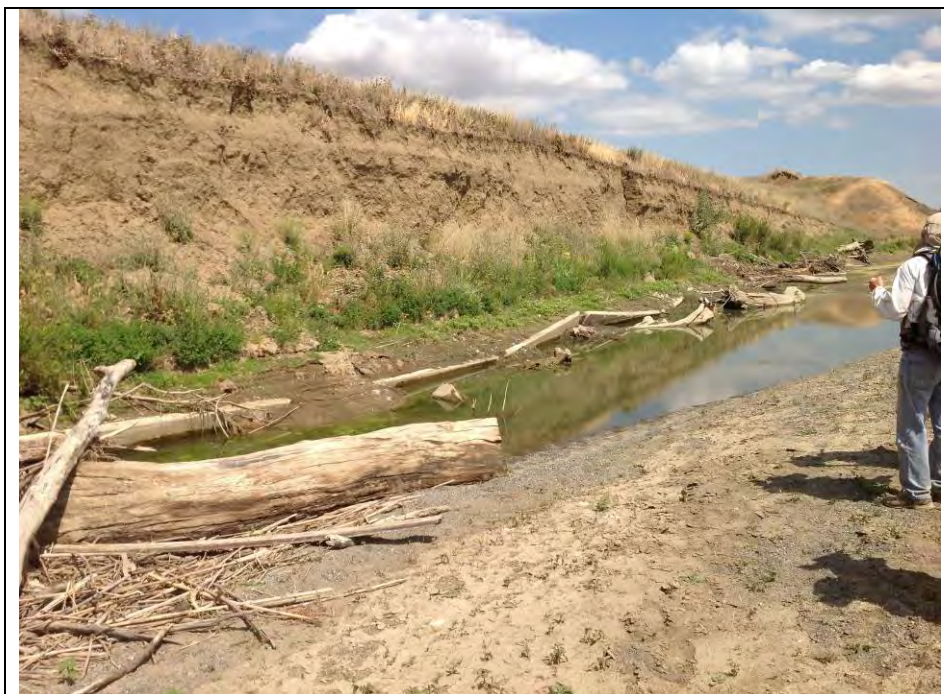
Gravel Bar Skimming - RM 22.8 - 23.0

In conjunction with the three most recent annual creek inspections (“Creek Walks”), the TAC has noted bank erosion where large woody debris was used to stabilize the toe of the slope in this area. As noted above, Questa Engineering did stabilization with large woody debris, cabled root-wads, and cement k-rails (Figure 2). In 2013 the TAC noted that the main channel had shifted away from the north bank, and that some deposition had occurred between the bank and the new channel, which provided a potential opportunity for bar skimming in this location. Comparison of field conditions encountered during the Creek Walk in 2013 to photographs of the site taken in 2012 do not indicate any changes in the condition of the bank at this location, nor are there indications that the entire berm is at risk of failure. Brandon Stauffer, the Teichert representative who met with the TAC during the 2013 Creek Walk, did not indicate that he felt that work needed to be performed this year to correct existing conditions.

Figure 2. 2013 image of exposed logs, scour holes, and k-rail where erosion is occurring at toe of bank

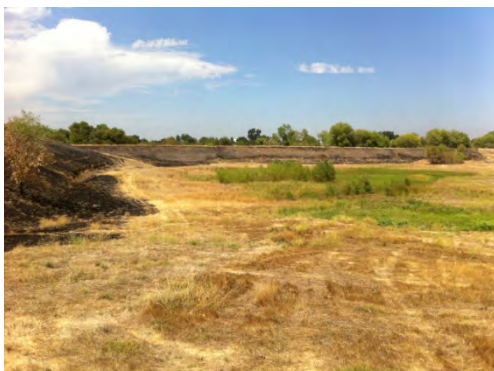
Figure 2 after August burn

prescribed burn was conducted on the east and south facing berms without our knowledge. The fire cleared the berms of vegetation, but no follow up work was done and the berms now pose an erosion threat. We are working to stabilize the berms with a native grass erosion control mix and will respond to any large washouts with appropriate measures.
